EASA	AIRWORTHINESS DIRECTIVE

<p>AD No.: 2015-0069</p> <p>Date: 29 April 2015</p> <p>Note: This Airworthiness Directive (AD) is issued by EASA, acting in accordance with Regulation (EC) No 216/2008 on behalf of the European Community, its Member States and of the European third countries that participate in the activities of EASA under Article 66 of that Regulation.</p>	
<p>This AD is issued in accordance with EU 748/2012, Part 21.A.3B. In accordance with EU 1321/2014 Annex I, Part M.A.301, the continuing airworthiness of an aircraft shall be ensured by accomplishing any applicable ADs. Consequently, no person may operate an aircraft to which an AD applies, except in accordance with the requirements of that AD, unless otherwise specified by the Agency [EU 1321/2014 Annex I, Part M.A.303] or agreed with the Authority of the State of Registry [EC 216/2008, Article 14(4) exemption].</p>		
<p>Design Approval Holder's Name: AGUSTAWESTLAND S.p.A.</p> <p>BELL HELICOPTER TEXTRON, Inc. BELL HELICOPTER TEXTRON CANADA Ltd. AIRBUS HELICOPTERS</p> <p>AIRBUS HELICOPTERS DEUTSCHLAND GmbH MD HELICOPTERS, Inc. SIKORSKY AIRCRAFT CORPORATION</p>	<p>Helicopter Type/Model designations: AW109SP, AB/AW 1

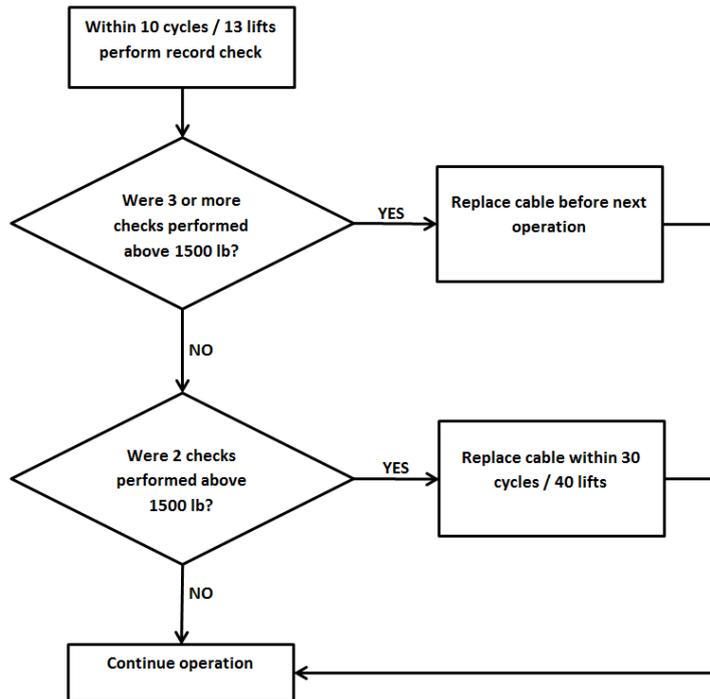
Figure 1

- Within 10 hoist operating cycles or 13 hoist lifts (as applicable, see Note 1 of this AD) after the effective date of this AD, determine the P/N of the hoist installed on the helicopter and, if a Goodrich hoist is installed with a P/N listed in Table 1 of this AD, accomplish a records check to determine whether, during any previous hoist load check/test, a cable was load-tested (average of 5 pulls) at 1 500 lb [680 kg] or more. If any cable is identified to have exceeded this limit during three or more hoist load checks/tests, before next hoist operation, replace the affected cable with a serviceable cable. If any cable is identified to have exceeded this limit during two hoist load checks/tests, within 30 cycles / 40 lifts replace the affected cable with a serviceable cable. For replacement of a cable, see figure 1 (flowchart) of this AD.

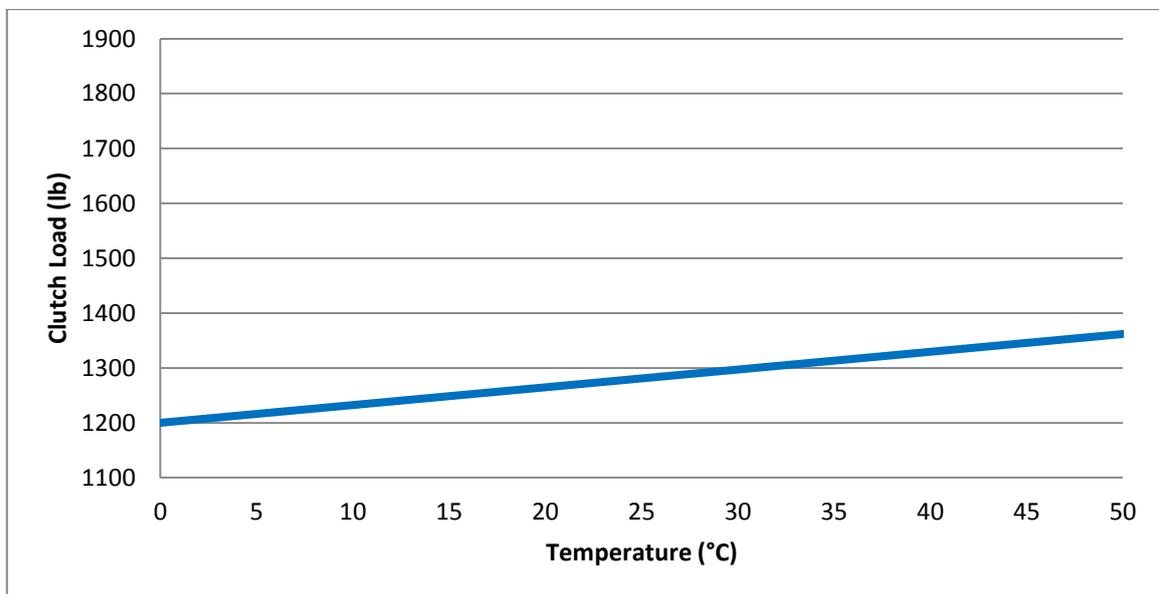
Figure 1-A: Acceptable lower load limit for 600-lb [272 kg] rated hoists

- Within 30 days after the effective date of this AD, accomplish an initial hoist load check/test in accordance with approved instructions from the helicopter manufacturer (type certificate holder), or from the hoist installation design approval holder (supplemental type certificate holder), as applicable to installation and helicopter type/model. The acceptable lower load limits are provided in Appendix 1 of this AD.
