| EASA | AIRWORTHINESS DIRECTIVE |
| | <p><b>AD No.: 2015-0069</b><br/> <b>[Correction: 30 April 2015]</b></p> <p><b>Date: 29 April 2015</b></p> <p>Note: This Airworthiness Directive (AD) is issued by EASA, acting in accordance with Regulation (EC) No 216/2008 on behalf of the European Community, its Member States and of the European third countries that participate in the activities of EASA under Article 66 of that Regulation.</p> |
| <p>Supersedure: This AD supersedes EASA AD 2014-0254 dated 21 November 2014.</p> | |
| ATA 25 | Equipment / Furnishings – Hoist – Test / Replacement |

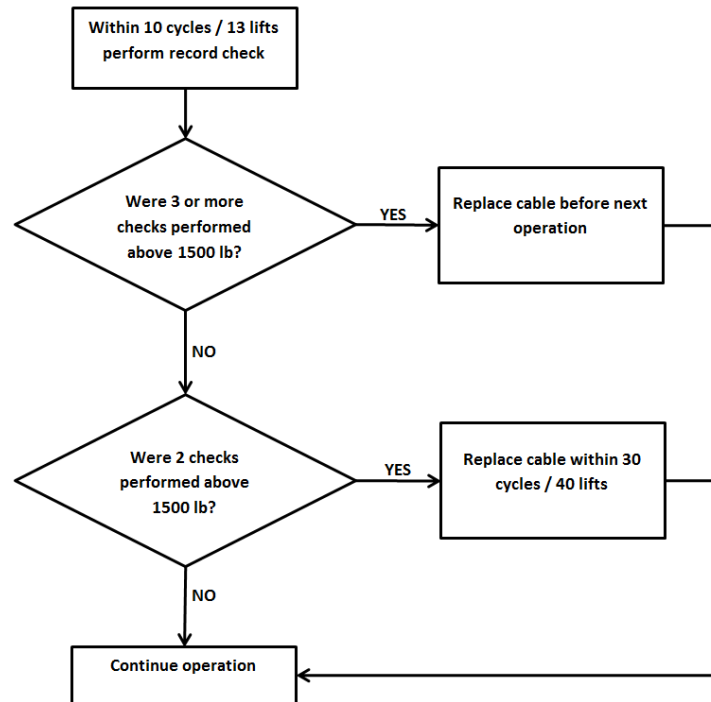
Figure 1

- (1) Within 10 hoist operating cycles or 13 hoist lifts (as applicable, see Note 1 of this AD) after the effective date of this AD, determine the P/N of the hoist installed on the helicopter and, if a Goodrich hoist is installed with a P/N listed in Table 1 of this AD, accomplish a records check to determine whether, during any previous hoist load check/test, a cable was load-tested (average of 5 pulls) at 1 500 lb [680 kg] or more. If any cable is identified to have exceeded this limit during three or more hoist load checks/tests, before next hoist operation, replace the affected cable with a serviceable cable. If any cable is identified to have exceeded this limit during two hoist load checks/tests, within 30 cycles / 40 lifts replace the affected cable with a serviceable cable. For replacement of a cable, see figure 1 (flowchart) of this AD.

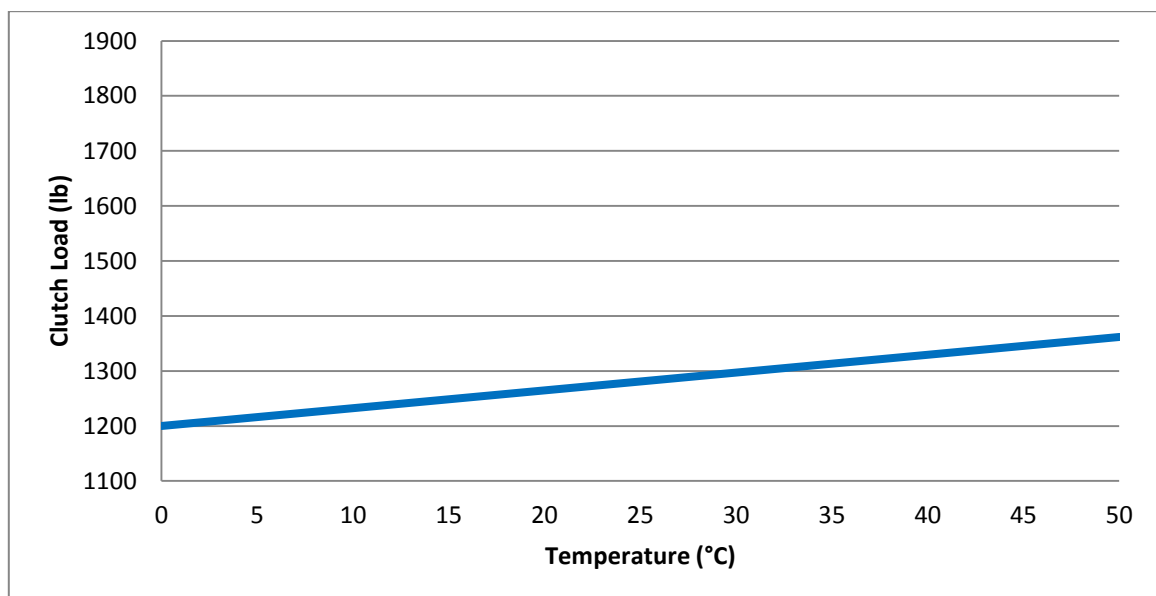
Figure 1-A: Acceptable lower load limit for 600-lb [272 kg] rated hoists

- (2) Within 30 days after the effective date of this AD, accomplish an initial hoist load check/test in accordance with approved instructions from the helicopter manufacturer (type certificate holder), or from the hoist installation design approval holder (supplemental type certificate holder), as applicable to installation and helicopter type/model. The acceptable lower load limits are provided in Appendix 1 of this AD.

- (3) Within the time interval, or hoist operating cycles/hoist lifts specified in the approved instructions from the type certificate holder, or from the supplemental type certificate holder, as applicable, whichever occurs first after the initial load check as required by paragraph (2) of this AD, and, thereafter, at intervals not to exceed the values (calendar time, or hoist operating cycles/hoist lifts, whichever occurs first) as specified in those same instructions, as applicable, accomplish a hoist load check/test (see Note 1 of this AD) in accordance with the instructions for on-going testing. The acceptable lower load limits are provided in Appendix 1 of this AD.
