EASA	NOTIFICATION OF A PROPOSAL TO ISSUE AN AIRWORTHINESS DIRECTIVE

<p>PAD No.: 10-016</p> <p>Date: 05 February 2010</p> <p>Note: This Proposed Airworthiness Directive (PAD) is issued by EASA, acting in accordance with Regulation (EC) No 216/2008 on behalf of the European Community, its Member States and of the European third countries that participate in the activities of EASA under Article 66 of that Regulation.</p>	
<p>In accordance with the EASA Continuing Airworthiness Procedures, the Executive Director is proposing the issuance of an EASA Airworthiness Directive (AD), applicable to the aeronautical product(s) identified below. All interested persons may send their comments, referencing the PAD Number above, to the e-mail address specified in the 'Remarks' section, prior to the consultation closing date indicated.</p>		
Type Approval Holder's Name :	Type/Model designation(s) :	
AIRBUS	A340-200/-300 aeroplanes

TCDS Number :	EASA.A.015	
Foreign AD :	Not applicable	
Supersedure :	None	
ATA 78	Exhaust – Thrust Reverser Actuation System Doors – Replacement	
Manufacturer(s):	Airbus (formerly Airbus Industrie)	
Applicability:	Airbus A340 aeroplanes, models -211, -212, -213, -311, -

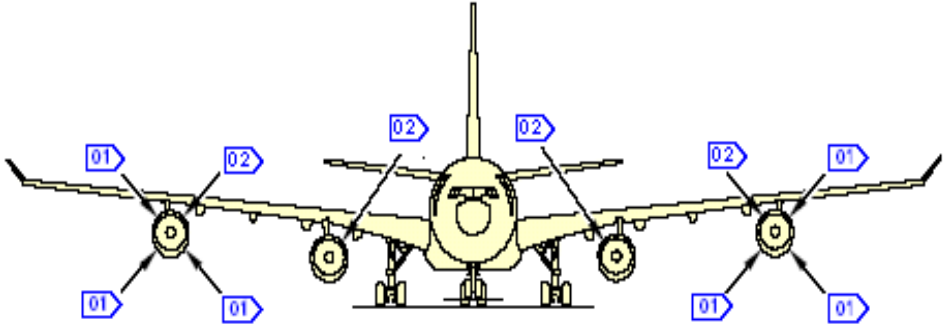
<p>Picture 1</p> </div>

Effective Date:	14 days after final AD issue date
Required action(s) and Compliance Time(s):	<p>Required as indicated, unless accomplished previously:</p> <ol style="list-style-type: none"> (1) No later than 28 February 2011, do the actions specified in paragraph (3) of this AD on the upper inboard thrust reverser pivoting door of each engine, as identified by the label 02 in Picture 1 below. (2) No later than 31 December 2012, do the actions specified in paragraph (3) of this AD on the upper outboard thrust reverser pivoting doors of engines n°1 and n°4, and lower thrust reverser pivoting doors (inboard and outboard) of engines n°1 and n°4 as identified by the label 01 in Picture 1 below. (3) Replace the primary lock in accordance with the instructions defined in Airbus Service Bulletin (SB) A340-78-4037, and Remove the installed shim and replace the actuator in accordance with the instructions defined in Airbus SB A340-78-4038. <div style="text-align: center;">
