EASA	<b>COMMENT RESPONSE DOCUMENT</b>

<b>EASA PAD No. 12-018</b> <b>[Published on the 23 February 2012 and officially closed for comments on the 22 March 2012]</b>

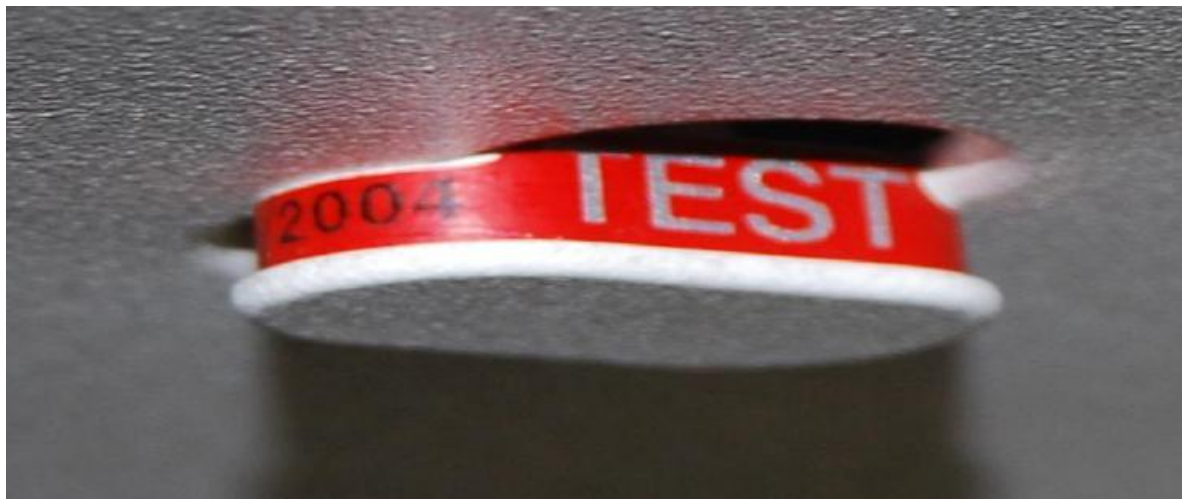
Picture 1 shows the operation of a Draeger container:

The surface of the test button remains parallel to the surface of the container door.

Puritan Bennett operates very similarly.

We would like to use this quick and reliable method to exclude the Draeger and Puritan Bennett containers (roughly 90% on DLH fleet) from the requirement of P/N+S/N identification by nameplate readout.

***Comment understood. The proposed alternative inspection method to exclude non affected containers from the P/N and s/n identification as required by paragraph (1) of this AD has been confirmed and improved by Airbus.***

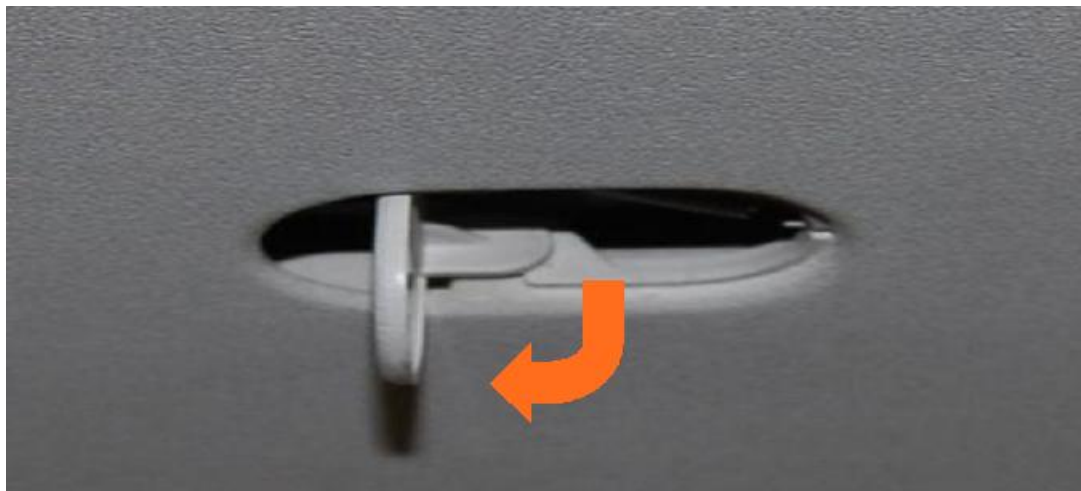
Picture 2 shows the operation of a BE Aerospace container:

The surface of the test button is at a 90° angle to the surface of the container door.

All containers with the door stop mechanism operating as in picture 2 naturally would have the full P/N and S/N identification as requested by step (1).
