AIRWORTHINESS DIRECTIVE

88-20 Hoffmann

Hoffmann-Constant-Speed-Propeller HO-V 123 ()-()/180R

Propeller blade

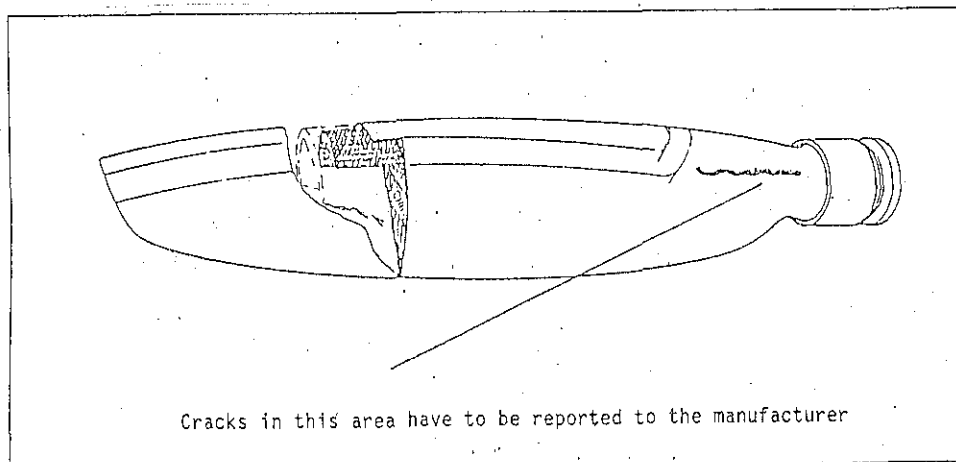
Cracks in the coating on the suction side near the blade shaft.

1. According to Instruction Manual E 287 the propeller blades have to be inspected for cracks on the surface during the daily inspection. Specially in the transition area of the blade shaft on the suction side according to the sketch.
2. If cracks are visible near the blade shaft, the propeller has to be removed and to be sent to the manufacturer for repair.
