LUFTTÜCHTIGKEITSANWEISUNG

92-191 doktor fiberglas

Geräte-Nr. 213  
H 101 "Salto"  
- Werknummern 59 bis 66

AIRWORTHINESS DIRECTIVE

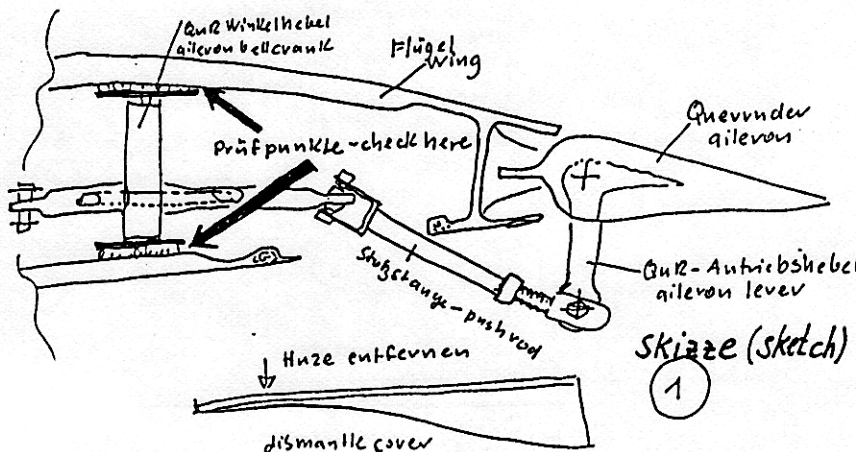
both bellcranks are to check for correct fastening in the wing shell. Try with feeling to press the bellcrank out of its position. Check the possibility to slide a metal tongue between gluing plate and shell (Sketch 1).
