DEPARTMENT OF TRANSPORTATION

Federal Aviation Administration

[Docket No. 97-CE-67-AD; Amendment 39-11514; AD 2000-01-16]

Airworthiness Directives; Cessna Aircraft Company 300 and 400 Series Airplanes

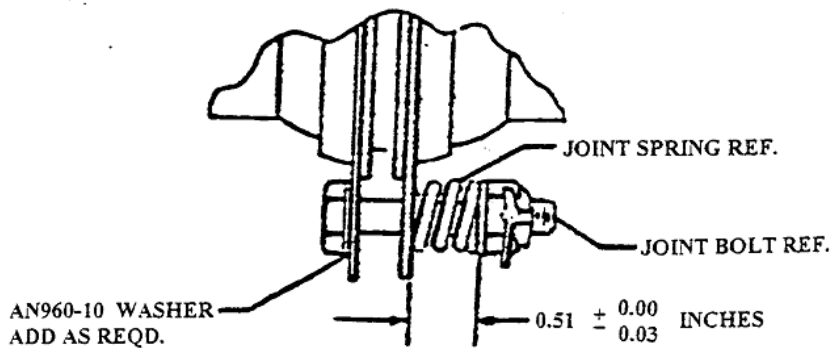
Figure 1 to the Appendix

(3) Visually inspect the exhaust joint springs for correct compression. If the joint is disturbed or if the springs are obviously loose or frozen, proceed with the following inspection (see Figure 1 of this Appendix).

(iii) Reinstall the springs and measure the installed length. The length must be .51 inch (+.00, -.03 inch).

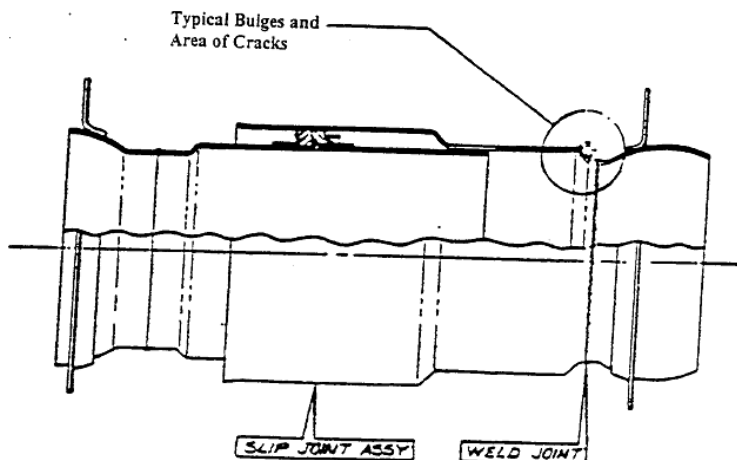
Figure 2 to the Appendix

(4) If installed, visually inspect the slip joint(s) for bulges beyond the normal manufacturing irregularities of .03 inches and/or cracks. If any bulges and/or cracks are present, replace the bulged or cracked slip joint(s). (Refer to the appropriate Cessna Aircraft Service Manual) (See Figure 2 of this Appendix).

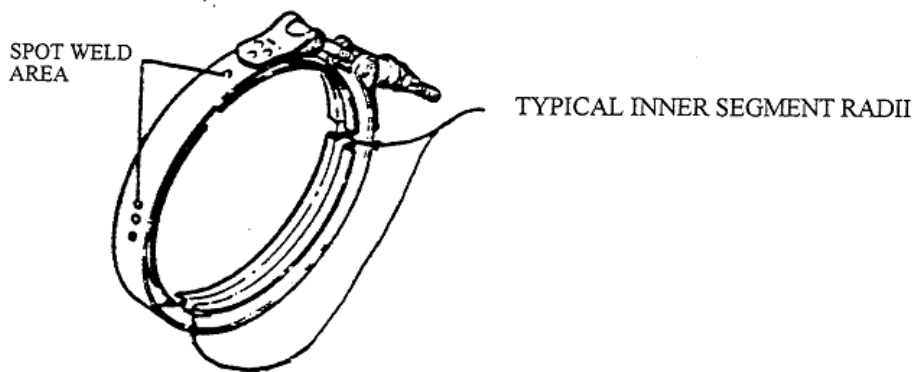
Figure 3 to the Appendix

(i) Visually inspect the outer band in the area of the spot weld for cracks (see Figure 3 of this Appendix). If cracks are found, replace the clamp(s) with new multi-segment "V" band clamp(s).

(ii) Visually inspect the corner radii of the clamp inner segments for cracks (see Figure 3 of this Appendix). This inspection requires careful use of artificial light and inspection mirrors.

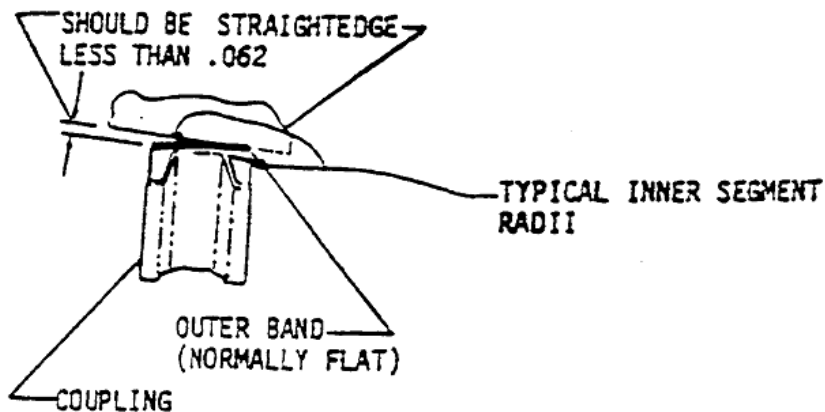
Figure 4 to the Appendix

(iii) Visually inspect the flatness of the outer band, especially within 2 inches of the spot welded tabs that retain the T-bolt fastener. This can be done by placing a straight edge across the flat part of the outer band as shown in Figure 4 of this Appendix, then check the gap between the straight edge and the outer band. This gap should be less than 0.062 inch. If deformation exceeds the 0.062- inch limit, replace the clamp(s) with new multi-segment clamp(s). (See Figure 3 of this Appendix). See Cessna maintenance manual(s) and revisions for correct installation procedures.

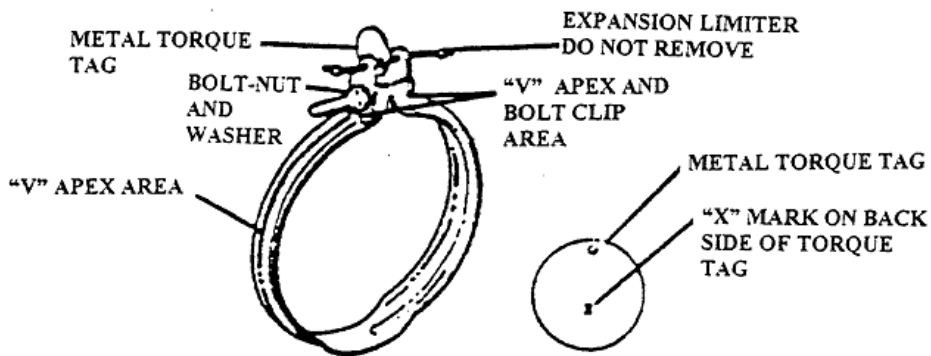
Figure 5 to the Appendix

(iv) Visually inspect the one-piece "V" band clamp (overboard exhaust to turbocharger) with a light and mirror, in the area of the clamp surfaces adjacent to the intersection of the "V" apex and bolt clips, and the entire length of the "V" apex of the clamp for signs of cracks or fractures. If cracks or fractures are visible, replace the clamp (see Figure 5 of this Appendix). See Cessna service manual(s) and revisions for correct installation procedures.
