[Docket No. 99-NM-361-AD; Amendment 39-11502; AD 2000-01-05]

Airworthiness Directives; Boeing Model 747 Series Airplanes

2000-01-05 BOEING: Amendment 39-11502. Docket 99-NM-361-AD. Supersedes AD 99-18-03, Amendment 39-11269.

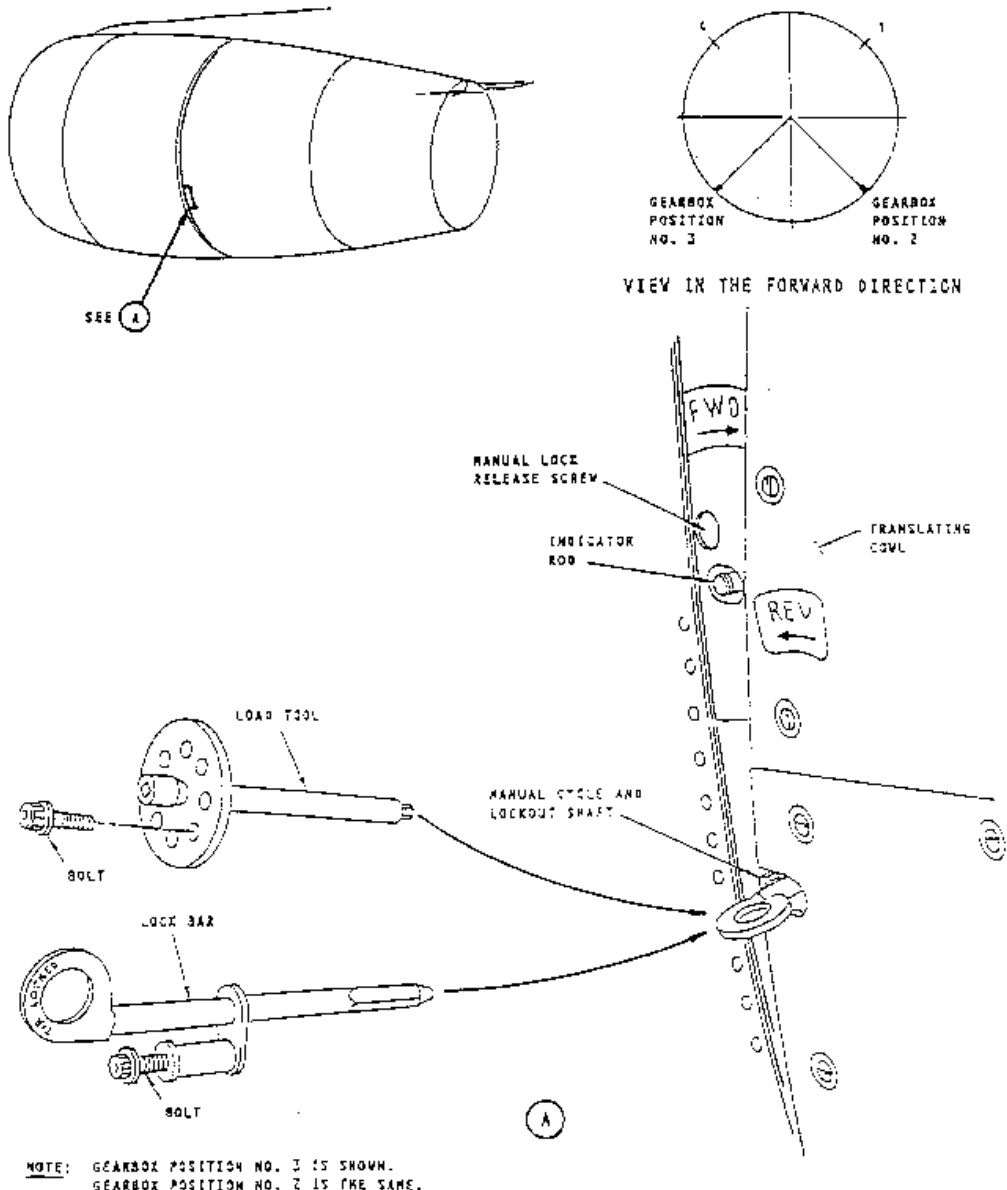
Lock Bar/Load Tool Installation and Gearbox Manual Lock Release
Figure 1
