[Docket No. 2000-NM-93-AD; Amendment 39-11711; AD 2000-09-03]

Airworthiness Directives; Boeing Model 747-400 Series Airplanes Equipped with General Electric CF6-80C2 Series Engines

**2000-09-03 BOEING:** Amendment 39-11711. Docket 2000-NM-93-AD. Supersedes AD 2000-02-33, Amendment 39-11551.

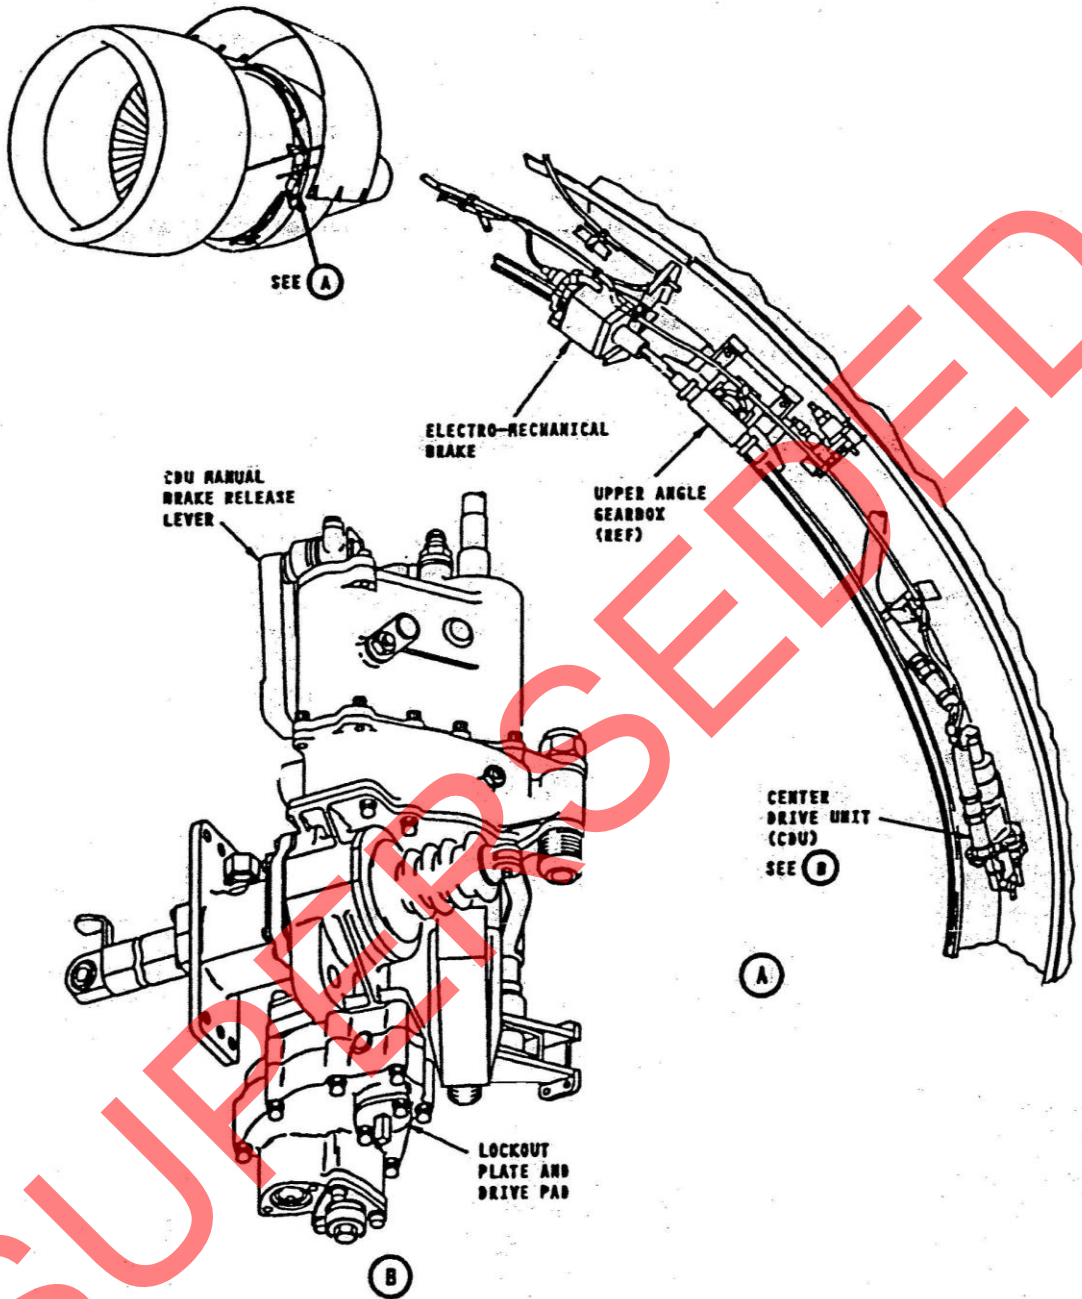
Electro-Mechanical Brake and CDU Cone Brake Torque Check  
Figure 1

1. This procedure contains steps to do a check of the holding torque of the CDU cone brake.
2. CDU cone brake check (Figure 1):

**NOTE:** The cone brake prevents movement in the extend direction only. If you try to measure the holding torque in the retract direction, you will get a false reading.

- (7) Turn the torque wrench to try to manually extend the translating cowl until you get at least 15 pound-inches.

- (8) If the torque is less than 15 pound-inches, you must replace the CDU.
- (9) Reinstall the lockout plate.
