[Docket No. 2001-SW-28-AD; Amendment 39-12479; AD 2001-22-01]

Airworthiness Directives; Enstrom Helicopter Corporation Model F-28, F-28A, F-28C, F-28F, 280, 280C, 280F and 280FX Helicopters

2001-22-01 Enstrom Helicopter Corporation: Amendment 39-12479. Docket No. 2001-SW-28-AD. Supersedes AD 76-17-08, Amendment 39-2700, and AD 76-17-08 R1, Amendment 39-3043, Docket 76-GL-15.

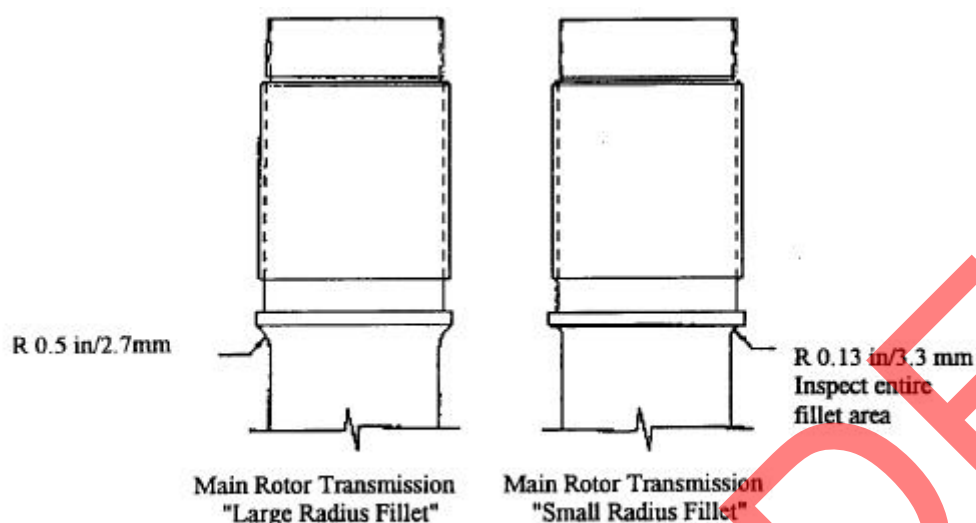
Figure 1. Main Rotor Shaft Inspection

The FAA and the National Transportation Safety Board (NTSB) investigated the accident involving the failure of a shaft on the EHC Model F28A helicopter. The shaft was designed with a small upper fillet radius of 0.13 inch and failed due to a fatigue crack. Such a shaft design causes a high stress concentration. That, coupled with the occurrence of more frequent than anticipated high flight load conditions, can accelerate the development of fatigue cracks. Preliminary investigation revealed that the shaft installed in the transmission, P/N 28-13101-1-R, failed because of a fatigue crack in the fillet area of the shaft directly beneath the main rotor hub. The FAA concluded, based on its investigation and after reviewing NTSB Report 01-052, dated April 13, 2001, that an inspection should be made of such shafts for cracks before further flight. The FAA determined that since inspections for cracks are imprecise and detection of all existing cracks is uncertain, a shaft with a small radius fillet should be replaced with an airworthy shaft with a large radius fillet on certain model helicopters within 300 hours time-in-service (TIS).

(a) Before further flight, determine the part number (P/N) of the main rotor transmission (transmission) and the radius of the upper fillet of the shaft (see Figure 1).

(2) If the installed transmission is P/N 28-13101-1 or -1-R and has a small radius shaft, before further flight and thereafter at intervals not to exceed 25 hours TIS, visually inspect each transmission for a crack in the shaft upper fillet using a 10X or higher magnifying glass.

(i) Dye-penetrant inspect the shaft upper fillet for a crack, a nick, or a scratch.

(ii) Polish out nicks or scratches less than 0.005-inch deep.

(iii) If the shaft is cracked or has a nick or scratch 0.005 inch or more deep, replace the transmission with an airworthy transmission having a large radius shaft fillet before further flight.

(4) Within 300 hours TIS or at the next overhaul after the effective date of this AD, whichever occurs first, replace transmission, P/N 28-13101-1 or -1-R, with an airworthy transmission having a large radius shaft fillet.
