[Docket No. 2001-SW-58-AD; Amendment 39-12726; AD 2001-25-52]

**Airworthiness Directives; Schweizer Aircraft Corporation Model 269A, 269A-1, 269B, 269C, and TH-55A Helicopters**

**2001-25-52 Schweizer Aircraft Corporation:** Amendment 39-12726. Docket No. 2001-SW-58-AD. Supersedes AD 76-18-01, Amendment No. 39-2707, Docket No. 72-WE-23-AD.

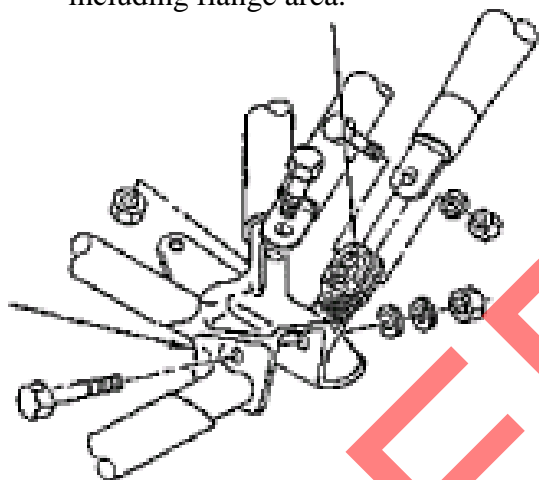
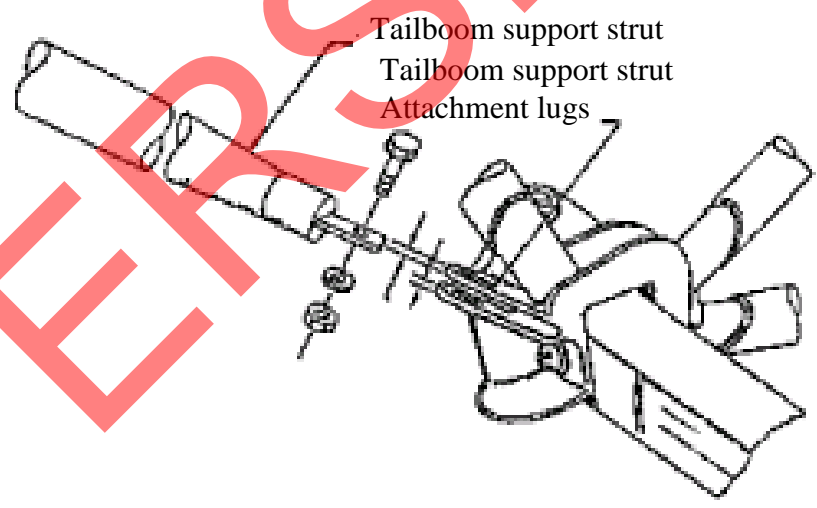
**Figure 1**

(2) Dye-penetrant inspect the lugs on each aft cluster fitting. See Figure 1.

Inspect both attachment lugs (top and bottom sides). Also entire cluster fitting including flange area.

269A2234  
Aft cluster fitting  
Left side shown  
(269A2235 Right side)

(3) If a crack is found, before further flight, replace the cracked cluster fitting with an airworthy cluster fitting. Cluster fittings, P/N 269A2234 and 269A2235, are not eligible to replace a cracked cluster fitting.
