AIRWORTHINESS DIRECTIVE

DASSAULT AVIATION

Fan Jet Falcon and Mystere Falcon 20-(X)5 aircraft

Aircraft structure - Windows frames (ATA 53)

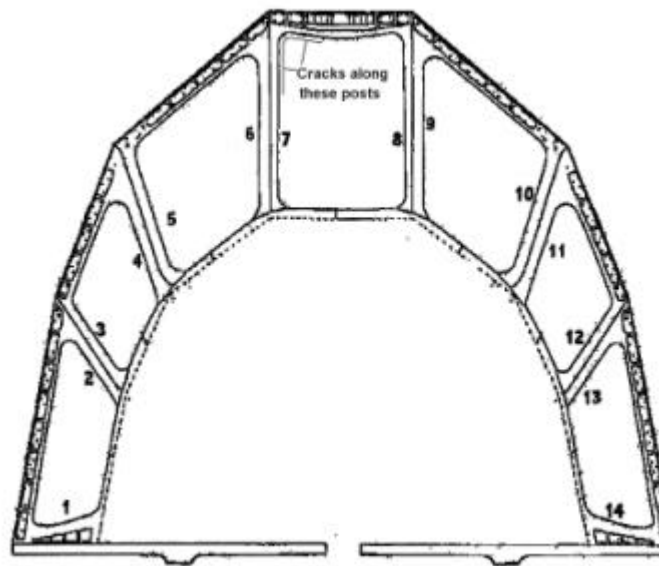
Post numbering

Some cracks have been recorded on "Falcon 20" vertical posts of window frames until now not suspected to develop any, and consequently not checked in maintenance.

The cracks may lead progressively to important cabin pressurization leakage.

- perform ultrasonic ND Testing upon according to WC 53-30-07 for window frames number 2, 5, 7, 8, 10 (see schematic next page) and endoscopic testing according to WC 53-30-12 for front pilot window frames:
 - within 7 months following the effective date of this AD, for aircraft being over 35 years old and those which total more than 20,000 flights,
 - within 25 months or 2,500 flight hours following the effective date of this AD, whichever occurs first, maximum for the other aircraft.
- record the observation in the following charts (under schematic next page) and sent them to DASSAULT AVIATION.
