[Docket No. 2001-SW-67-AD; Amendment 39-12710; AD 2002-08-03]

Airworthiness Directives; Enstrom Helicopter Corporation Model F-28, F-28A, F-28C, F-28F, 280, 280C, 280F, and 280FX Helicopters

2002-08-03 Enstrom Helicopter Corporation: Amendment 39-12710. Docket No. 2001-SW-67-AD. Supersedes AD 2001-22-01, Amendment 39-12479, Docket No. 2001-SW-28-AD.

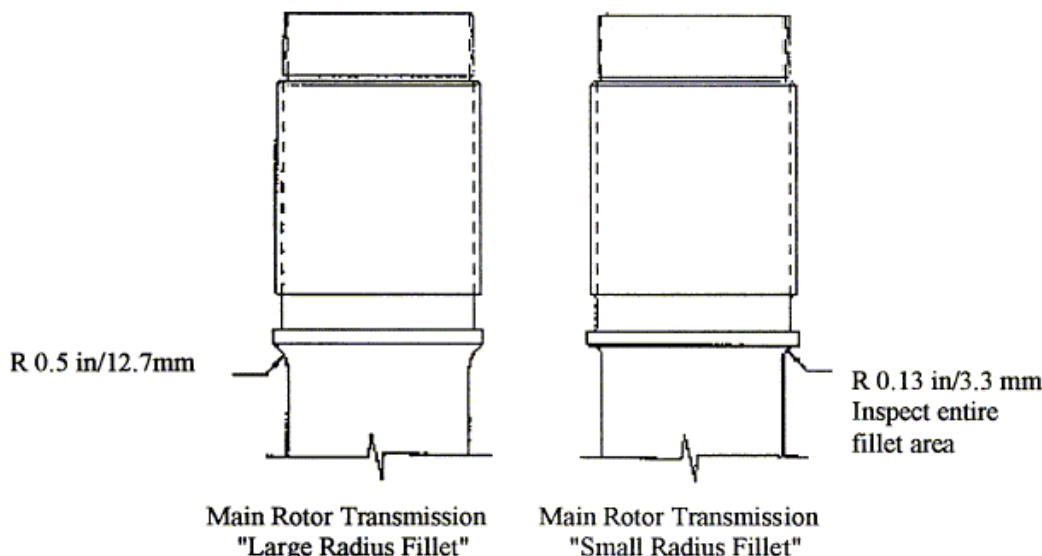
Figure 1. Main Rotor Shaft Inspection

Since the issuance of AD 2001-22-01, Amendment 39-12479, the FAA received a comment that the AD should have cited additional part numbers (part number (P/N) 28-13101-3 and P/N 28-13101-3-R) in Table 1 of the AD. Further, Figure 1 of AD 2001-22-01 contained an error - "2.7mm" is now corrected to state "12.7mm". This AD also corrects another part number and other minor typographical errors. Also, since the issuance of the previous AD, the manufacturer has revised its service information and issued Enstrom Helicopter Corporation Service Directive Bulletin No. 0094, Revision 2, dated February 15, 2002.

(a) Before further flight, determine the part number (P/N) of the main rotor transmission (transmission) and the radius of the upper fillet of the shaft (as shown in the following Figure 1):

(b) For EHC Model F-28C, F-28F, 280C, 280F, and 280FX helicopters, before further flight, replace any transmission having a small radius shaft fillet with an airworthy transmission having a large radius shaft fillet as specified in Table 1 of this AD.

(2) If the installed transmission is P/N 28-13101-1 or -1-R, or P/N 28-13101-3 or -3-R, and has a small radius shaft, before further flight and thereafter at intervals not to exceed 25 hours TIS, visually inspect each transmission for a crack in the shaft upper fillet using a 10X or higher magnifying glass.

(i) Dye-penetrant inspect the shaft upper fillet for a crack, a nick, or a scratch.

(ii) Polish out nicks or scratches less than 0.005-inch deep.

(iii) If the shaft is cracked or has a nick or scratch 0.005 inch or more deep, replace the transmission with an airworthy transmission having a large radius shaft fillet before further flight.
