[Docket No. 2002-SW-14-AD; Amendment 39-13015; AD 2003-01-04]

### Airworthiness Directives; Bell Helicopter Textron, Inc. Model 204B, 205A, 205A-1, 205B and 212 Helicopters

**2003-01-04 Bell Helicopter Textron, Inc.:** Amendment 39-13015. Docket No. 2002-SW-14-AD.

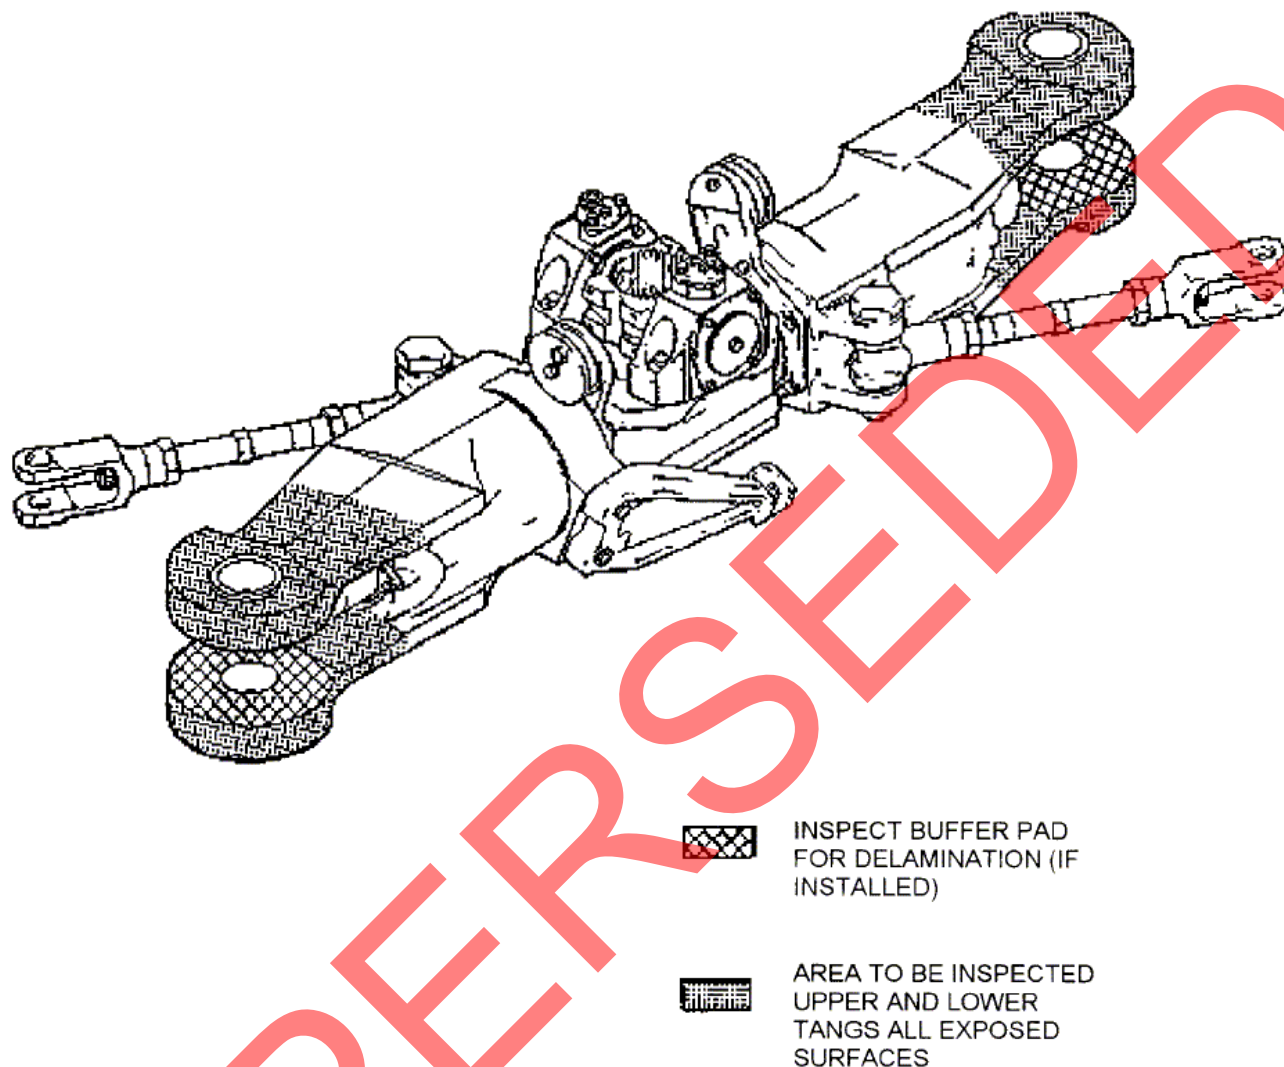
**Figure 1. Inspection of Main Rotor Hub Grip Tangs**

(2) Using a 10-power or higher magnifying glass, visually inspect the exposed surfaces of the upper and lower tangs of each grip for a crack. Pay particular attention to the lower surface of each lower grip tang from the main rotor blade bolt-bushing flange to the leading and trailing edge of each grip tang. See Figure 1 as follows:

- (1) Remove each main rotor blade, and
- (2) Inspect each grip buffer pad on the inner surfaces of each grip tang for delamination (see Figure 1 of this AD). If there is any delamination, remove the buffer pad and inspect the grip surface for corrosion or other damage.

- (f) Before further flight:
- (1) Replace with an airworthy grip any grip with a crack.
  - (2) Replace with an airworthy grip or repair, if within maximum repair damage limits, any grip with any corrosion or other damage.
