### **Airworthiness Directives; MD Helicopters, Inc. Model 369A, D, E, H, HE, HM, HS, F, and FF Helicopters; Correction**

#### Airworthiness Directives; MD Helicopters, Inc. Model 369A, D, E, H, HE, HM, HS, F, and FF Helicopters

**2003-08-51 MD Helicopters, Inc.:** Amendment 39-13215. Docket No. 2003-SW-17-AD.

**Applicability:** Model 369A, D, E, H, HE, HM, HS, F, and FF helicopters, with tail rotor blades, part number (P/N) 369D21640-501, 369D21641-501, 369D21642-501, 369D21643-501, 500P3100-101, 500P3100-301, 500P3300-501, or 500P3500-701, installed, certificated in any category.

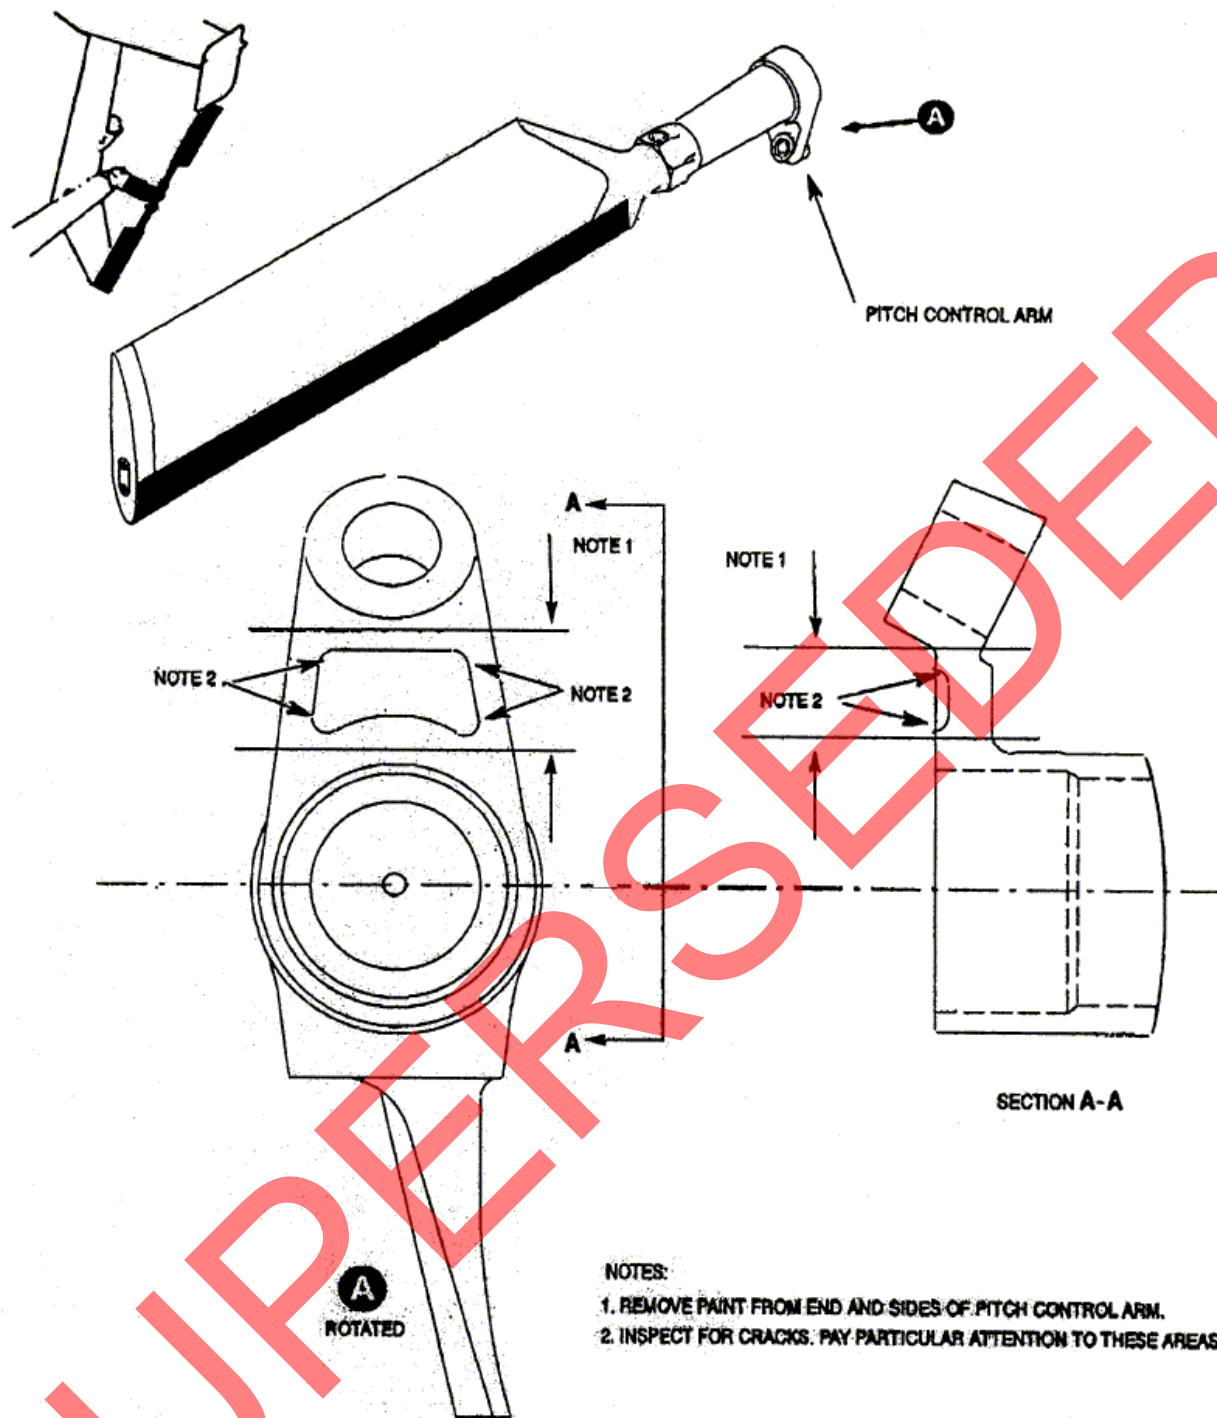
**Figure 1. Tail Rotor Blade Assembly Inspection**

To prevent a tail rotor blade pitch horn (pitch horn) from separating from the tail rotor blade, leading to an unbalanced condition, vibration, loss of tail rotor pitch control, and loss of directional control of the helicopter, accomplish the following:

(b) Before further flight, perform a one-time visual inspection of each pitch horn for a crack or corrosion in the area indicated by Note 2 in Figure 1 of this AD. Paint removal in accordance with Note 1 of Figure 1 of this AD is not required for the visual inspection.

(a) This airworthiness directive (AD) establishes a new retirement life of 400 hours time-in-service (TIS) for the tail rotor blades listed in the Applicability section. For helicopters with an affected tail rotor blade installed that has 390 through 700 hours TIS, remove and replace the tail rotor blade with an airworthy tail rotor blade within 10 hours TIS.

(d) For helicopters with a tail rotor blade installed that has more than 700 hours TIS, a one-time special flight permit to fly it to a repair facility may be issued only upon completion of an eddy current surface scan of each affected pitch horn (see Figure 1 of this AD). Paint removal in accordance with Note 1 of the Figure 1 of this AD IS required for the surface scan. If a crack is found, remove the tail rotor blade and replace it with an airworthy tail rotor blade before further flight.
