Airworthiness Directives; The Cessna Aircraft Company Models C208 and C208B Airplanes

Airworthiness Directives; the Cessna Aircraft Company Models 208 and 208B Airplanes

2005-07-01 The Cessna Aircraft Company: Amendment 39-14025; Docket No. FAA-2005-20514; Directorate Identifier 2005-CE-08-AD.

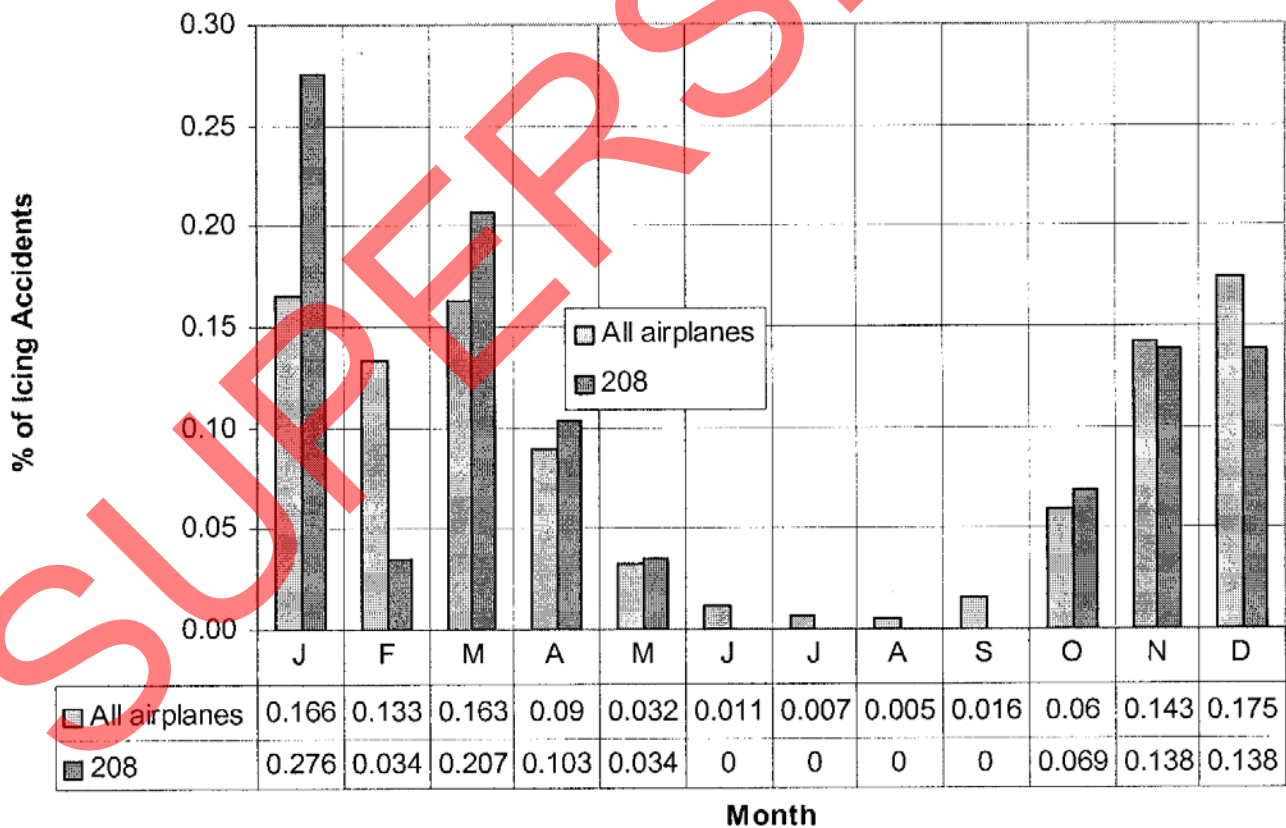
U.S. Icing Accidents per Month since 1983

What events have caused this AD? The FAA has received several reports of accidents/incidents concerning problems with Cessna Models 208 and 208B airplanes during operations in icing conditions. This includes a total of six accidents in the previous two icing seasons and nine events in the past few months. Most of the accidents occur on approach and landing. One-third are suspected to be in supercooled large droplets, icing conditions outside the 14 CFR part 25 Appendix C certification envelope. The Cessna Models 208 and 208B are certificated to 14 CFR part 23, but 14 CFR part 23 references 14 CFR part 25 Appendix C for icing certification. The following chart shows the monthly breakdown of the icing accidents/incidents of the affected airplanes:

The information shows that icing accidents/incidents are just as prevalent or more prevalent during the months of March and April than in November, December, and January. Therefore, the next month is critical for the continued operational safety of the Cessna Models 208 and 208B in icing conditions.
