[Docket No. FAA-2005-23221; Directorate Identifier 2005-CE-51-AD; Amendment 39-14459; AD 2006-02-51]

#### Airworthiness Directives; Raytheon Aircraft Company Model 390 Airplanes

**2006-02-51 Raytheon Aircraft Company:** Amendment 39-14459; Docket No. FAA-2005-23221; Directorate Identifier 2005-CE-51-AD.

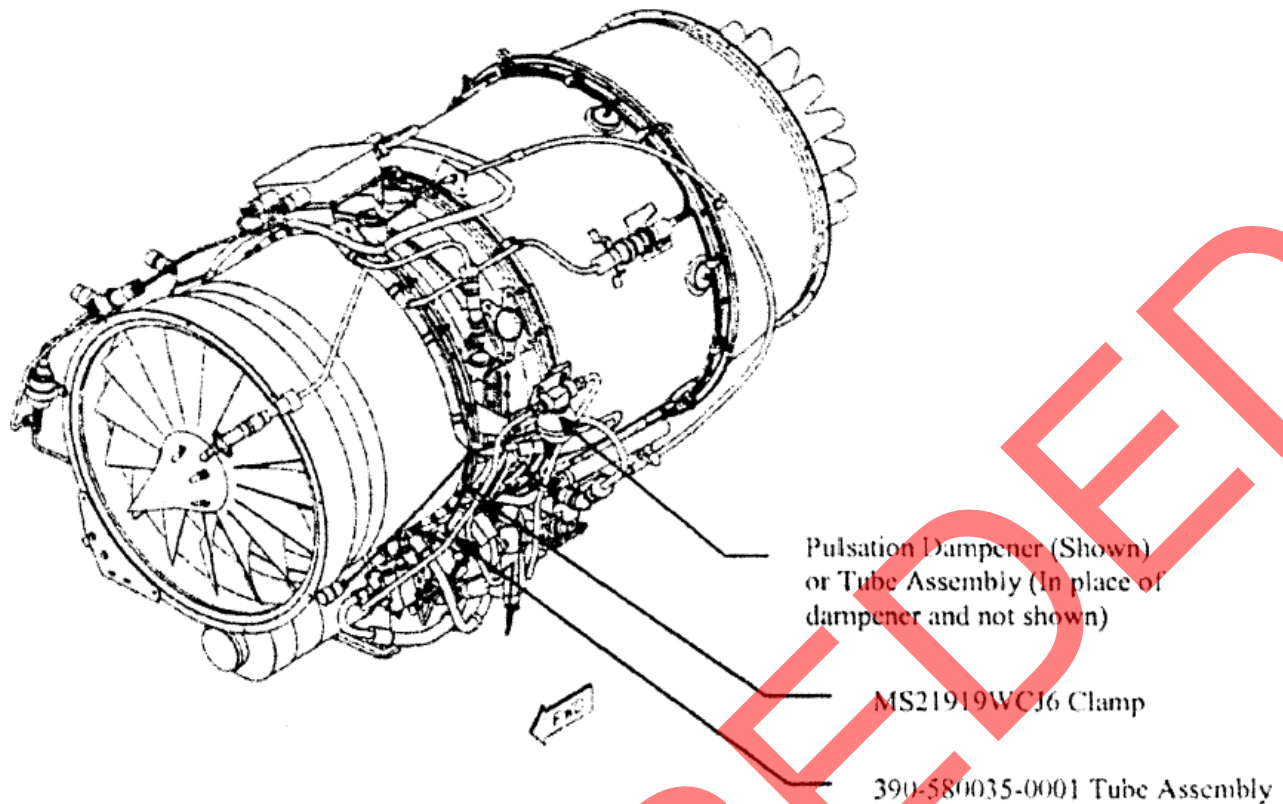
The FAA received reports of four failures of the part number (P/N) 390-580035-0001 hydraulic tube assembly located on the left engine assembly of Raytheon Model 390 airplanes. The failures resulted in in-flight loss of hydraulic fluid. The tube is installed between the hydraulic pump and the hydraulic pulsation damper and carries hydraulic pump output pressure.

- (d) This AD is the result of failure of the hydraulic tube assembly, which caused in-flight loss of hydraulic fluid. We are issuing this AD to prevent failure of the hydraulic tube assembly and the clamp and consequent leaking of hydraulic fluid. This failure could result in loss of hydraulic system functions and risk of fire because of flammable fluid leakage in the engine nacelle and lead to loss of control of the airplane.

Figure 1. Hydraulic Tube Assembly with Clamp on Left Hand Engine.

| Actions | Compliance | Procedures |
|--|---|---|
| <p>(1) Perform a one-time visual inspection of the hydraulic tube assembly and clamp using Raytheon Safety Communique No. 267, dated January 2006. Perform repetitive detailed inspections thereafter per Raytheon Mandatory Service Bulletin No. SB 29-3771, dated January, 2006.</p> <p>(i) The tube assembly part number is P/N 390-580035-0001 or P/N 390-580035-0005).</p> <p>(ii) The clamp part number is P/N MS21919WCJ6 or P/N MS21919WCJ7.</p> | <p>Visually inspect before further flight after February 2, 2006 (the effective date of this AD), except for those who received emergency AD 2006-02-51, issued January 19, 2006, unless already done. Perform the detailed inspection within 10 hours time-in-service (TIS) after February 2, 2006 (the effective date of this AD), except for those who received emergency AD 2006-02-51, issued January 19, 2006, unless already done. Inspect thereafter at intervals not to exceed 50 hours TIS. You may perform the detailed inspection before further flight instead of the visual inspection. Emergency AD 2006-02-51 contained the requirements of this amendment and became effective immediately upon receipt.</p> | <p>For the visual inspection, use Raytheon Safety Communique No. 267, dated January, 2006. For the detailed inspections, use the procedures in Raytheon Mandatory Service Bulletin No. SB 29-3771, dated January, 2006.</p> |
| <p>(2) Replace the hydraulic tube assembly (P/N 390-580035-0001 or P/N 390-580035-0005) and the clamp (P/N MS21919WCJ6 or P/N MS21919WCJ7) (or FAA-approved equivalent part numbers) with new P/N 390-580035-0001 or P/N 390-580035-0005 and P/N MS21919WCJ7 (or FAA-approved equivalent part numbers) or used parts.</p> | <p>Replace the clamp at each inspection. Replace the tube assembly prior to further flight after any inspection where evidence of chafing, excessive vibration, wear, deterioration, or hydraulic fluid leakage is found. Refer to SB 29-3771, dated January, 2006 for acceptance/rejection information for the tube assembly.</p> | <p>Follow the procedures in Raytheon Mandatory Service Bulletin No. SB 29-3771, dated January, 2006.</p> |
