[Docket No. FAA-2006-23871; Directorate Identifier 2006-NE-01-AD; Amendment 39-14975; AD 2007-05-14]

Airworthiness Directives; General Electric Company (GE) CF6-80C2 Turbofan Engines

ACTION: Final rule.

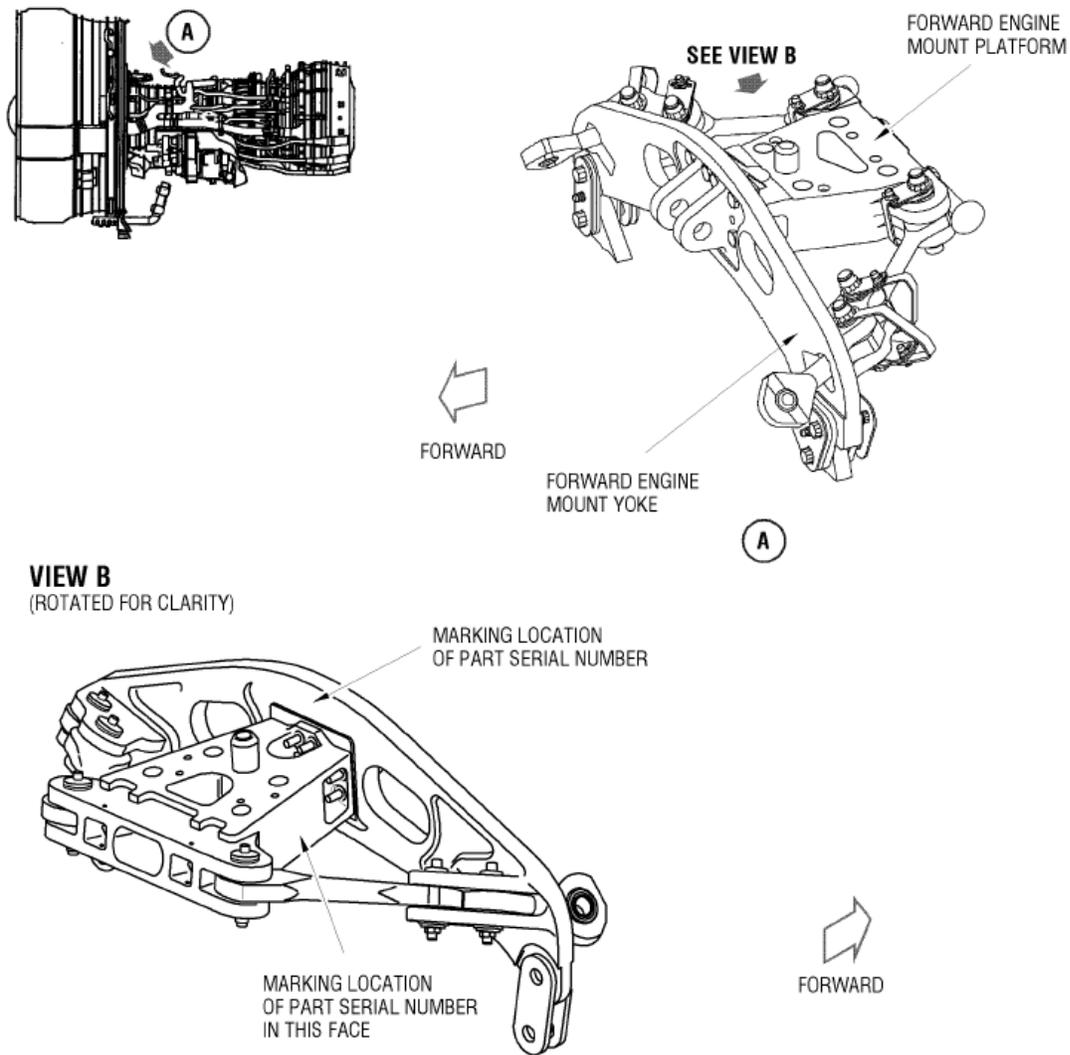
Location of Forward Engine Mount Platform and Forward Engine Mount Yoke
Figure 1

(d) This AD results from the discovery of cracks in a forward engine mount platform and a forward engine mount yoke found during fluorescent penetrant inspection (FPI). We are issuing this AD to prevent cracks in the forward engine mount platform and forward engine mount yoke that could result in possible separation of the engine from the airplane.

(p) Location of the forward engine mount platform and forward engine mount yoke and SN are illustrated in the following Figure 1.

(n) Replace the affected forward engine mount platform and or the affected forward engine mount yoke with a non-weld-repaired cast titanium forward engine mount platform and or the forward engine mount yoke or a forged titanium forward engine mount platform or a forged titanium forward engine mount yoke.
