EMERGENCY AIRWORTHINESS DIRECTIVE

AD 2007-18-51; Docket No. FAA-2007-29089; Directorate Identifier 2007-NM-214-AD

Emergency airworthiness directive (AD) 2007-18-51 is sent to all owners and operators of Boeing Model 737-600, -700, -700C, -800, -900, and -900ER series airplanes.

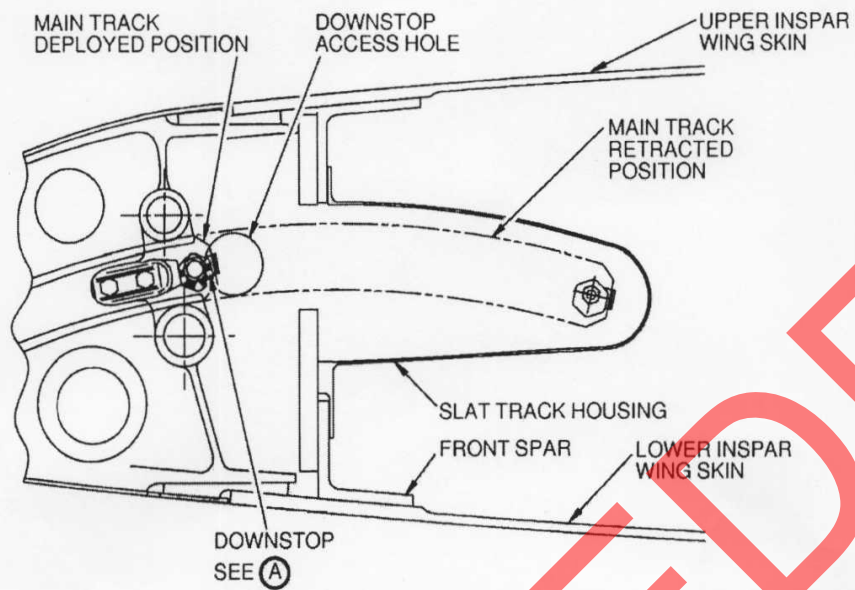
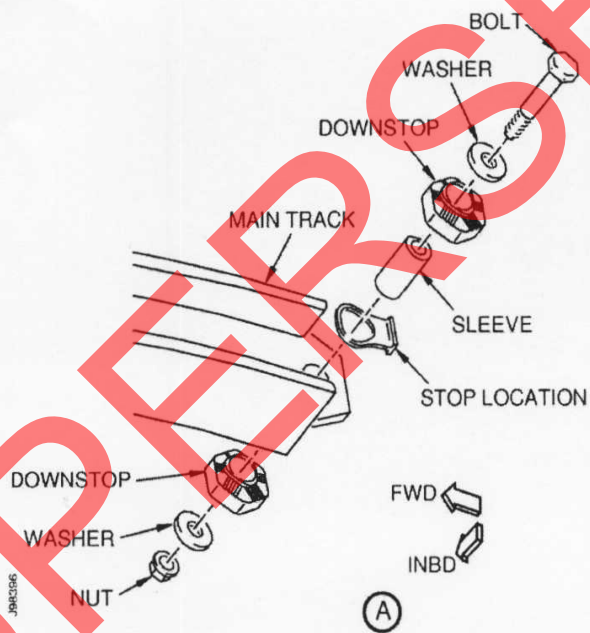
(d) This AD results from reports of the main slat track downstop hardware coming off the retaining bolts for the main slat track downstops. The Federal Aviation Administration is issuing this AD to detect and correct loose or missing parts from the main slat track downstop assemblies, which could result in a fuel leak and consequent fire.

(1) Do a detailed inspection of each main slat track downstop assembly to verify proper installation of the slat track hardware (the bolt, washers, downstops, sleeve, stop location, and nut shown in Figure 1 of Boeing Service Letter 737-SL-57-084-B, dated July 10, 2007, and in this AD). If any part is missing or is installed improperly, before further flight, install a new or serviceable part using a method approved in accordance with the procedures specified in paragraph (g) of this AD; and do a detailed inspection of the inside of the slat can for foreign object debris (FOD) and damage. Before further flight, remove any FOD found and repair any damage found using a method approved in accordance with the procedures specified in paragraph (g) of this AD. Using Boeing Correspondence (Multi-Operator Message) Service Request ID 1-523812011, issued August 25, 2007, is one approved method for verifying proper installation; installing a new or serviceable part; and inspecting for damage and FOD, and removing FOD and repairing damage. Repeat the actions required by paragraph (f)(1) of this AD thereafter at intervals not to exceed 3,000 flight cycles:

(2) Apply a torque between 50 to 80 inch-pounds to the nut. The bolt head must be held with the torque applied to the nut.
