[Docket No. FAA-2007-29089; Directorate Identifier 2007-NM-215-AD; Amendment 39-15197; AD 2007-18-52]

#### Airworthiness Directives; Boeing Model 737-600, -700, -700C, -800, -900, and -900ER Series Airplanes

**ACTION:** Final rule; request for comments.

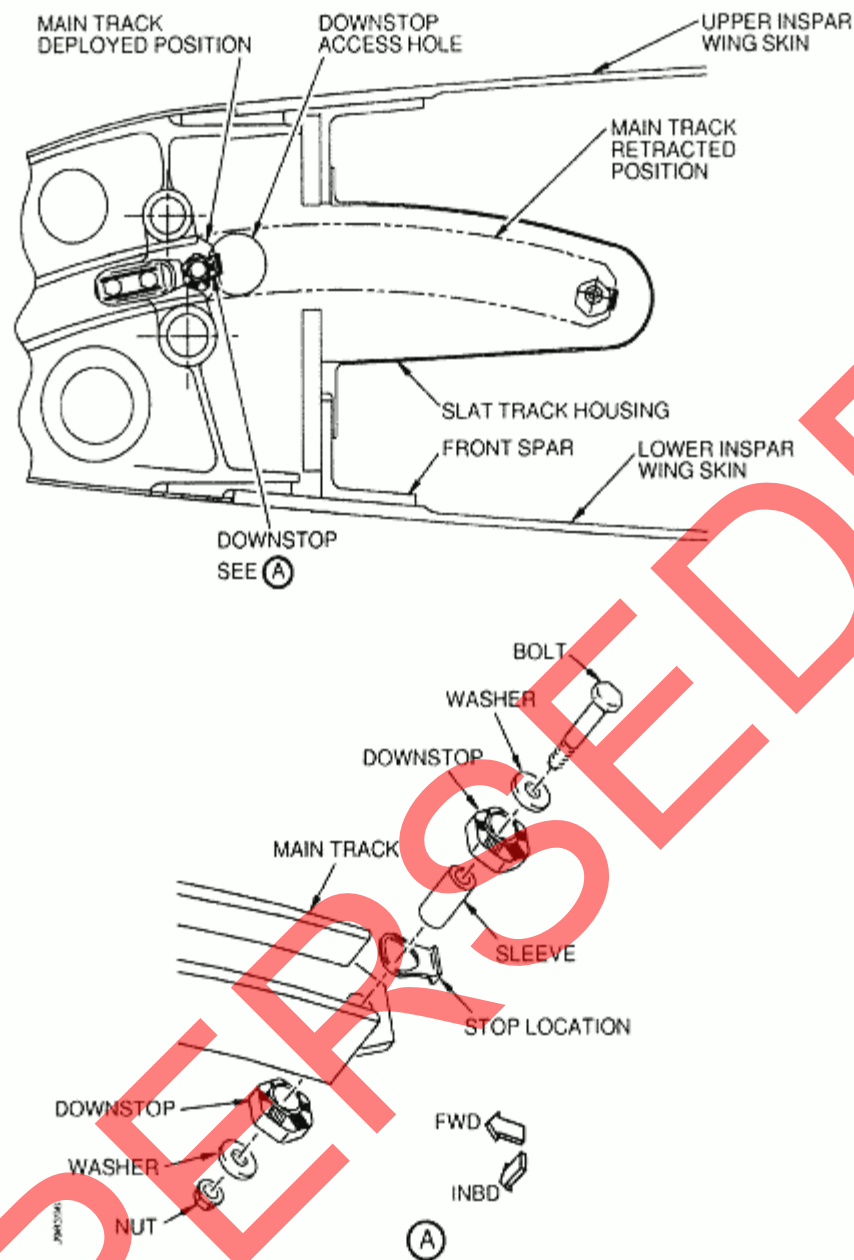
**Figure 1**

(d) This AD results from additional reports of parts coming off the main slat track downstop assemblies. We are issuing this AD to detect and correct loose or missing parts from the main slat track downstop assemblies, which could result in a fuel leak and consequent fire.

**Slat Track Downstop Assembly**

(f) Within 10 days after the effective date of this AD: Do a detailed inspection or a borescope inspection of each main slat track downstop assembly to verify proper installation of the slat track hardware (i.e., the bolt, washers, downstops, stop location, and nut shown in Figure 1 of Boeing Service Letter 737-SL-57-084-B, dated July 10, 2007, and in this AD). Proper installation of the sleeve need not be confirmed, and the stop location part may be installed on either the inboard or the outboard side of the slat track. If any part is missing or is installed improperly, before further flight, install a new or serviceable part using a method approved in accordance with the procedures specified in paragraph (h) of this AD; and do a detailed inspection of the inside of the slat can for foreign

object debris (FOD) and damage. Before further flight, remove any FOD found and repair any damage found using a method approved in accordance with the procedures specified in paragraph (h) of this AD. Using Boeing Multi Operator Message Number 1-523812011-1, issued August 25, 2007; or 1-527463441-1, issued August 28, 2007; is one approved method for verifying proper installation; installing a new or serviceable part; and inspecting for damage and FOD, and removing FOD and repairing damage. Repeat the actions required by paragraph (f) of this AD thereafter at intervals not to exceed 3,000 flight cycles.

(g) Within 24 days after receipt of AD 2007-18-51: Apply a torque between 50 to 80 inch-pounds to the nut. The bolt head must be held with the torque applied to the nut.
