[Docket No. FAA-2008-0490; Directorate Identifier 2008-SW-26-AD; Amendment 39-15509; AD 2008-10-03]

Airworthiness Directives; Bell Helicopter Textron Model 204B, 205A, 205A-1, 205B, 210, 212, 412, 412CF, and 412EP Helicopters

ACTION: Final rule; request for comments.

2008-10-03 Bell Helicopter Textron: Amendment 39-15509. Docket No. FAA-2008-0490;
Directorate Identifier 2008-SW-26-AD.

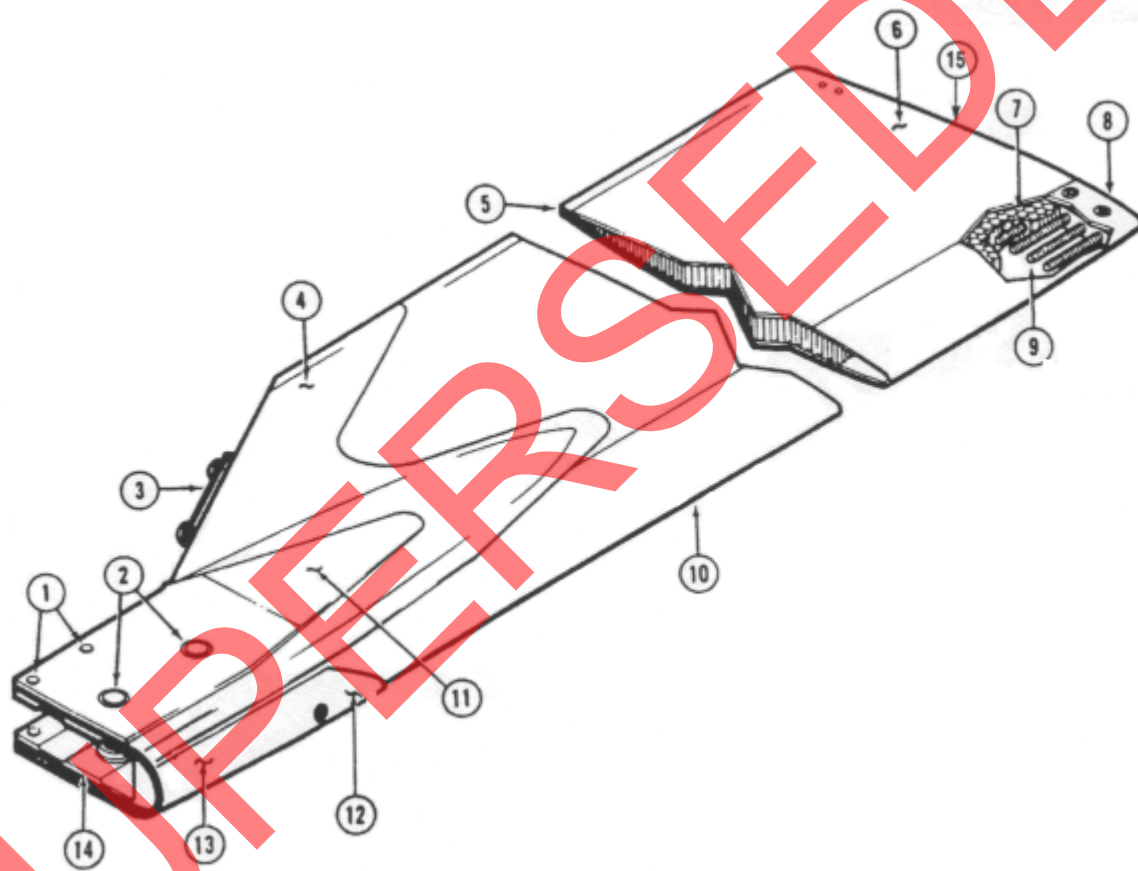
T/R Blade Assembly
Figure 1

(2) Using a 3-power or higher magnifying glass and a bright light, visually inspect the T/R blade skins, leading edge spar, doublers, grip plates, and trailing edge for a crack, corrosion (may be indicated by blistering, peeling, flaking, bubbling, or cracked paint) and any other damage (including a nick, scratch, or dent). See Figure 1 of this AD. Pay particular attention to both sides of the T/R blade in the area located 16 to 26 inches from the T/R blade tip (blade station 25 to 35—the T/R blade tip is located at blade station 51) and to the inboard blade butt area near the attachment of the external balance weights and screws. Also pay particular attention to any blade surface that was snagged by the cloth, as that may be an indication of a crack or paint chip that could lead to corrosion.

(3) If any blistering, peeling, flaking, bubbling, or cracked paint is detected, remove the paint from the affected area and visually inspect the affected area for corrosion or a crack using a 10-power or higher magnifying glass. If any corrosion is found, measure the depth of the corrosion (a digital optical micrometer is one tool that can be used for this measurement).

(4) If a nick, scratch, or dent is found, visually inspect for a crack using a 10-power or higher magnifying glass and measure the depth of the damage (a digital optical micrometer is one tool that can be used for this measurement).
