**[Docket No. FAA-2008-1311; Directorate Identifier 2007-NE-48-AD; Amendment 39-15976; AD 2009-15-13]**

#### **Airworthiness Directives; Honeywell International Inc., T5313 and T5317 Series Turboshift Engines**

**ACTION:** Final rule.

**2009-15-13 Honeywell International Inc. (Formerly AlliedSignal and Textron-Lycoming):**  
Amendment 39-15976. Docket No. FAA-2008-1311; Directorate Identifier 2007-NE-48-AD.

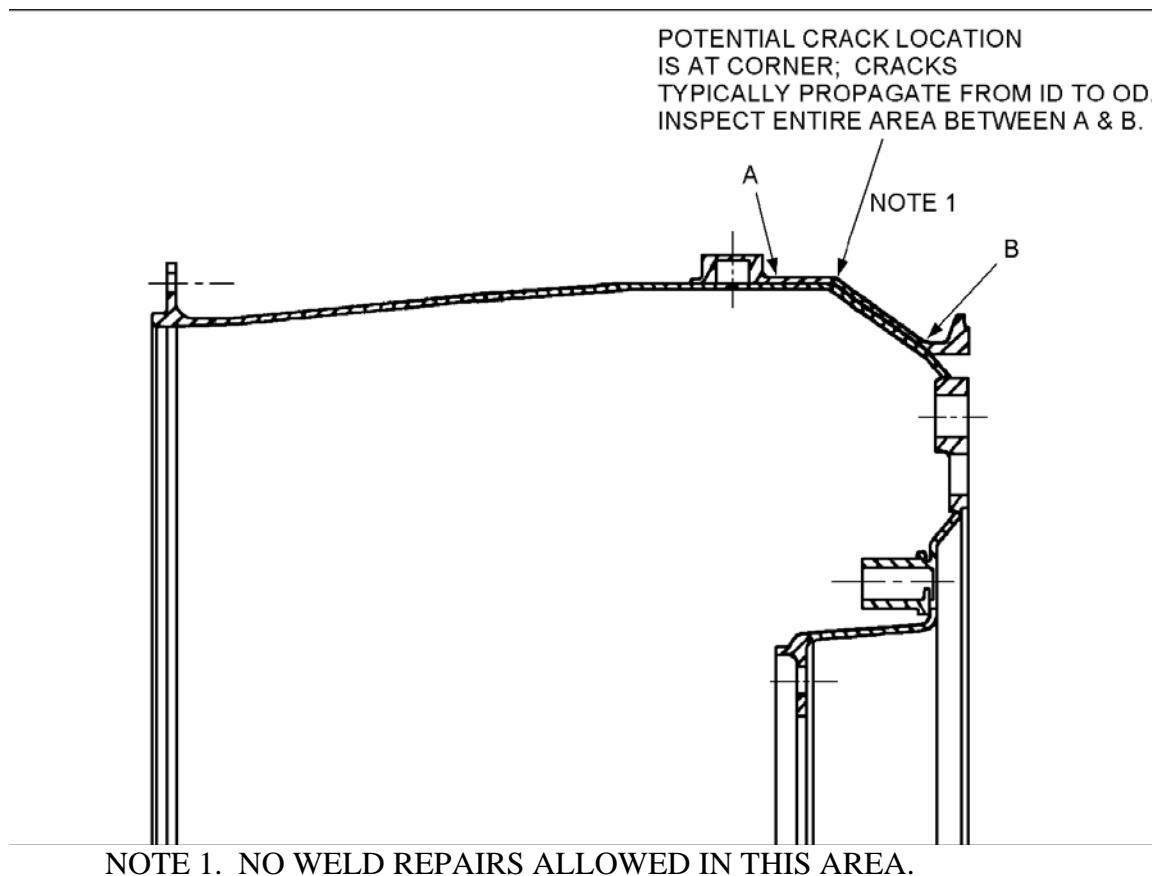
Figure 1. Visual Inspection of CCH

(d) This AD results from eight instances of cracks in CCHs. Two of the instances resulted in an engine shutdown during flight. We are issuing this AD to detect cracks in the CCH, which could result in rupture of the CCH, leading to loss of engine power and damage to the helicopter.

(f) For CCH, P/N 1-130-610-05 and 1-130-610-12, within 50 hours time-in-service (TIS) after the effective date of this AD, inspect the area between points A and B around the entire housing circumference in Figure 1 of this AD for weld repairs and cracks.

(g) For CCH, P/N 1-130-610-05 and 1-130-610-12, inspect the area between points A and B around the entire housing circumference in Figure 1 of this AD for cracks within every 50 hours time-since-last inspection. Honeywell International Inc. Standard Practices Manual 70-20-02, SP 1302, contains additional guidance on visual inspection.

(1) If you find any cracks, replace the CCH before further flight. Honeywell International Inc. Alert Service Bulletin (ASB) T53-A0142, Revision 1, dated September 14, 2006, contains additional guidance on replacing the CCH.

(2) If you find any weld repairs, replace the CCH within 100 hours TIS after the visual inspection. Honeywell International Inc. ASB T53-A0142, Revision 1, dated September 14, 2006, contains additional guidance on replacing the CCH.

(h) If you find any cracks, replace the CCH before further flight. Honeywell International Inc. ASB T53-A0142, Revision 1, dated September 14, 2006, contains additional guidance on replacing the CCH.
