[Docket No. FAA-2007-0096; Directorate Identifier 2007-NE-39-AD; Amendment 39-16141; AD 2009-26-06]

Airworthiness Directives; Honeywell International Inc. ALF502 Series and LF507 Series Turbofan Engines

ACTION: Final rule.

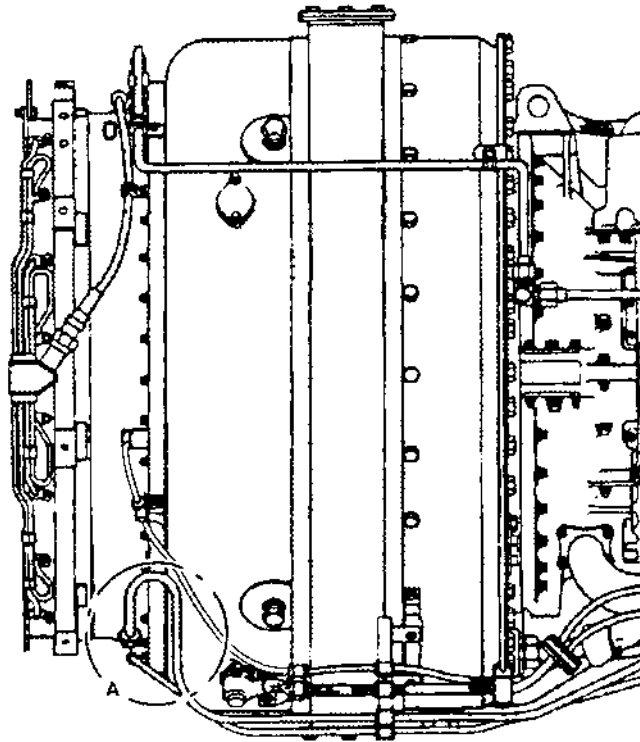
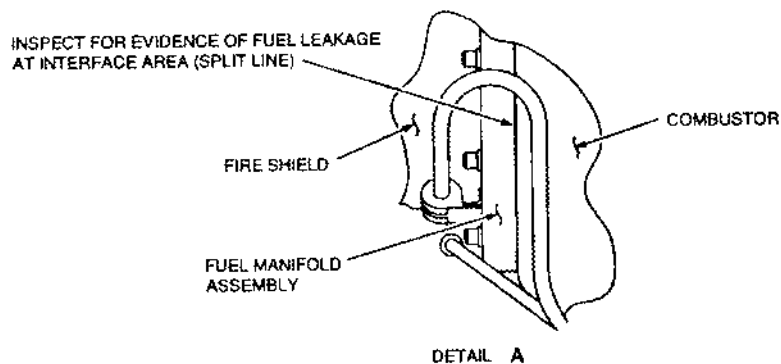
- (g) For fuel manifold assemblies, P/Ns 2-163-620-37 or 2-163-620-38, with 1,800 or more CSN or cycles-since-overhaul (CSO), inspect for leaks within 300 CIS after the effective date of this AD as follows:
- (1) Start engine and let stabilize at ground idle.
 - (2) With the engine operating, look for fuel leaking from the fuel manifold assembly to the fire shield interface area (see Figure 1 of this AD). No leaks allowed.
 - (3) If you find any leaks, shutdown the engine and replace the fuel manifold assembly with an FAA-approved serviceable assembly.
 - (4) Shut down engine.
 - (5) Look for fuel leaking from the fuel manifold assembly to the fire shield interface area (see Figure 1 of this AD). No leaks allowed.
 - (6) If you find any leaks, replace the fuel manifold assembly with an FAA-approved serviceable assembly.
