DEPARTMENT OF TRANSPORTATION

Federal Aviation Administration

[Docket No. FAA-2012-0182; Directorate Identifier 2012-CE-005-AD; Amendment 39-16958; AD 2012-03-52]

Airworthiness Directives; Mooney Aviation Company, Inc. (Mooney) Airplanes

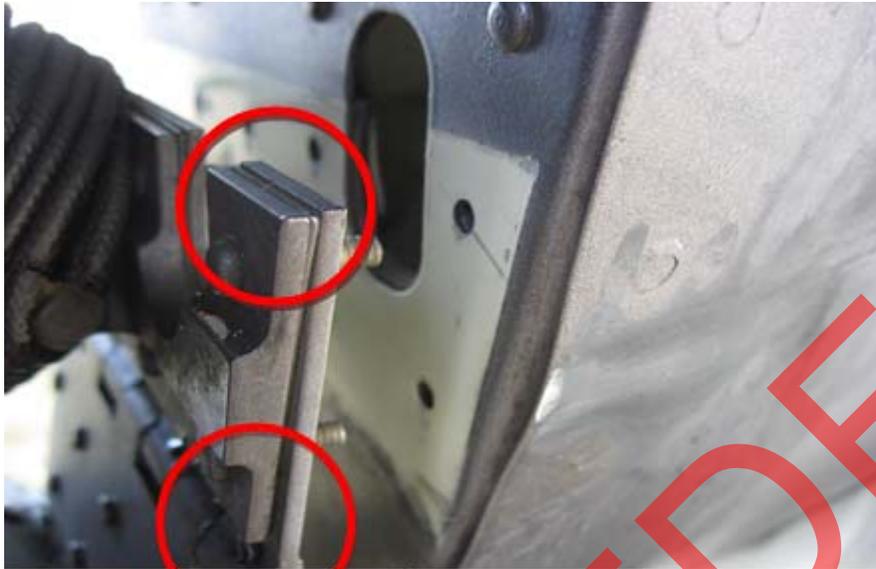
Figure 1

Mooney inspected several other aircraft and found that on one airplane the filler plate was incorrectly installed. The filler plate was not correctly installed between the aft side of the hinge and the bulkhead. Instead, the filler plate was located on the forward side of the hinge between the hinge and trim fitting. It was then noted the incident aircraft had the same issue, as shown in the upper circle of figure 1.

Because the hinge has a lip on the bottom, on the side toward the bulkhead (as shown in the bottom circle of figure 1), if the filler plate is not installed correctly, the hinge will not fit flush against the bulkhead, the Huck Bolt fasteners will not fit perpendicular to the bulkhead, and the

collars will not swage properly. The condition also causes excessive tension pre-load on the Huck Bolts.

The incident aircraft was manufactured in 2008. Mooney has determined the incorrect installation was a manufacturing quality escape during production.

If during the inspection required in paragraph (g) of this AD you find incorrect positioning or improper attachment of the trim fitting, hinge, and filler plate of the tail pitch trim assembly; and/or you find loose or improperly installed Huck Bolt fasteners, before further flight, contact Mooney for FAA-approved repair instructions and perform the repair. Use the contact information found in paragraph (n)(2) of this AD.
