**[Docket No. FAA-2012-0704; Directorate Identifier 2012-SW-040-AD; Amendment 39-17113; AD 2012-13-11]**

#### **Airworthiness Directives; Eurocopter Deutschland GmbH Helicopters**

**2012-13-11 Eurocopter Deutschland GmbH Helicopters:** Amendment 39-17113; Docket No. FAA-2012-0704; Directorate Identifier 2012-SW-040-AD.

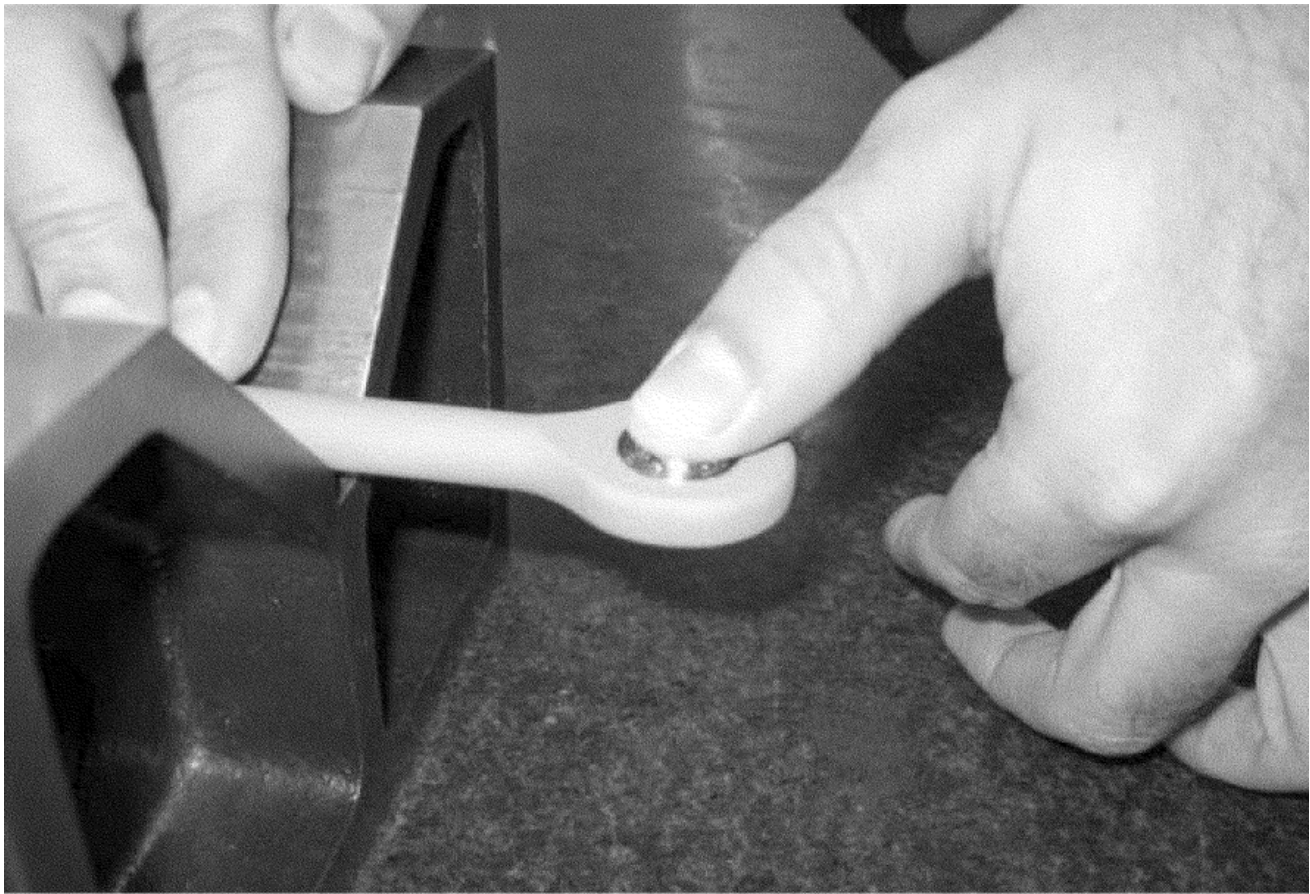
**Figure 1 to Paragraph (e)**

- (1) Remove the pitch link.
- (2) Clean the area around the spherical bearings and pitch link bearing bore chamfer.
- (3) Apply axial hand pressure to the faces of both spherical bearings as shown in Figure 1 to Paragraph (e) of this AD.

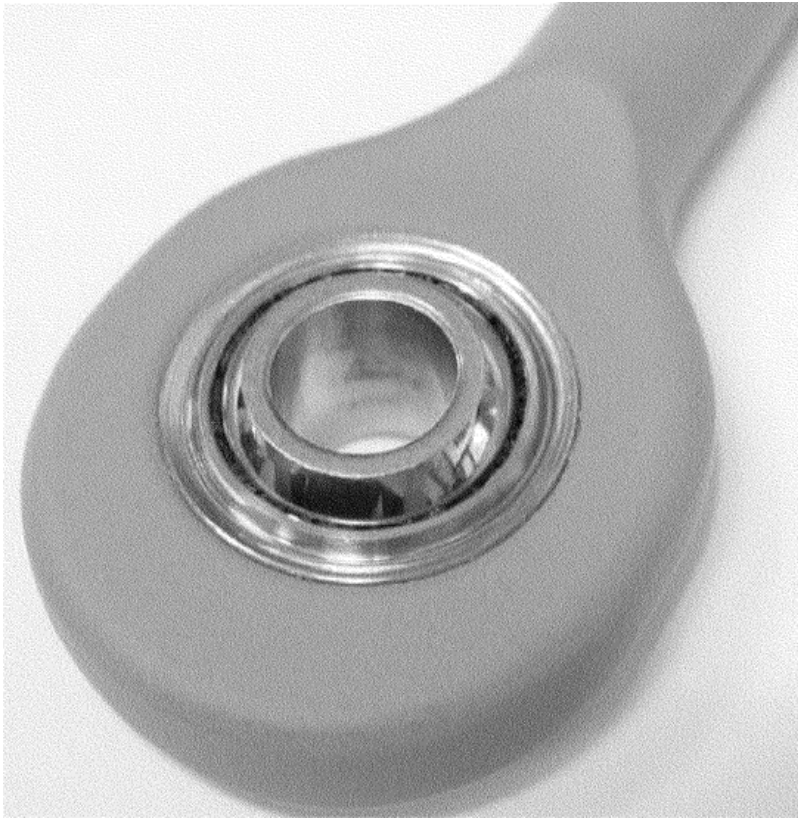
**Figure 2 to Paragraph (e)**

(4) Using an 8X or higher power magnifying glass, inspect the boundaries between the bearing and the bearing bore chamfer surface. Determine that the bearings have been completely swaged and there is no gap between the edge of the bearing and the chamfer as shown in Figure 2 to Paragraph (e) of this AD.

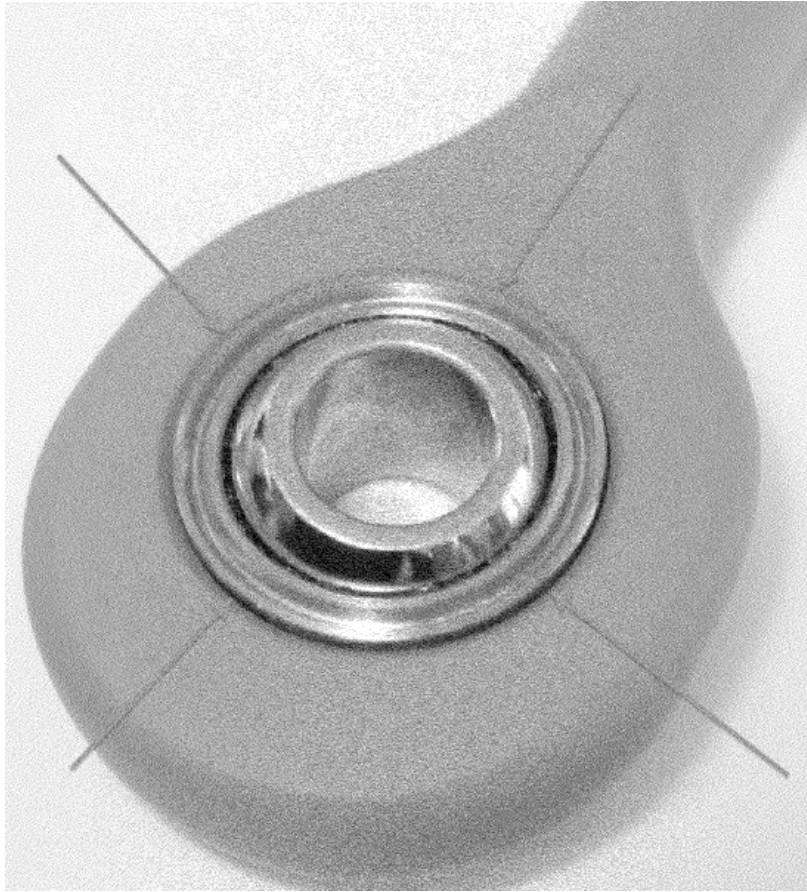
**Figure 3 to Paragraph (e)**

This AD defines the unsafe condition as an improperly swaged spherical bearing on the pitch link, which could result in loss of tail rotor control and subsequent loss of control of the helicopter.

(5) If a bearing is not completely swaged or there is a gap between the edge of the bearing and the chamfer, as shown in Figure 3 to Paragraph (e) of this AD, replace the pitch link with an airworthy pitch link.
