[Docket No. FAA-2013-0486; Directorate Identifier 2010-SW-031-AD; Amendment 39-17622; AD 2013-20-16]

Airworthiness Directives; MD Helicopters, Inc. (MDHI) Helicopters

ACTION: Final rule.

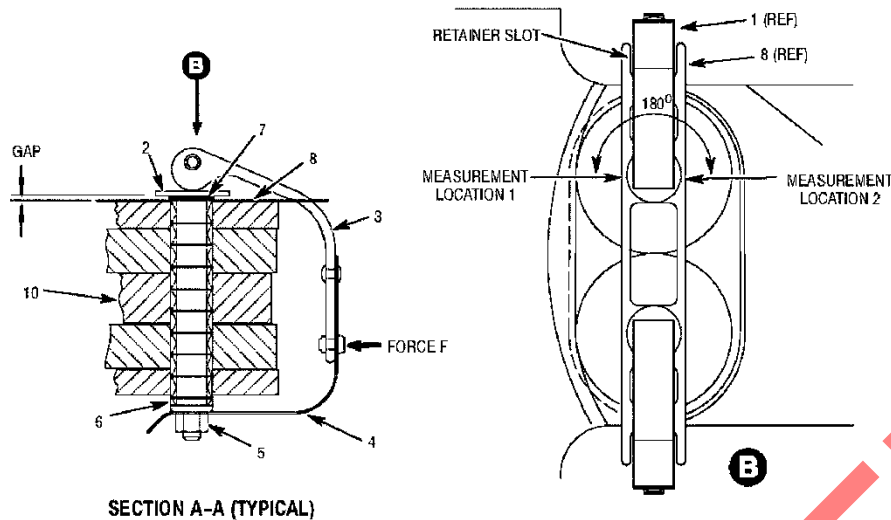
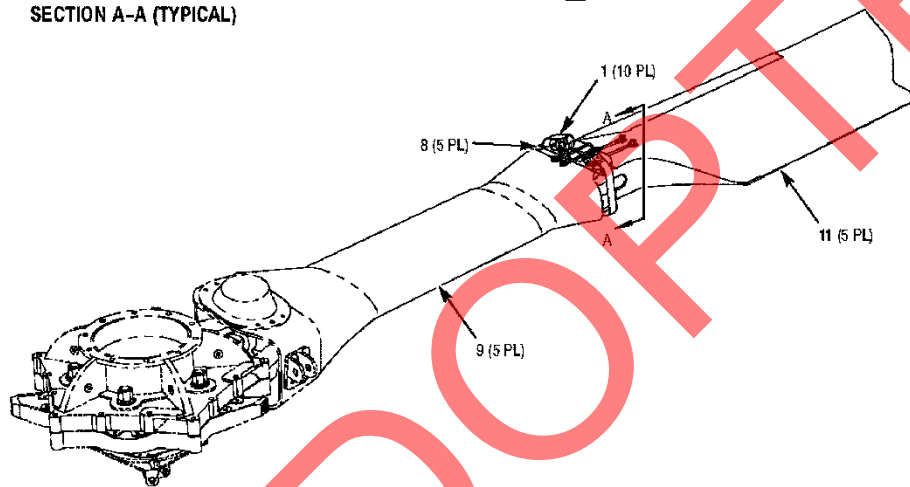
Figure 1 to Paragraph (e)
Gap and Force Check of the Blade Retention Bolts

(i) Visually check each bolt for failure. Failure of a bolt may be indicated by movement of the bolt out of the bolt hole or by inconsistent extension of the bolt above or below the other bolts being inspected (a failed bolt migrates out of the bolt hole).

(ii) Visually check for a gap between the thrust washer and the retainer, P/N 900R2100009-101 or -103. The thrust washer is depicted as item 2 and the retainer is depicted as item 8 in Figure 1 to paragraph (e) of this AD.

(iv) If there is any indication of bolt failure or if there is no gap between the thrust washer and retainer, before further flight, remove and inspect the bolt for a crack. Replace any cracked bolt with an airworthy bolt.

(iii) If there is a gap between the thrust washer and retainer, measure the gap in two locations, 180 degrees apart, with a feeler gage. If the gap is more than 0.100 inch (2.54 mm) at either location, before further flight, remove and inspect the bolt for a crack. Replace any cracked bolt with an airworthy bolt.
