SAIB: NE-16-19

Date: July 22, 2016

SUBJ: Turbine Engine Compressor Section – Stator Nozzle Distress

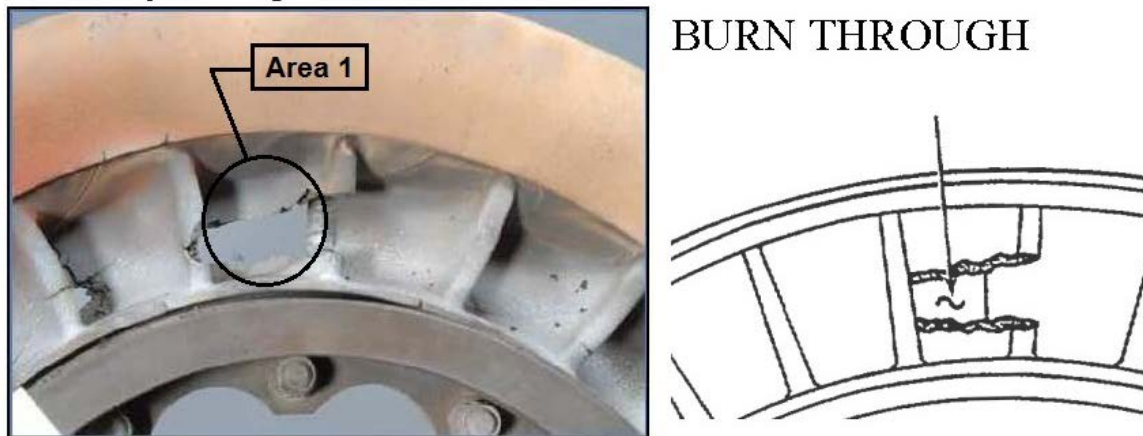
Area 1: Stator nozzle vane burn-through; unacceptable and unserviceable

Figure 2. 1st Stage Turbine Stator Nozzle with Nozzle Vane Burn-through

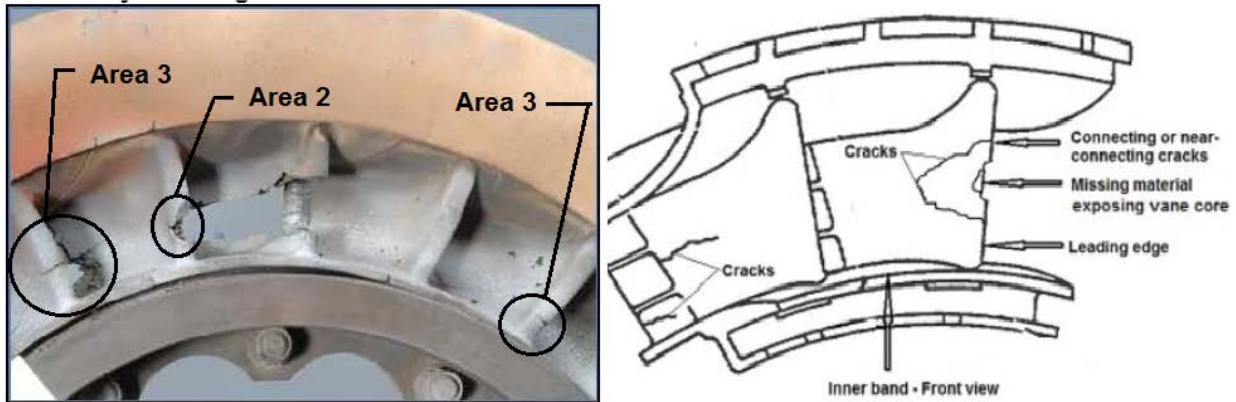
Area 2: Missing material exposing vane core; acceptable, but re-inspect at next fuel nozzle inspection interval

Area 3: Blisters, leading or trailing edge cracks, or connecting or near-connecting cracks; acceptable, but re-inspect at next fuel nozzle inspection interval

Figure 3. 1st Stage Turbine Stator Nozzle with Nozzle Vane Distress

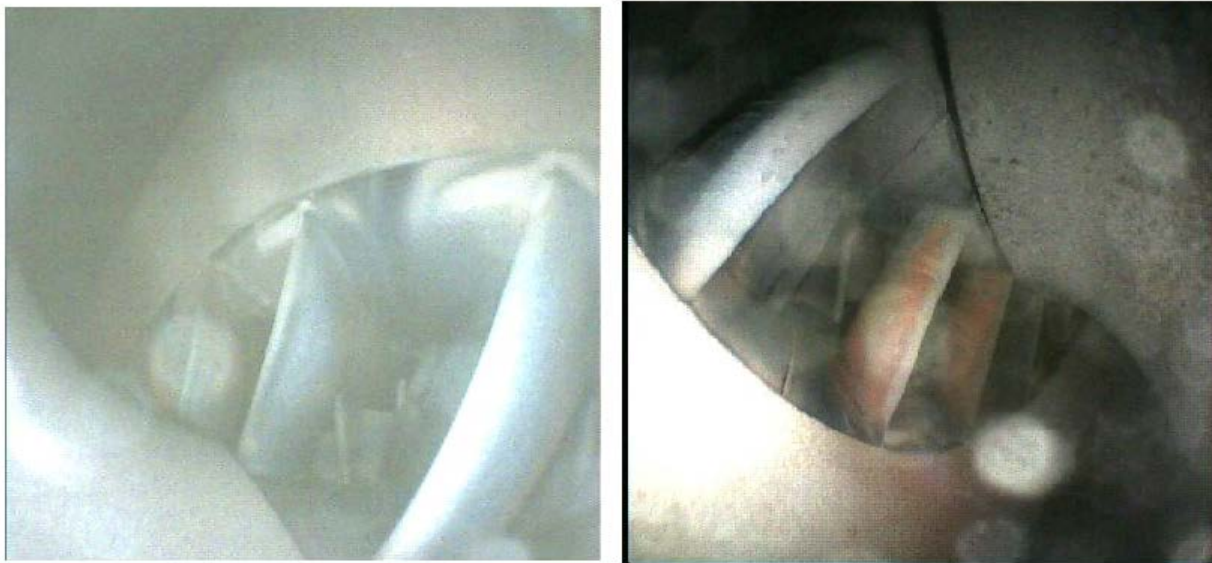
Figure 4. 1st Stage Turbine Stator Nozzle with Acceptable Nozzle Vanes
