[Docket No. FAA-2016-9254; Directorate Identifier 2015-CE-030-AD; Amendment 39-18948; AD 2017-14-04]

Airworthiness Directives; Piper Aircraft, Inc. Airplanes

2017-14-04 Piper Aircraft, Inc.: Amendment 39-18948; Docket No. FAA-2016-9254; Directorate Identifier 2015-CE-030-AD.

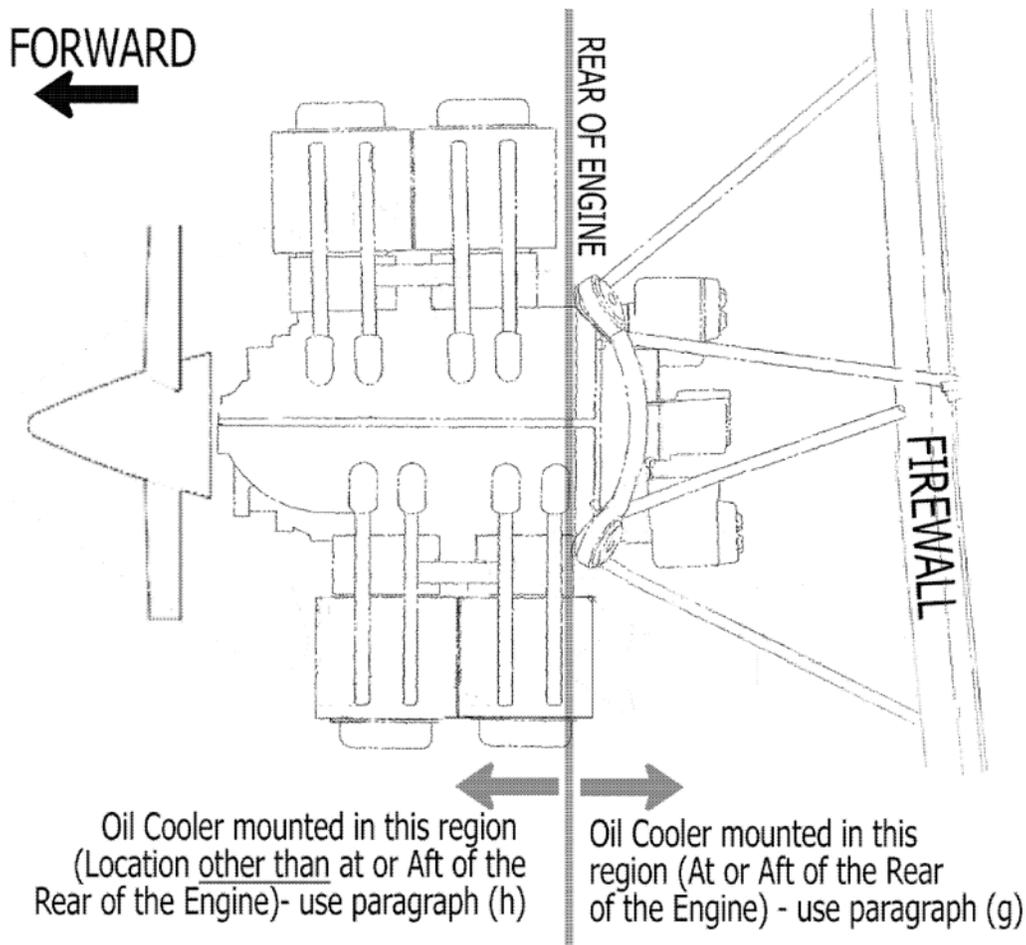
Figure 1 to paragraphs (g) and (h) of this AD: Oil cooler

AD 95-26-13 was prompted by numerous incidents/accidents caused by rupture or failure of the oil cooler hose assemblies. This AD action was prompted by requests to clarify the intent of AD 95-26-13. We are issuing this AD to prevent rupture or failure of the oil cooler hose assemblies, which could result in engine stoppage with consequent loss of control.

For any oil cooler hose assemblies that do not meet TSO-C53a, Type D requirements: Within the next 100 hours time-in-service (TIS) after February 5, 1996 (the effective date retained from AD 95-26-13), and repetitively thereafter at intervals not to exceed 100 hours TIS, inspect the fire sleeve of

each oil cooler hose assembly for soaked oil, a brownish or whitish color, and any evidence of brittleness or deterioration as a result of heat or oil seepage. See figure 1 to paragraphs (g) and (h) of this AD for additional information.

(1) If any of the conditions described in paragraph (g) or (h)(1) of this AD are found on an oil cooler hose assembly during the inspection required in paragraph (g) or (h)(1) of this AD, as applicable, before further flight, replace the oil cooler hose assembly with a serviceable new or used TSO-C53a Type D oil cooler hose assembly or TSO-C53a Type C oil cooler hose assembly. If a used TSO-C53a Type C oil cooler hose assembly is installed, it must have documented hours TIS.

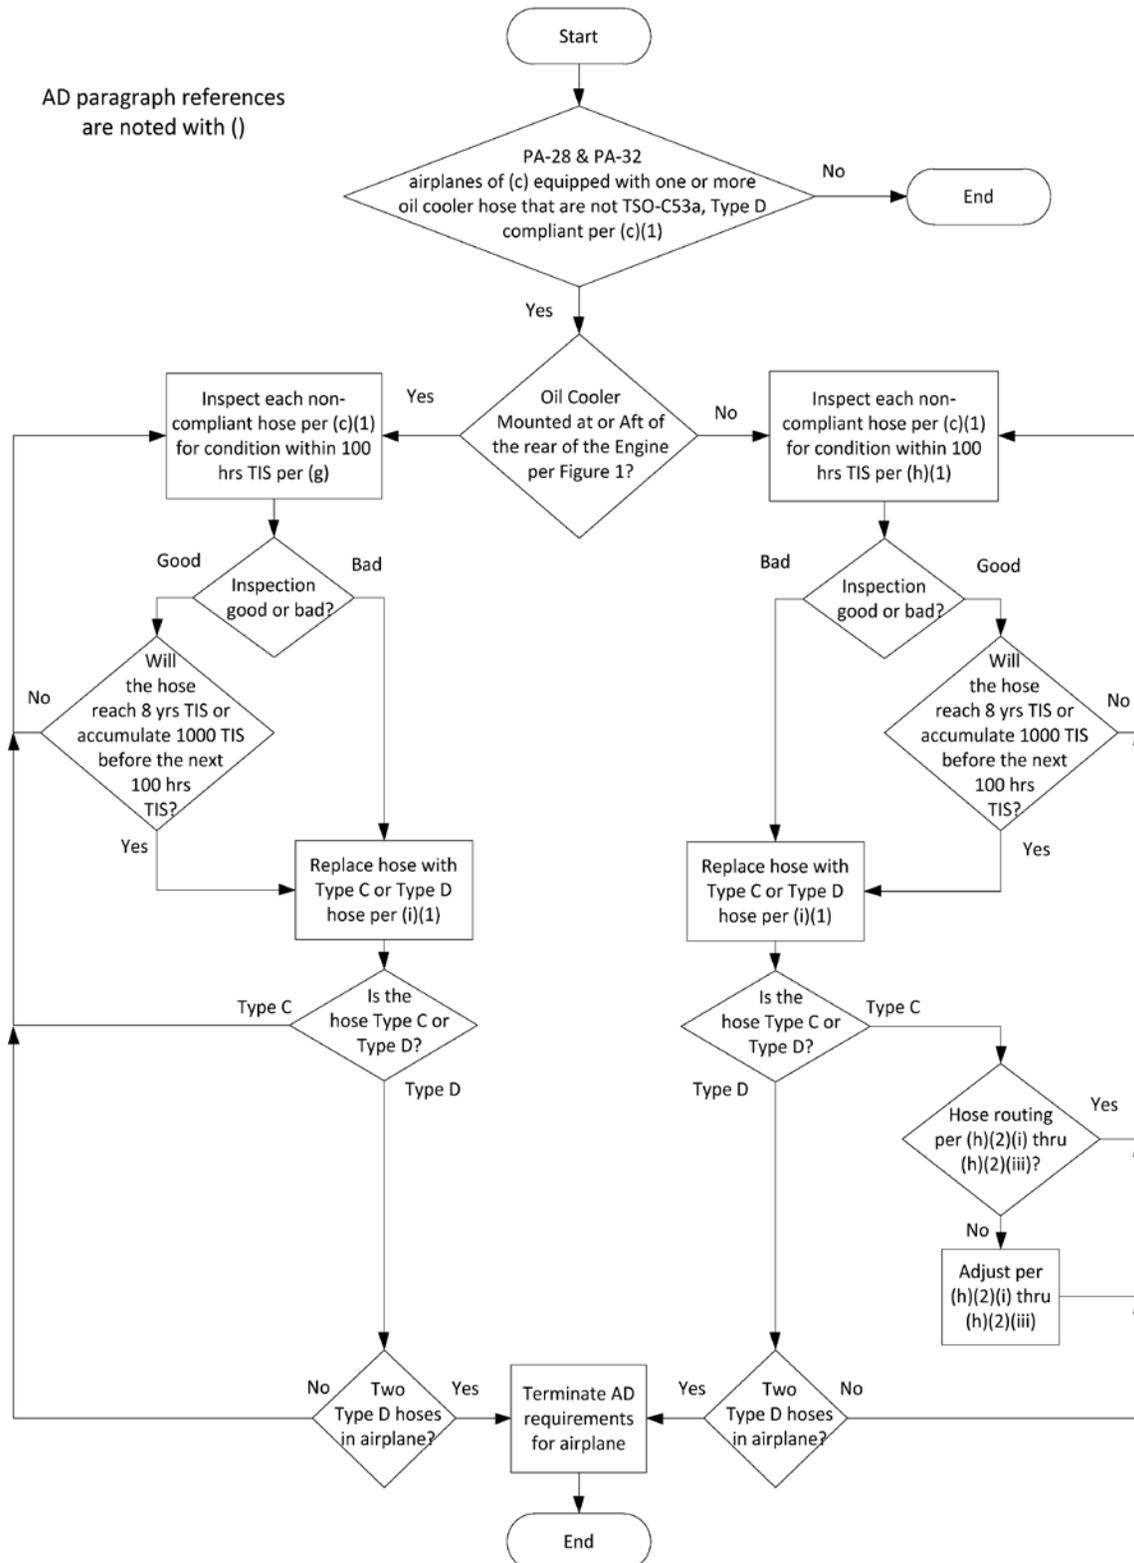
Appendix 1 to AD 2017-14-04

Comply with this AD within the compliance times specified, unless already done. You may review the flow chart found in appendix 1 to assist you in complying with the actions of this AD.
