**[Docket No. FAA-2016-9418; Product Identifier 2016-NE-23-AD; Amendment 39-19167; AD 2018-02-14]**

**Airworthiness Directives; Honeywell International Inc. Turboprop and Turboshift Engines**

**2018-02-14 Honeywell International Inc.** (Type Certificate previously held by AlliedSignal Inc., Garrett Engine Division; Garrett Turbine Engine Company; and AiResearch Manufacturing Company of Arizona): Amendment 39-19167; Docket No. FAA-2016-9418; Product Identifier 2016-NE-23-AD.

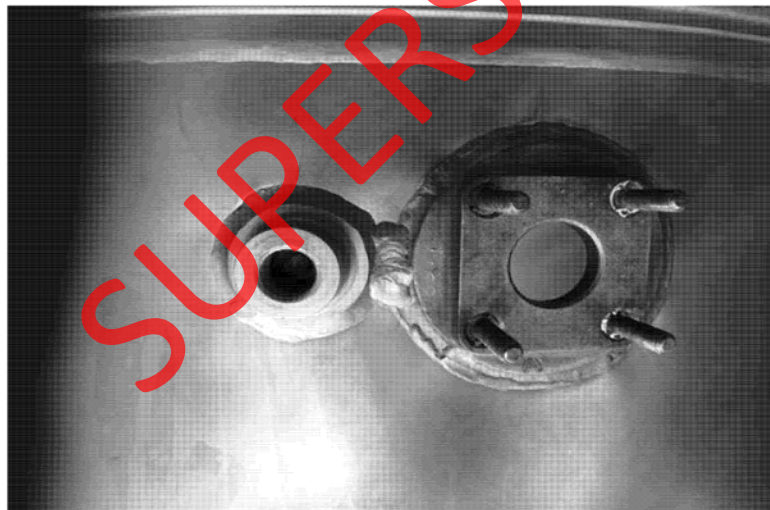
We agree. We note that five of the six combustion chamber case assemblies that ruptured were assemblies without the one-piece bleed pad. P/N 3101668-x has the one-piece bleed pad with P3 boss, which demonstrated significantly reduced cracking between the P3 and bleed boss; therefore, this combustion chamber case assembly is not affected by this AD. No further changes are needed. We did not change this AD.

(2) For TPE331-3U, -3UW, -5, -5A, -5AB, -5B, -6, and -6A engines with combustion chamber case assemblies, P/Ns 869728-1, 869728-3, or 893973-5, installed, and without the one-piece bleed pad with P3 boss; and for TPE331-1, -2, and -2UA engines modified by National Flight Services, Inc., supplemental type certificate (STC) SE383CH, remove the combustion chamber case assembly from service at the next removal of the combustion chamber case from the engine, not to exceed 3,700 hours time-in-service since last hot section inspection.

**Figure 1 to Paragraph (h) of this AD. Combustion Chamber Case Assembly**

**Without the One-Piece Bleed Pad with P3 Boss**

After the effective date of this AD, do not install a combustion chamber case assembly, P/N 869728-1, 869728-3, or 893973-5, in TPE331-3U, -3UW, -5, -5A, -5AB, -5B, -6, and -6A engines or in TPE331-1, -2, and -2UA engines modified by National Flight Services, Inc., STC SE383CH, unless the combustion chamber case assembly has a one-piece bleed pad with P3 boss.
