[Docket No. FAA-2017-0288; Product Identifier 2017-CE-007-AD; Amendment 39-19231; AD 2018-06-11]

Airworthiness Directives; Textron Aviation Inc. Airplanes

SUMMARY: We are adopting a new airworthiness directive (AD) for certain Textron Aviation Inc. Models A36TC, B36TC, S35, V35, V35A, and V35B airplanes. This AD was prompted by a fatal accident where the exhaust tailpipe fell off during takeoff. This AD adds a life limit to the exhaust tailpipe v-band coupling (clamp) that attaches the exhaust tailpipe to the turbocharger and requires an annual visual inspection of the exhaust tailpipe v-band coupling (clamp). We are issuing this AD to address the unsafe condition on these products.

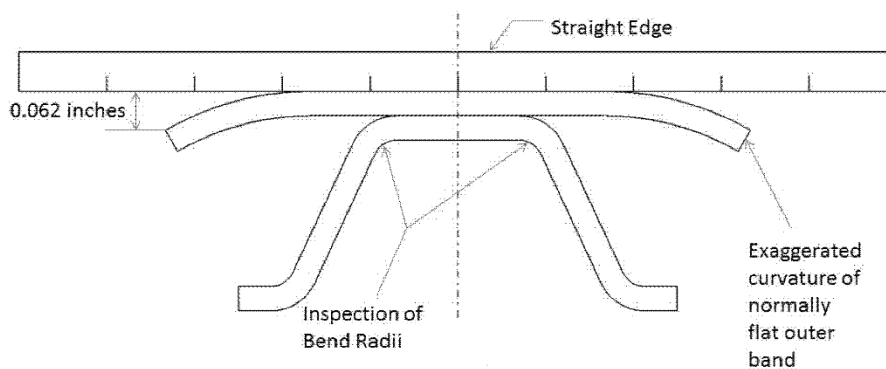
Figure 1 to paragraphs (k)(1)(iii) and (v) of this AD: Cross section of v-band coupling

(iii) Visually inspect the flatness of the outer band using a straight edge. Lay the straight edge across the width of the outer band. The gap must be less than 0.062 inches. See figure 1 to paragraphs (k)(1)(iii) and (v) of this AD. If the gap exceeds 0.062 inches between the outer band and the straight edge, do not re-install the v-band coupling. Before further flight, you must install a new v-band coupling and restart the hours TIS for the repetitive replacement of the v-band coupling.

(v) Visually inspect the bend radii of the coupling v-retainer coupling segments for cracks. Inspect the radii throughout the length of the segment. See figure 1 to paragraphs (k)(1)(iii) and (v) of this AD. If any cracks are found, do not re-install the v-band coupling. Before further flight, you must install a new v-band coupling and restart the hours TIS for the repetitive replacement of the v-band coupling.
