[Docket No. FAA-2018-0479; Product Identifier 2016-NE-23-AD; Amendment 39-19369; AD 2018-17-15]

Airworthiness Directives; Honeywell International Inc. Turboprop and Turboshaft Engines

2018-17-15 Honeywell International Inc. (Type Certificate previously held by AlliedSignal Inc., Garrett Engine Division; Garrett Turbine Engine Company; and AiResearch Manufacturing Company of Arizona): Amendment 39-19369; Docket No. FAA-2018-0479; Product Identifier 2016-NE-23-AD.

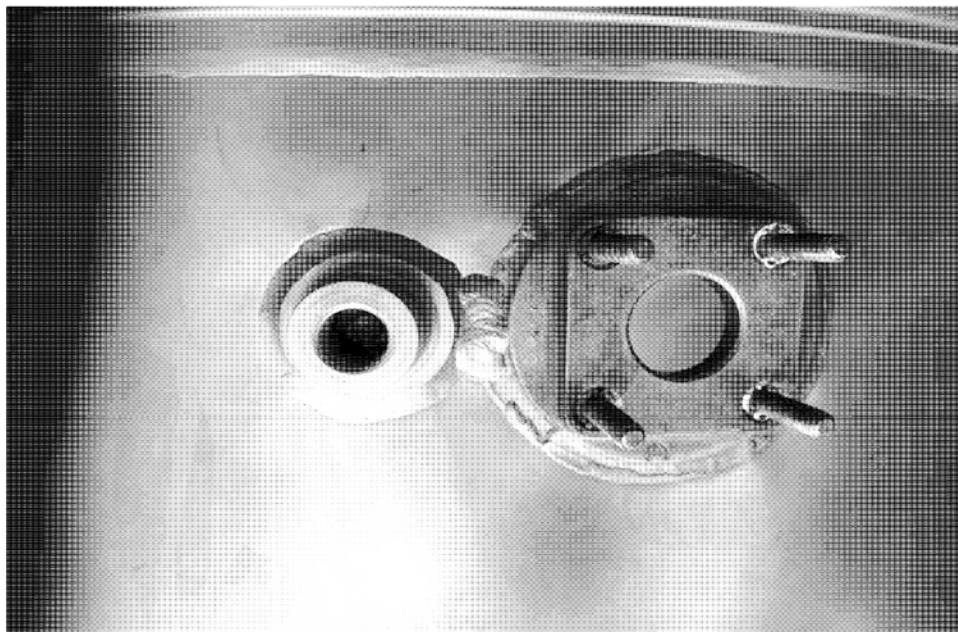
Figure 1 to Paragraph (h) of this AD. Combustion Chamber Case Assembly Without the One-Piece Bleed Pad with P3 Boss

(2) Figures 1 and 2 to paragraph (h) of this AD illustrate the appearance of combustion chamber case assembly, P/N 893973-5, without and with, respectively, the one-piece bleed pad with the P3 boss.

After the effective date of this AD, do not install a combustion chamber case assembly, P/N 869728-1, 869728-3, or 893973-5, in TPE331-3U, -3UW, -5, -5A, -5AB, -5B, -6, and -6A engine models or in TPE331-1, -2, and -2UA engine models modified by National Flight Services, Inc., STC SE383CH, unless the combustion chamber case assembly has a one-piece bleed pad with P3 boss.
