AIRWORTHINESS DIRECTIVE

№ 2018-322-01

Applicability - RRJ-95 Aircraft

TECHNICAL DECISION RRJ0000-OR-470-1975

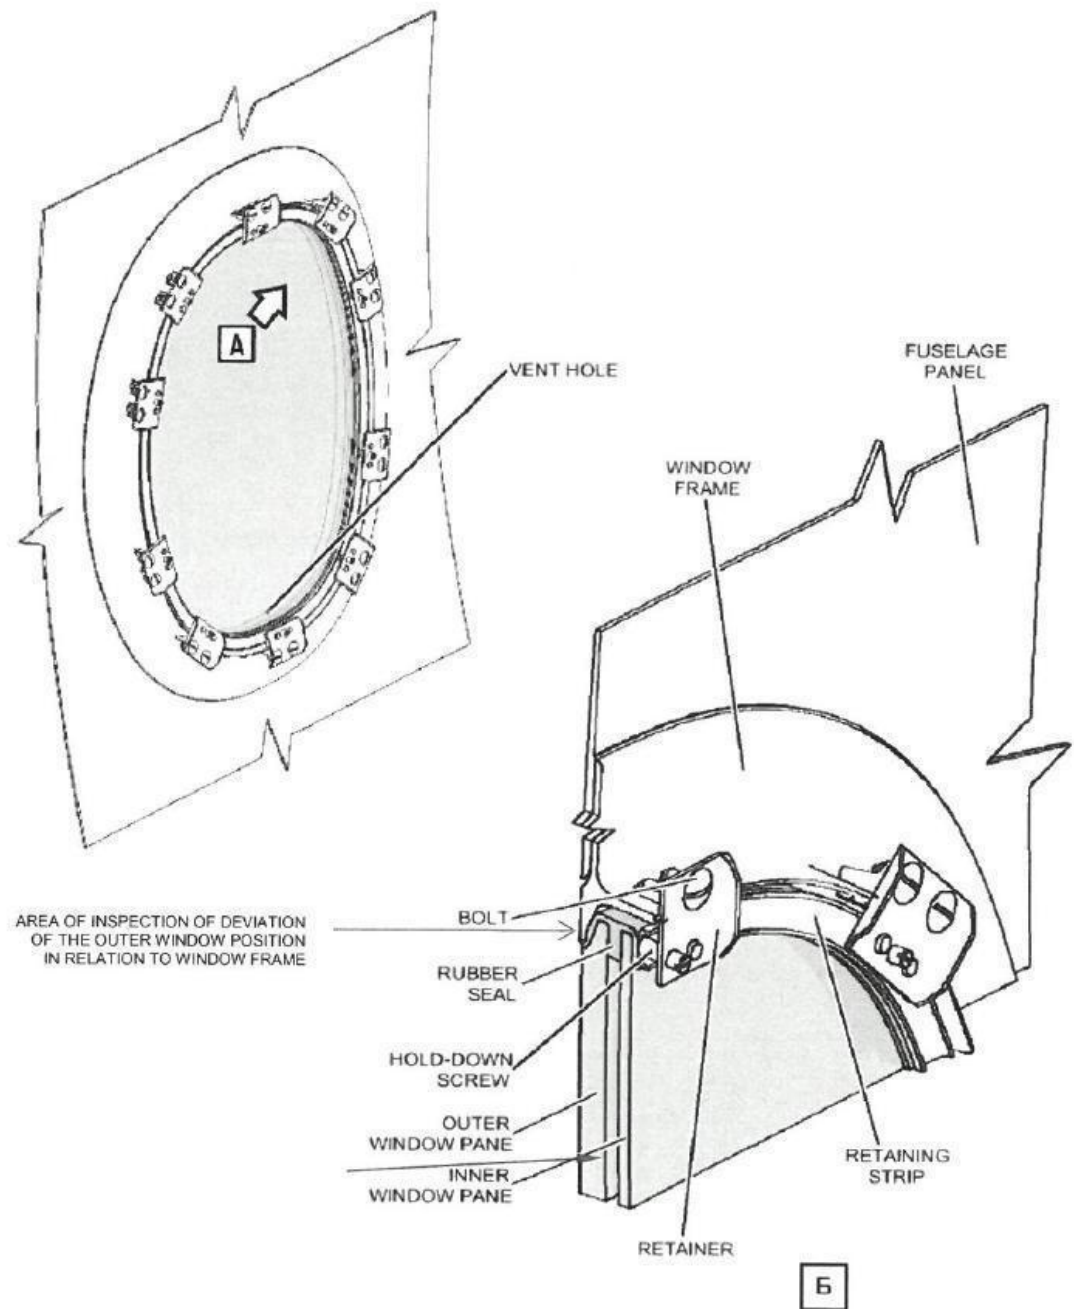
Fig.1. Passenger Cabin Window.

Due to identification of non-conformity in the mounts of passenger cabin windows retainers p/n T7.92.0704.105.000.70/B on AC RRJ-95B RA-89024 and RA-89026: loosen and fallen out hold-down screws 5-16-ХИМ.Пас.-ОСТ 1 31574-80, as well as loss of locking features of anchor nuts 5-Ц ОСТ 1 33264-89 the following decision has been taken:

NOTE 3: Installation of retainers p/n T7.92.0704.105.000.70/B with the bolts p/n 5-12-Ц-ОСТ 1 31158-80 to be performed with application of a thin layer of paste LU-052 or sealer IS-069 on a threaded part of screws after preliminary cleaning of the contacting surface of the retainer and retaining strip (see Fig.1) with a cleaning rug soaked in solvent.

2. In case non-conformity is revealed, upon the results of cl.1 of this Decision – to perform replacement of defective mount of passenger cabin window in accordance with the procedure described below:
 - 2.1. To perform preparatory activities in order to open the access areas IAW cl.3 Б. of AMM 56-21-01-900-801 “Removal/Installation of passenger cabin window”;
 - 2.2. Remove seats units in the area of passenger cabin window removal (see activity AMM 25-21-01-900-801);
 - 2.3. Remove side panels in the area of passenger cabin window removal (see activity AMM 25-23-05-900-801);
 - 2.4. Perform replacement of retainers p/n T7.92.0704.105.000.70/B;

NOTE 2: During retainers installation instead of previously installed hold-down screws p/n 5-16-Хим.Пас-ОСТ 1 31574-80 to perform installation of new screws with hexagon head p/n 5-16-Хим.Пас-ОСТ 1 31503-80.

To perform tightening of screws IAW AMM 56-21-01-900-801. To perform tightening of screws 6 (clause 4 "Б (6)", page 402) as per the following procedure: removing one-by-one each screw on the opposite sides of the strip until the gap appearance, again tighten the screws until they contact with the retaining strip. After contact to turn the screw for 1.5 of the turn, at that deformation (bending) of the corner for 1.5 mm is allowed.
