DEPARTMENT OF TRANSPORTATION

Federal Aviation Administration

[Docket No. FAA-2019-0469; Product Identifier 2019-CE-028-AD; Amendment 39-19664; AD 2019-12-09]

Airworthiness Directives; Rockwell Collins, Inc. Flight Display System Application

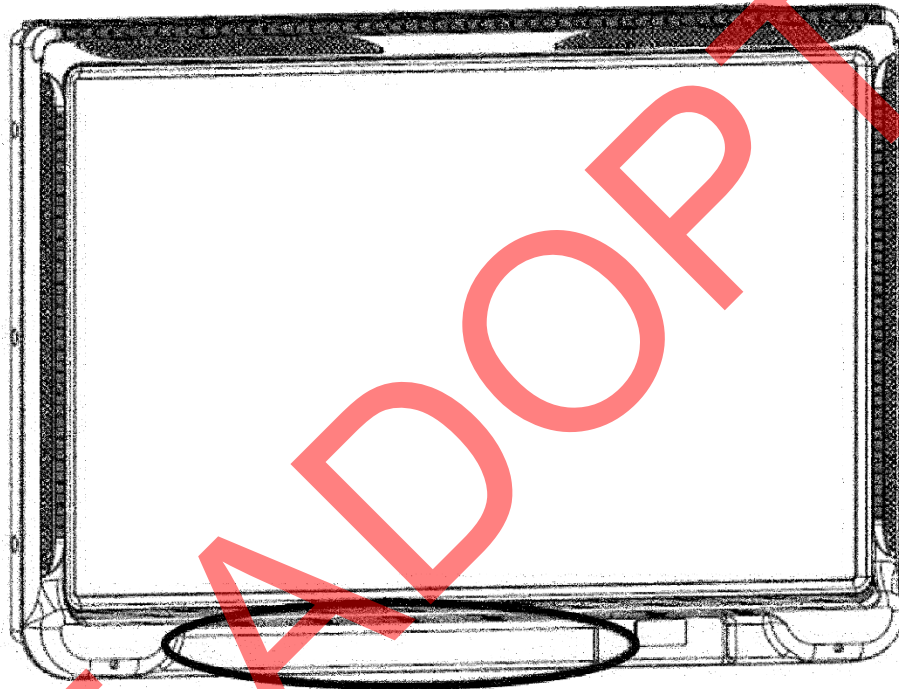
Figure 1 to paragraph (g)(3) of this AD; placard location on bezel

This AD was prompted by a conflict between the traffic collision avoidance system (TCAS) primary display indications and aural alerts during a resolution advisory (RA) scenario. The FAA is issuing this AD to prevent conflicting TCAS information. The unsafe condition, if not addressed, could result in the pilot under-correcting or over-correcting and may lead to inadequate aircraft separation and a mid-air collision.

(2) Fabricate a placard for each aircraft primary flight display, using at least 1/8 inch letters, with the following text: TCAS Flight Ops–TA Only mode (TA/RA mode prohibited).

(3) Install the placard on the bottom of each aircraft primary flight display bezel in the area depicted in figure 1 to paragraph (g)(3) of this AD.
