[Docket No. FAA-2019-0715; Product Identifier 2019-NM-151-AD; Amendment 39-19760; AD 2019-20-07]

Airworthiness Directives; The Boeing Company Airplanes

SUMMARY: The FAA is adopting an airworthiness directive (AD) for all The Boeing Company Model 787-8, 787-9, and 787-10 airplanes. This AD requires repetitive operational checks of the leading edge (LE) outboard (OB) slats and applicable on-condition actions. This AD also requires revising the airplane flight manual (AFM) to prohibit flap retraction under icing conditions and revising the existing maintenance or inspection program, as applicable, to incorporate a new operation check. This AD was prompted by a determination that the LE OB slat system could be out of position without flight deck annunciation. The FAA is issuing this AD to address the unsafe condition on these products.

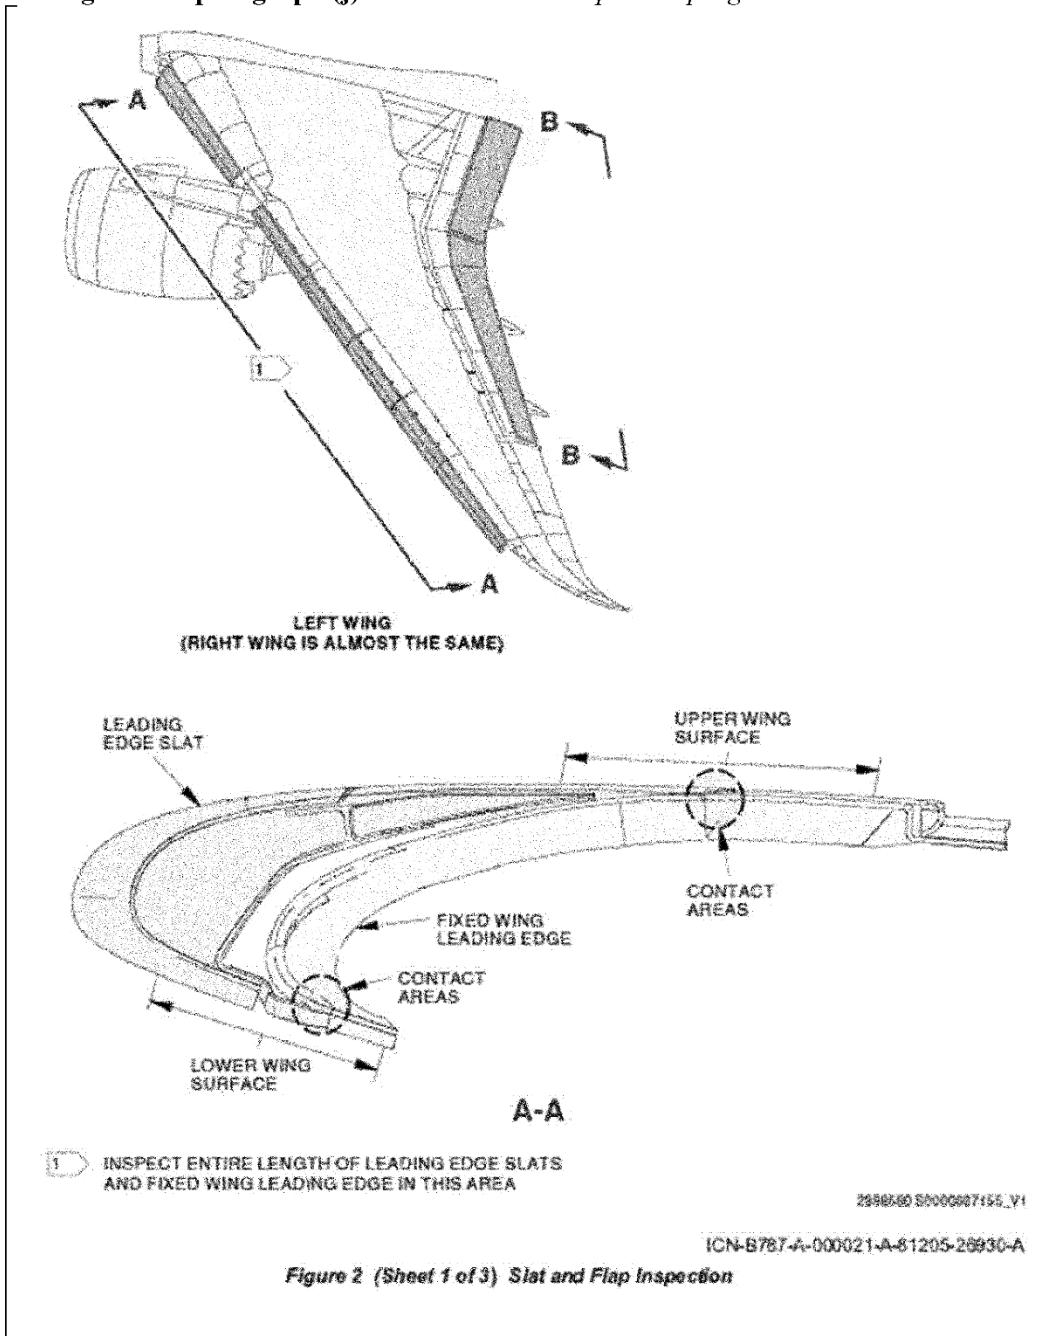
Figure 2 (Sheet 1 of 3) Slat and Flap Inspection

After any landing in icing conditions, do this inspection with the slats/flaps (flaps 25 detent) fully extended (Figure 2):

- (a) Examine these areas for contaminants (ice, snow, slush):

- 1) Slats/flaps surfaces
- 2) Leading edge contact surfaces

NOTE: “Contact surfaces” refers to the areas of the slat and the fixed wing that will be in contact after slat retraction.

- 3) Slat actuation areas, including exposed areas of the slat track cavity, and slat cove
- 4) Flap tracks, hinges, seals

- (b) Remove the contamination that you find.

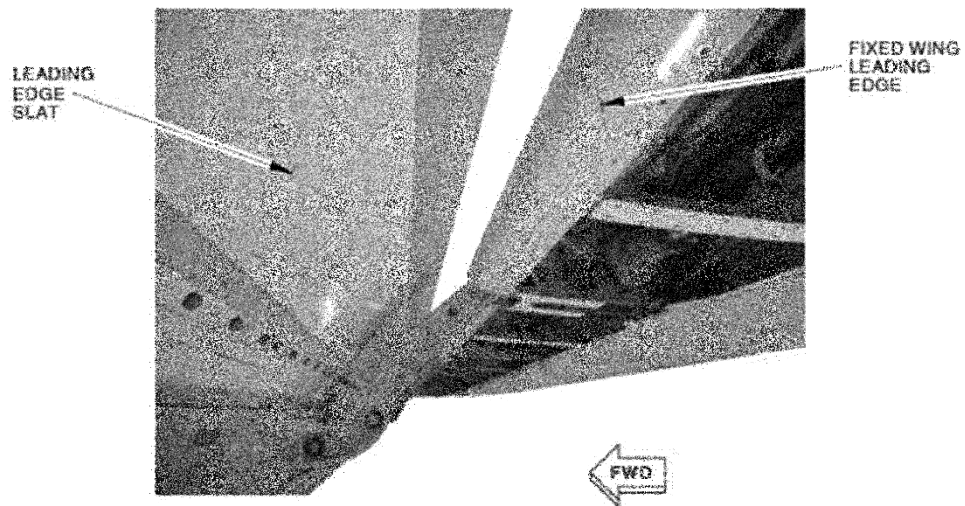
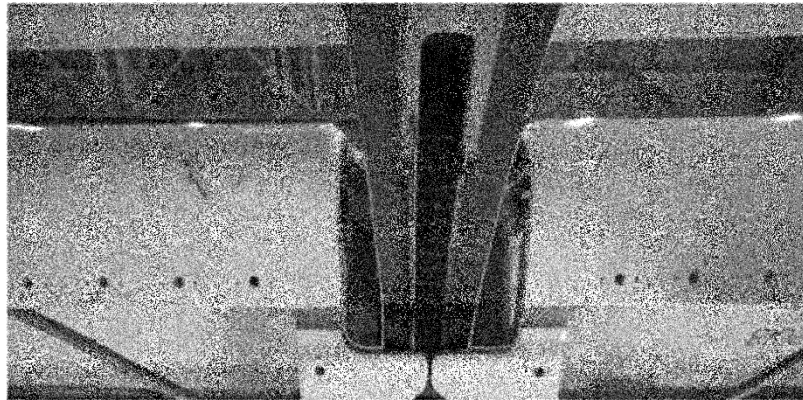
Figure 2 (Sheet 2 of 3) Slat and Flap Inspection

**ACTUATION AREAS
(TYPICAL)
A-A**

**SLAT TRACK CAVITY
(TYPICAL)
(VIEW IN THE AFT DIRECTION)
A-A**
