## **AIRWORTHINESS DIRECTIVE**

Ref. No. 2019-FATA-01020A-06

Applicability -- RRJ-95 aircraft

In the course of implementation of AD Nos. 2019-322-03 and 2019-322-05 on RRJ-95 A/C fleet (hereinafter – A/C) cracks on inner ring of a bearing of link of track of a slat section 1 have been revealed. In order to timely detect and eliminate the identified non-conformity as regards to link of track of a slat section

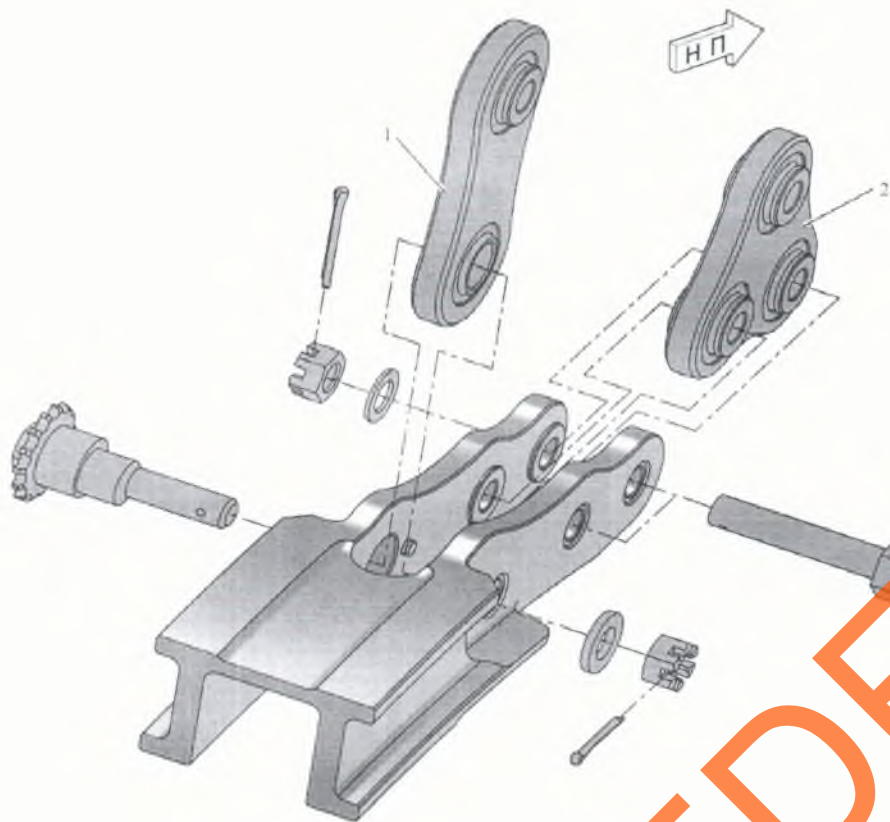
1. During the weekly WY-Check/8 DY on RRJ-95 A/C MSN 95030, 95037 and 95116-95220 to perform inspections of links of tracks (See Fig.1 (items1,2) and Fig.2 (item 3) and bearings of links of tracks of sections 2, 3 and 4 of a slat of LH and RH outer wing in accordance with provisions of p. 4. B. (2) and (6) of AMM Tasks Nos. 57-43-00-220-802, 57-44-00-220-802 and 57-45-00-220-802 until the implementation of SB No. RRJ-57-00451-BD “Wing – Replacement of link of track of a slat section”.

3. In case of finding a crack of link of track and/or destruction and/or press-out of the bearing of link of track of sections 1, 2, 3 and 4 of a slat of LH and RH outer wing following the results of implementation of p.1 and 2 of this AD – to replace the damaged track link assembly (link of track and bearing):

- For slat sections 2,3 and 4 – to replace with the configuration of link of track of sections 2, 3 and 4 of a slat IAW identification information in Table 1 and IAW AMM Tasks Nos. 57-43-00-900-804, 57-44-00-900-804 and 57-45-00-900-804.

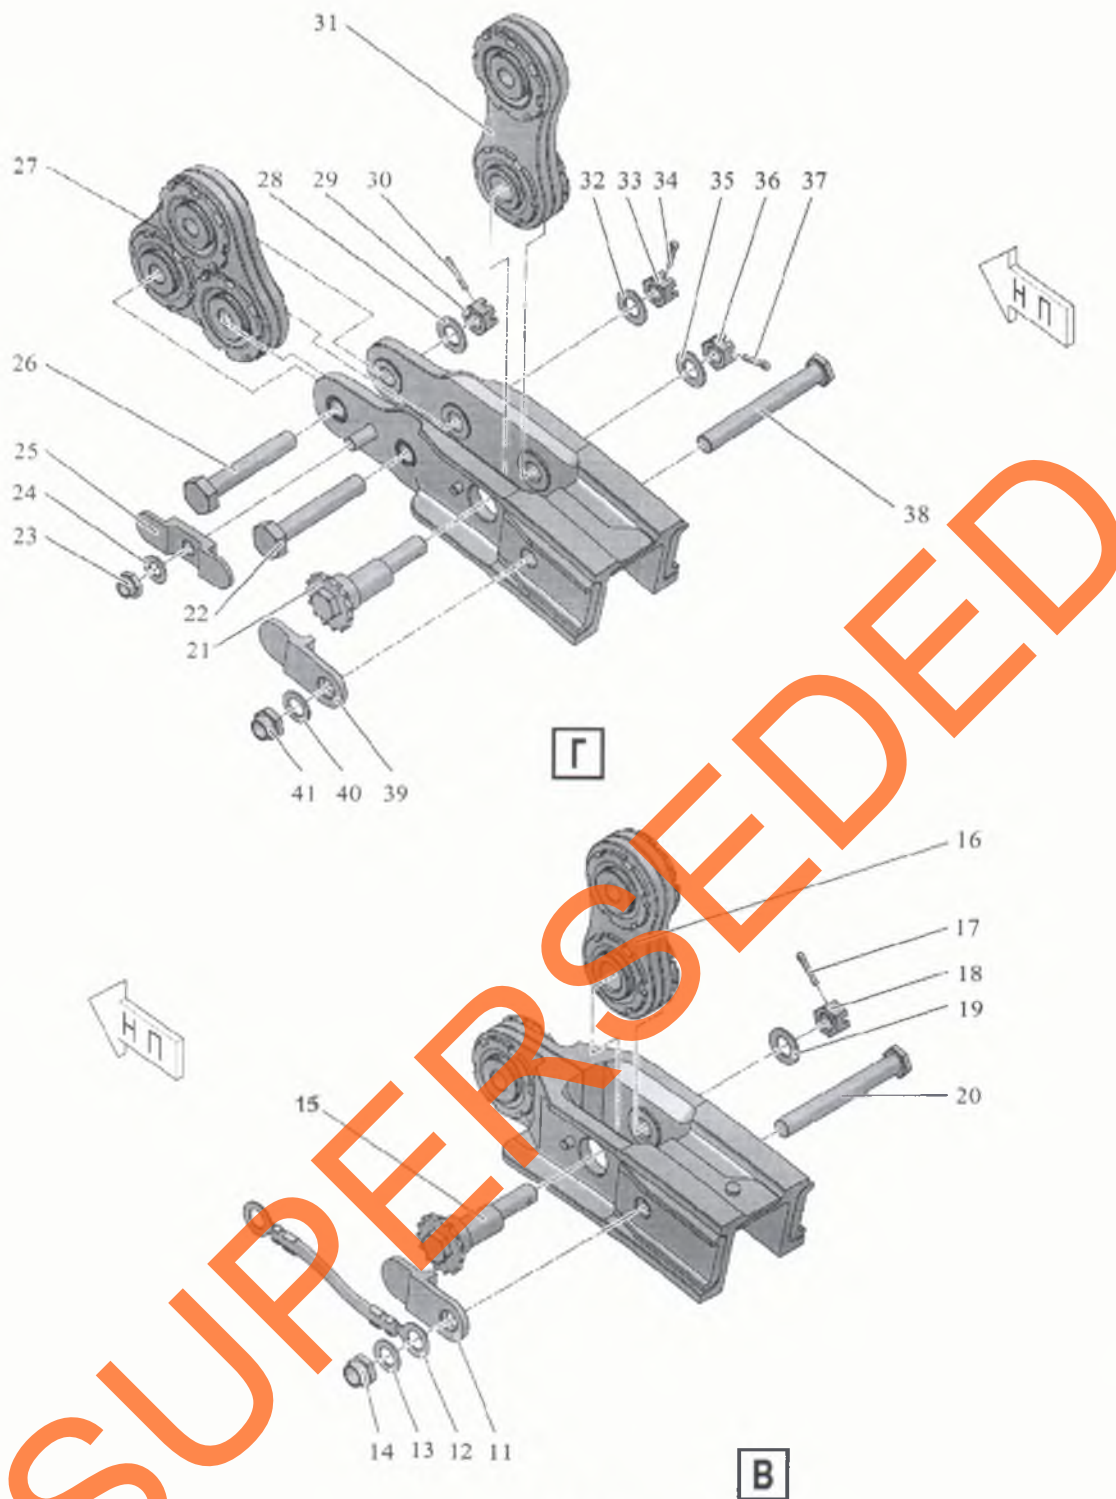
2. During the weekly WY-Check/8 DY on RRJ-95 A/C MSN 95007-95220 to perform one-time inspection of links of tracks (See Fig.3 (items16, 27 and 31) and bearings of links of tracks of section 1 of a slat of LH and RH outer wing in accordance with provisions of p. 4. B. (2) and (6) of AMM Tasks Nos. 57-42-00-220-802.

- For slat section 1 – to replace with the current configuration of link of track of section 1 of a slat, IAW AMM Task No. 57-42-00-900-804.
