[Docket No. FAA-2020-0883; Project Identifier 2019-CE-034-AD; Amendment 39-21460; AD 2021-05-17]

Airworthiness Directives; Rockwell Collins, Inc. Flight Display System Application

2021-05-17 Rockwell Collins, Inc.: Amendment 39-21460; Docket No. FAA-2020-0883; Project Identifier 2019-CE-034-AD.

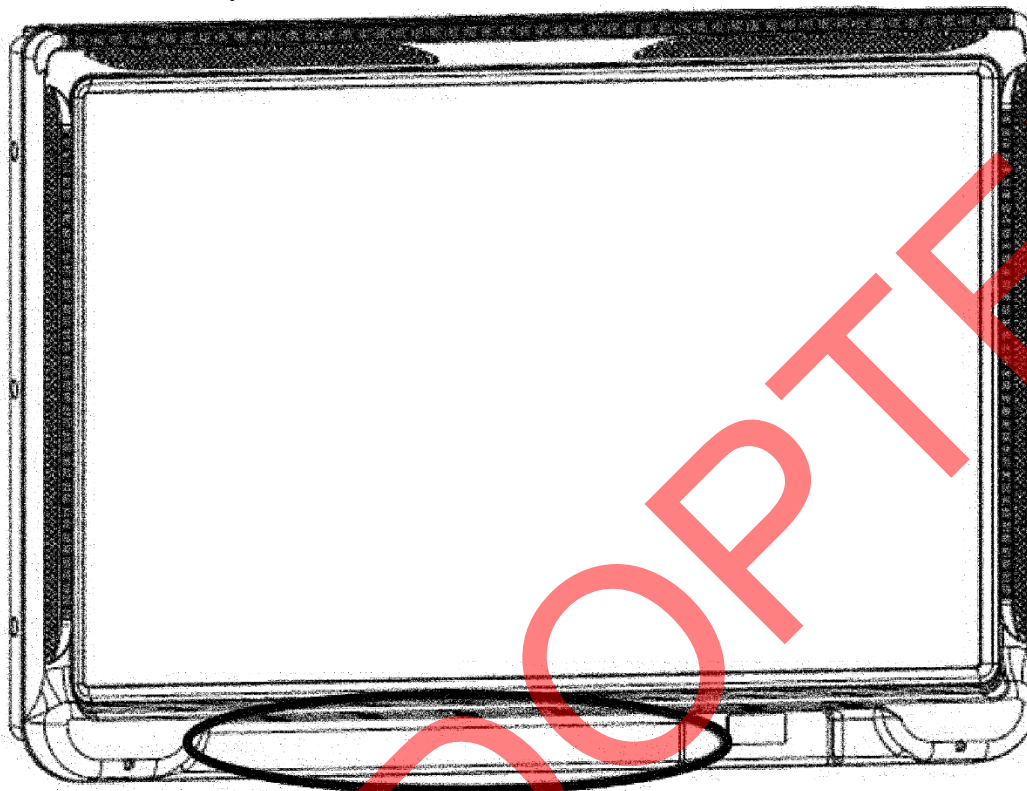
Figure 1 to paragraph (g)(1)(iii); placard location on bezel

This AD was prompted by a conflict between the traffic collision avoidance system (TCAS) primary display indications and aural alerts during a resolution advisory (RA) scenario. The FAA is issuing this AD to prevent conflicting TCAS information, which could result in the pilot under-correcting or over-correcting and may lead to inadequate aircraft separation and a mid-air collision.

- (1) Within 30 days after July 23, 2019 (the effective date of AD 2019-12-09), do the following:
 - (i) Revise the airplane flight manual (AFM) or AFM supplement (AFMS) by adding the following text to the Limitations section: For TCAS II installations, during flight, do not operate TCAS in the “TA/RA” mode; TCAS may only be operated in “TA Only” mode.
 - (ii) Fabricate a placard for each aircraft primary flight display, using at least 1/8 inch letters, with the following text: TCAS Flight Ops–TA Only mode (TA/RA mode prohibited).

(iii) Install the placard on the bottom of each aircraft primary flight display bezel in the area depicted in figure 1 to paragraph (g)(1)(iii) of this AD.
