**[Docket No. FAA-2020-0442; Project Identifier AD-2020-00260-E; Amendment 39-21640; AD 2021-14-13]**

#### **Airworthiness Directives; Pratt & Whitney Turbofan Engines**

**ACTION:** Final rule.

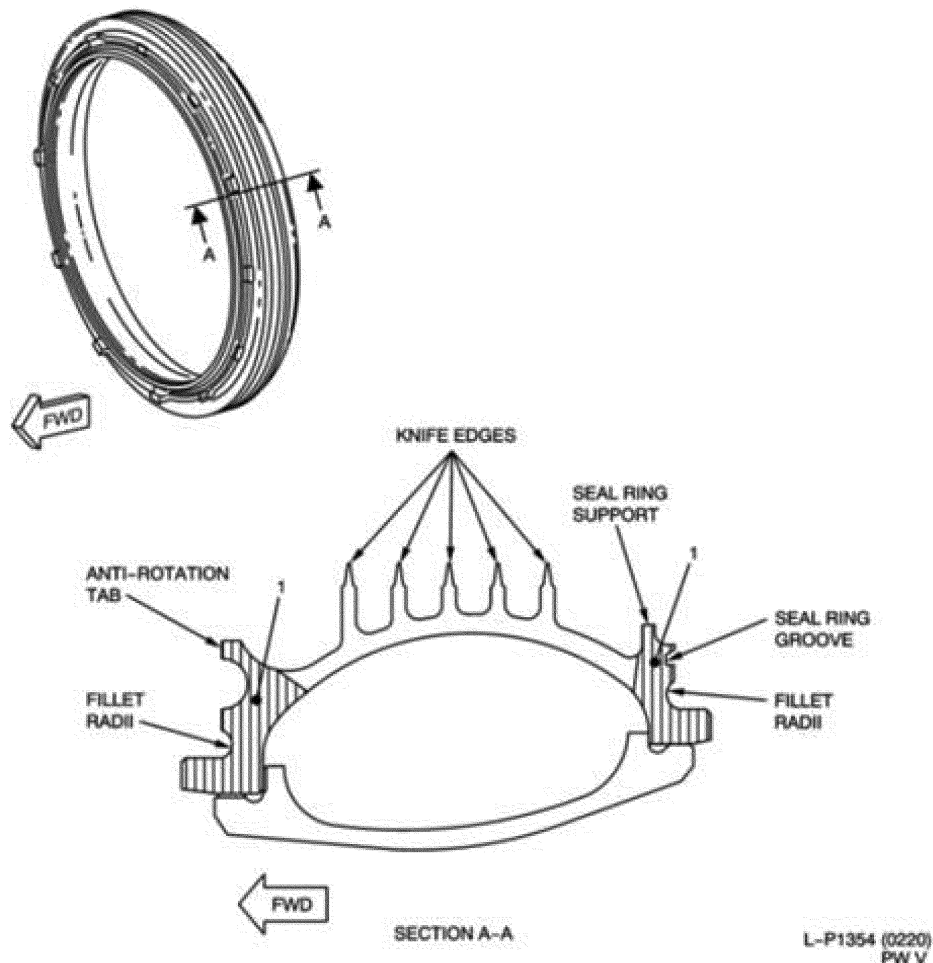
**Figure 1 to Paragraph (g)(1)(iii) – Crack Inspection Critical Areas**

The FAA did not revise this AD in response to this comment. A crack, as identified in the shaded regions of Figure 1 to paragraph (g)(1)(iii) of this AD (Figure 1), which extends towards the knife-edge region of the HPT 2nd-stage air seal assembly, impacts the serviceability of the mating HPT 1st-stage disk and the HPT 2nd-stage hub. A crack identified in the shaded region of Figure 1 of this AD of the HPT 2nd-stage air seal assembly results in the requirement to remove the HPT 2nd-stage air seal assembly, mating HPT 1st-stage disk, and HPT 2nd-stage hub.

This AD was prompted by a report of an uncontained engine failure resulting from cracks originating in the knife edge of the high-pressure turbine (HPT) 2nd-stage air seal assembly. The FAA is issuing this AD to prevent failure of the HPT 2nd-stage air seal assembly. The unsafe condition, if not addressed, could result in uncontained HPT 2nd-stage air seal assembly release, damage to the engine, and damage to the airplane.

(iii) During the visual inspection or FPI required by paragraph (g)(1)(i) of this AD, if a crack is found in the shaded regions of the HPT 2nd-stage air seal assembly identified in Figure 1 to paragraph (g)(1)(iii) of this AD (Figure 1), which extends towards the knife-edge region of the HPT 2nd-stage air seal assembly, remove the HPT 2nd-stage air seal assembly, mating HPT 1st-stage disk, and HPT 2nd-stage hub from service, and replace the parts with parts eligible for installation. In order to return the mating HPT 1st-stage disk and HPT 2nd-stage hub to service, the inspections of the HPT 2nd-stage air seal assembly cannot reveal a crack identified in the shaded regions of Figure 1, which extends towards the knife-edge region.

If a crack is found as identified in the shaded region of Figure 1 to paragraph (g)(1)(iii) of this AD (Figure 1) that extends toward the knife-edge region of the HPT 2nd-stage air seal assembly, this AD requires replacement of the HPT 2nd-stage air seal assembly, mating HPT 1st-stage disk, and HPT 2nd-stage hub.

(ii) If a crack is found in the HPT 2nd-stage air seal assembly during the visual inspection or FPI required by paragraph (g)(1)(i) of this AD, remove the HPT 2nd-stage air seal assembly from service and replace it with a part eligible for installation.
