### Federal Aviation Administration

[Docket No. FAA-2023-1055; Project Identifier AD-2023-00583-T; Amendment 39-22445; AD 2023-10-09]

### Airworthiness Directives; The Boeing Company Airplanes

The FAA is adopting a new airworthiness directive (AD) for all The Boeing Company Model 787-8, 787-9, and 787-10 airplanes. This AD was prompted by reports of damaged decompression panels from operators. This AD requires repetitive inspections for damaged fastener holes on the vertical and bottom edges of the inward and outward blowing decompression panels installed on the forward and aft cargo compartment vertical sidewall linings and applicable on-condition actions. The FAA is issuing this AD to address the unsafe condition on these products.

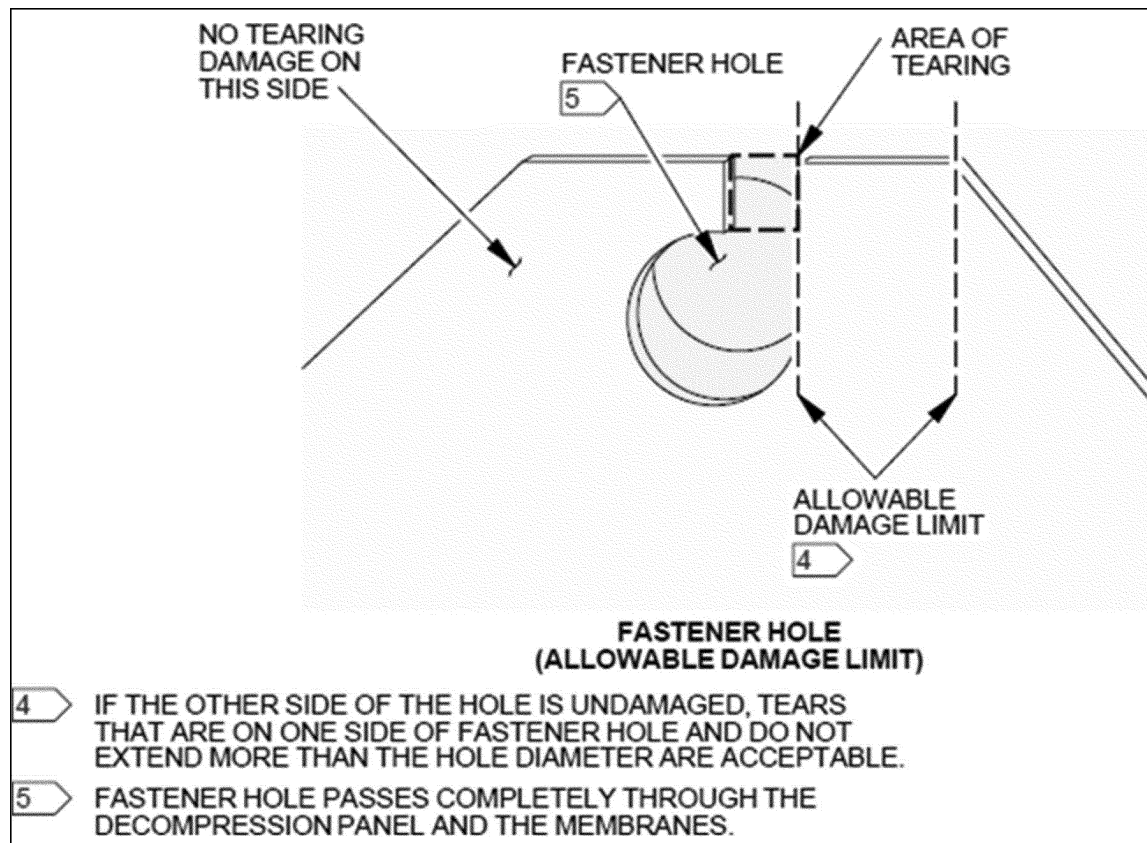
**Figure 2 to paragraph (g)(3)(ii) – Allowable damage not extending more than fastener hole diameter**

(ii) If the damage is on one side of the fastener hole and the other side of the fastener hole has no damage, the damage must not extend more than the diameter of the fastener hole. Refer to figure 2 to

paragraph (g)(3)(ii) of this AD. Where figure 2 to paragraph (g)(3)(ii) of this AD refers to tears, tearing, or tearing damage, this includes all types of damage as defined in paragraph (g)(2) of this AD.
