[Docket No. FAA–2023–2232; Project Identifier AD–2023–00943–R; Amendment 39–22681; AD 2024–04–02]

### Airworthiness Directives; Robinson Helicopter Company Helicopters

**2024-04-02 Robinson Helicopter Company:** Amendment 39-22681; Docket No. FAA-2023-2232; Project Identifier AD-2023-00943-R.

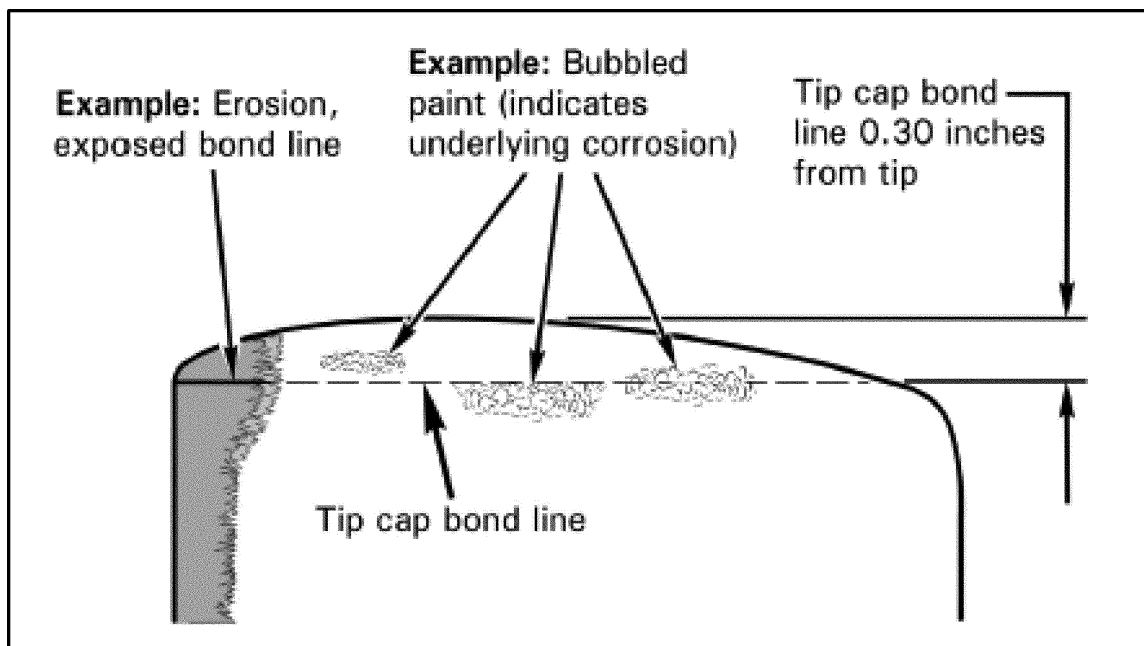
**Figure 1 to Paragraph (g)(1)—TRB Tip Cap Check/Inspection**

A debonded TRB tip cap can cause severe vibration and possible failure of the tail rotor gearbox housing. This condition, if not addressed, could result in increased vibrations, reduced controllability, and subsequent loss of control of the helicopter. The FAA is issuing this AD to address the unsafe condition on these products.

(1) Within 10 hours time-in-service (TIS) after the effective date of this AD and thereafter before the first flight of each day, visually check each TRB tip cap area (at and adjacent to the tip cap bond line on each surface and edge of the TRB) for an exposed tip cap bond line or bubbled paint, as depicted in Figure 1 to paragraph (g)(1) of this AD. These items may indicate evidence of corrosion. The owner/operator (pilot) holding at least a private pilot certificate may accomplish this TRB tip cap check and must enter compliance with this paragraph of the AD into the helicopter maintenance records in accordance with [14 CFR 43.9\(a\)](#) and [91.417\(a\)\(2\)\(v\)](#). The record must be maintained as required by [14 CFR 91.417](#), [121.380](#), or [135.439](#).

(2) Within 100 hours TIS or during the next 100 hour or annual inspection after the effective date of this AD, whichever occurs first, and thereafter at intervals not to exceed 100 hours TIS or during the next 100 hour or annual inspection, whichever occurs first, visually inspect each TRB tip cap area (at and adjacent to the tip cap bond line on each surface and edge of the TRB) for evidence of corrosion, which may be indicated by an exposed tip cap bond line or bubbled paint, as depicted in Figure 1 to paragraph (g)(1) of this AD.

(3) As a result of the actions required by either paragraph (g)(1) or (2) of this AD, if there is evidence of corrosion, an exposed tip cap bond line, or bubbled paint, before further flight, remove all of the

(4) Within 10 months of the effective date of this AD, remove all TRBs identified in paragraph (c) of this AD from service.
