[Docket No. FAA-2024-0769; Project Identifier AD-2023-00556-T; Amendment 39-22815; AD 2024-16-09]

Airworthiness Directives; The Boeing Company Airplanes

Final rule.

2024-16-09 The Boeing Company: Amendment 39-22815; Docket No. FAA-2024-0769; Project Identifier AD-2023-00556-T.

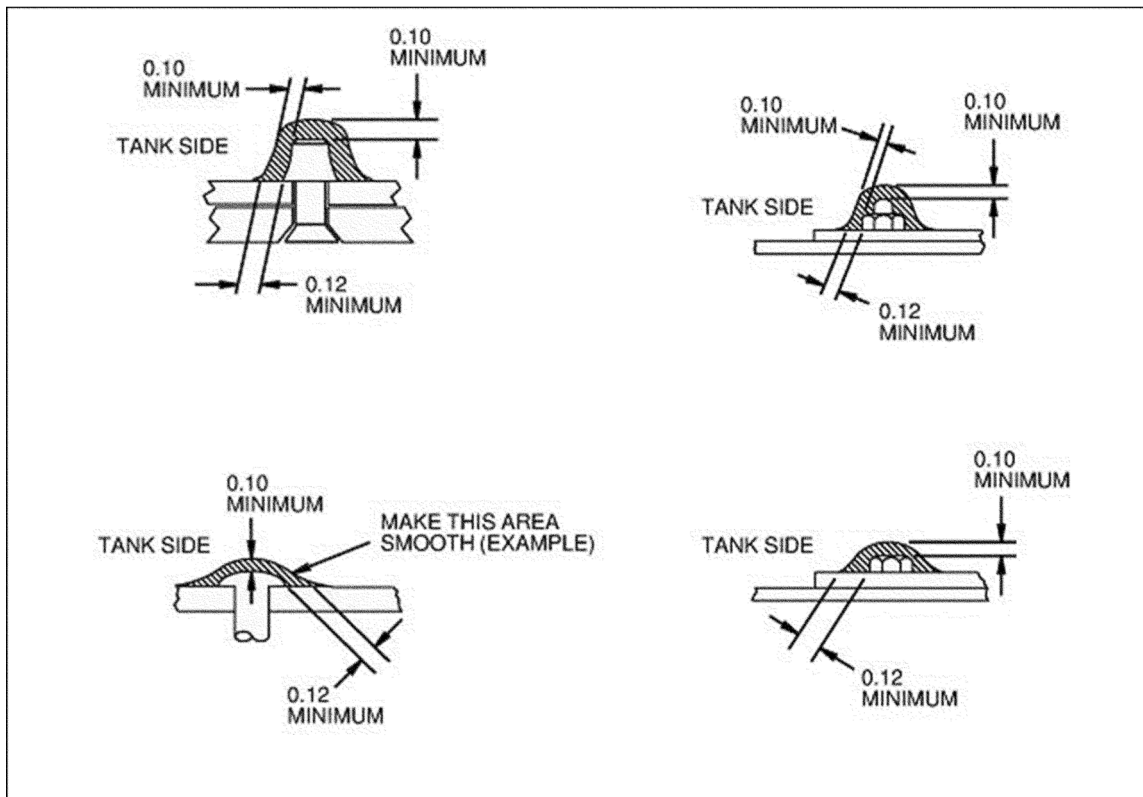
Figure 1 to Paragraph (h)(3)—Cap Sealing Dimensions (all Dimensions are in Inches)

Boeing concluded that only the cap seals on the interior side of the fuel tank require the dimensions specified in Figure 1 of paragraph (h)(3) of the proposed AD to perform their intended function, which is consistent with the labels shown in Figure 1 of paragraph (h)(3) of the proposed AD. Boeing recommended replacing the text “applying a cap seal (sealant) to a fastener, fastener head, and fastener threads and collars, for this AD, during application of any cap seal to a fastener, fastener head, or fastener threads and collars” with the text “applying a cap seal (sealant) to a fastener location that penetrates the fuel tank boundary, for this AD, during application of any cap seal to a fastener, fastener head, or fastener threads and collars inside the fuel tank.”

The FAA agrees to clarify paragraph (h)(3) of this AD for the reasons provided by the commenter. Locations that do not penetrate the fuel tank boundary do not require the same sealant application procedures. The FAA has added the text “inside the fuel tank” to paragraph (h)(3) of this AD. However, the FAA did not replace the text “to a fastener, fastener head, and fastener threads and collars” with the text “to a fastener location that penetrates the fuel tank boundary,” as recommended by the commenter, because the text “to a fastener, fastener head, and fastener threads and collars inside the fuel tank” better aligns with the language within the service information.

The FAA agrees. Boeing 777 AMM 28-11-00 meets the sealant requirements of Figure 1 to paragraph (h)(3) of this AD. As such, it would be an acceptable procedure to follow when sealing inside the fuel tank in accordance with paragraph (h)(3) of this AD. The FAA has added a note to paragraph (h)(3) of this AD accordingly.

(3) Where any service information referenced in Boeing Alert Requirements Bulletin 777-53A0100 RB, dated March 16, 2023, specifies applying a cap seal (sealant) to a fastener, fastener head, and fastener threads and collars inside the fuel tank, for this AD, during application of any cap seal to a fastener, fastener head, or fastener threads and collars inside the fuel tank, the cap seal must be applied using a cap sealing procedure with thickness greater than or equal to the dimensions given in Figure 1 to paragraph (h)(3) of this AD.

Note 4 to paragraph (h)(3): Guidance on an acceptable cap sealing procedure for accomplishing the actions required by paragraph (h)(3) of this AD can be found in Boeing Model 777 Aircraft Maintenance Manual (AMM) section 28-11-00.
