#### **14 CFR Part 39**

**[Docket No. FAA-2024-0237; Project Identifier AD-2023-00491-R; Amendment 39-22853; AD 2024-19-11]**

### **Airworthiness Directives; Robinson Helicopter Company Helicopters**

Final rule.

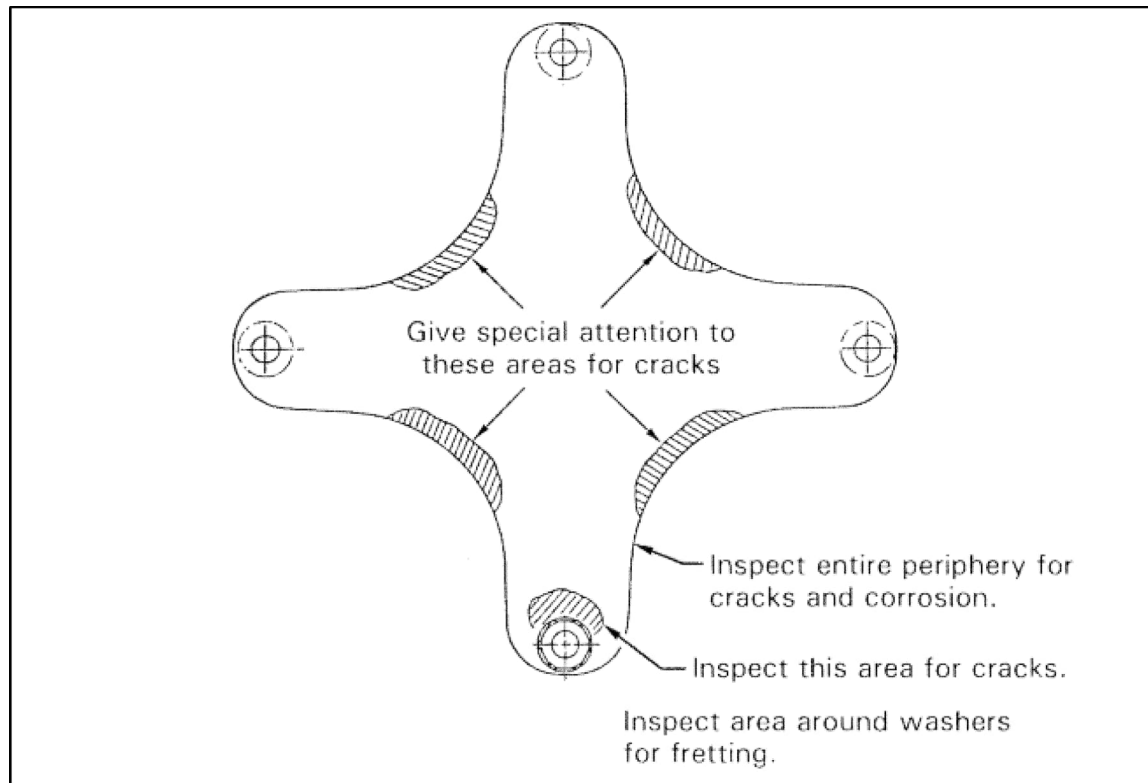
Figure 1 to Paragraph (g)(1)(i)—Flex Plate Inspection

(i) Visually inspect forward flex plate assembly (flex plate) part number (P/N) C947-1 for any loose fasteners, cracks, fretting, corrosion, wear, and to ensure that the washers are bonded to both sides of each flex plate arm, in the areas depicted in Figure 1 to paragraph (g)(1)(i) of this AD. If there is any loose fastener (can be moved by hand), crack, fretting, corrosion, or wear that consists of the

washers not securely bonded to both sides of each flex plate arm, before further flight, remove the flex plate from service and replace with an airworthy flex plate.
