[Docket No. FAA-2024-0237; Project Identifier AD-2023-00491-R; Amendment 39-22853; AD 2024-19-11]

#### Airworthiness Directives; Robinson Helicopter Company Helicopters

Final rule.

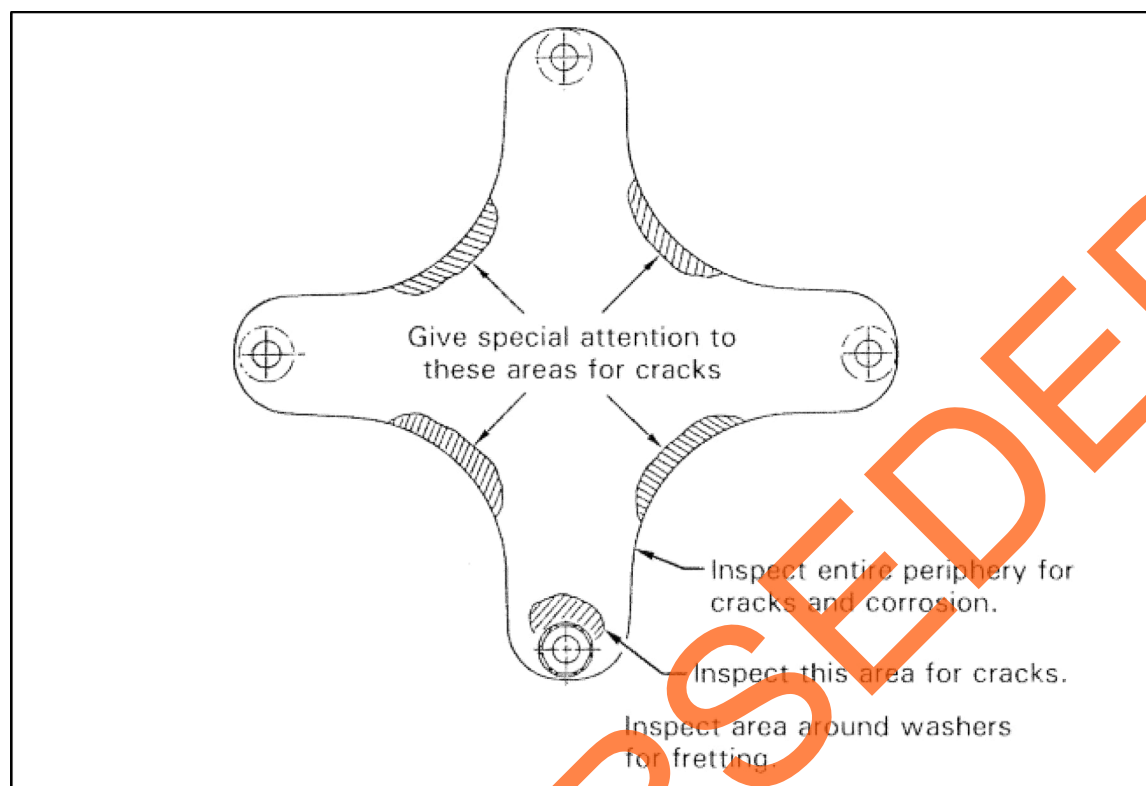
Figure 1 to Paragraph (g)(1)(i)—Flex Plate Inspection

(i) Visually inspect forward flex plate assembly (flex plate) part number (P/N) C947-1 for any loose fasteners, cracks, fretting, corrosion, wear, and to ensure that the washers are bonded to both sides of each flex plate arm, in the areas depicted in Figure 1 to paragraph (g)(1)(i) of this AD. If there is any loose fastener (can be moved by hand), crack, fretting, corrosion, or wear that consists of the

washers not securely bonded to both sides of each flex plate arm, before further flight, remove the flex plate from service and replace with an airworthy flex plate.
