DEPARTMENT OF TRANSPORTATION

Federal Aviation Administration

[Docket No. FAA-2023-1993; Project Identifier AD-2023-00129-T; Amendment 39-22940; AD 2025-02-07]

Airworthiness Directives; The Boeing Company Airplanes

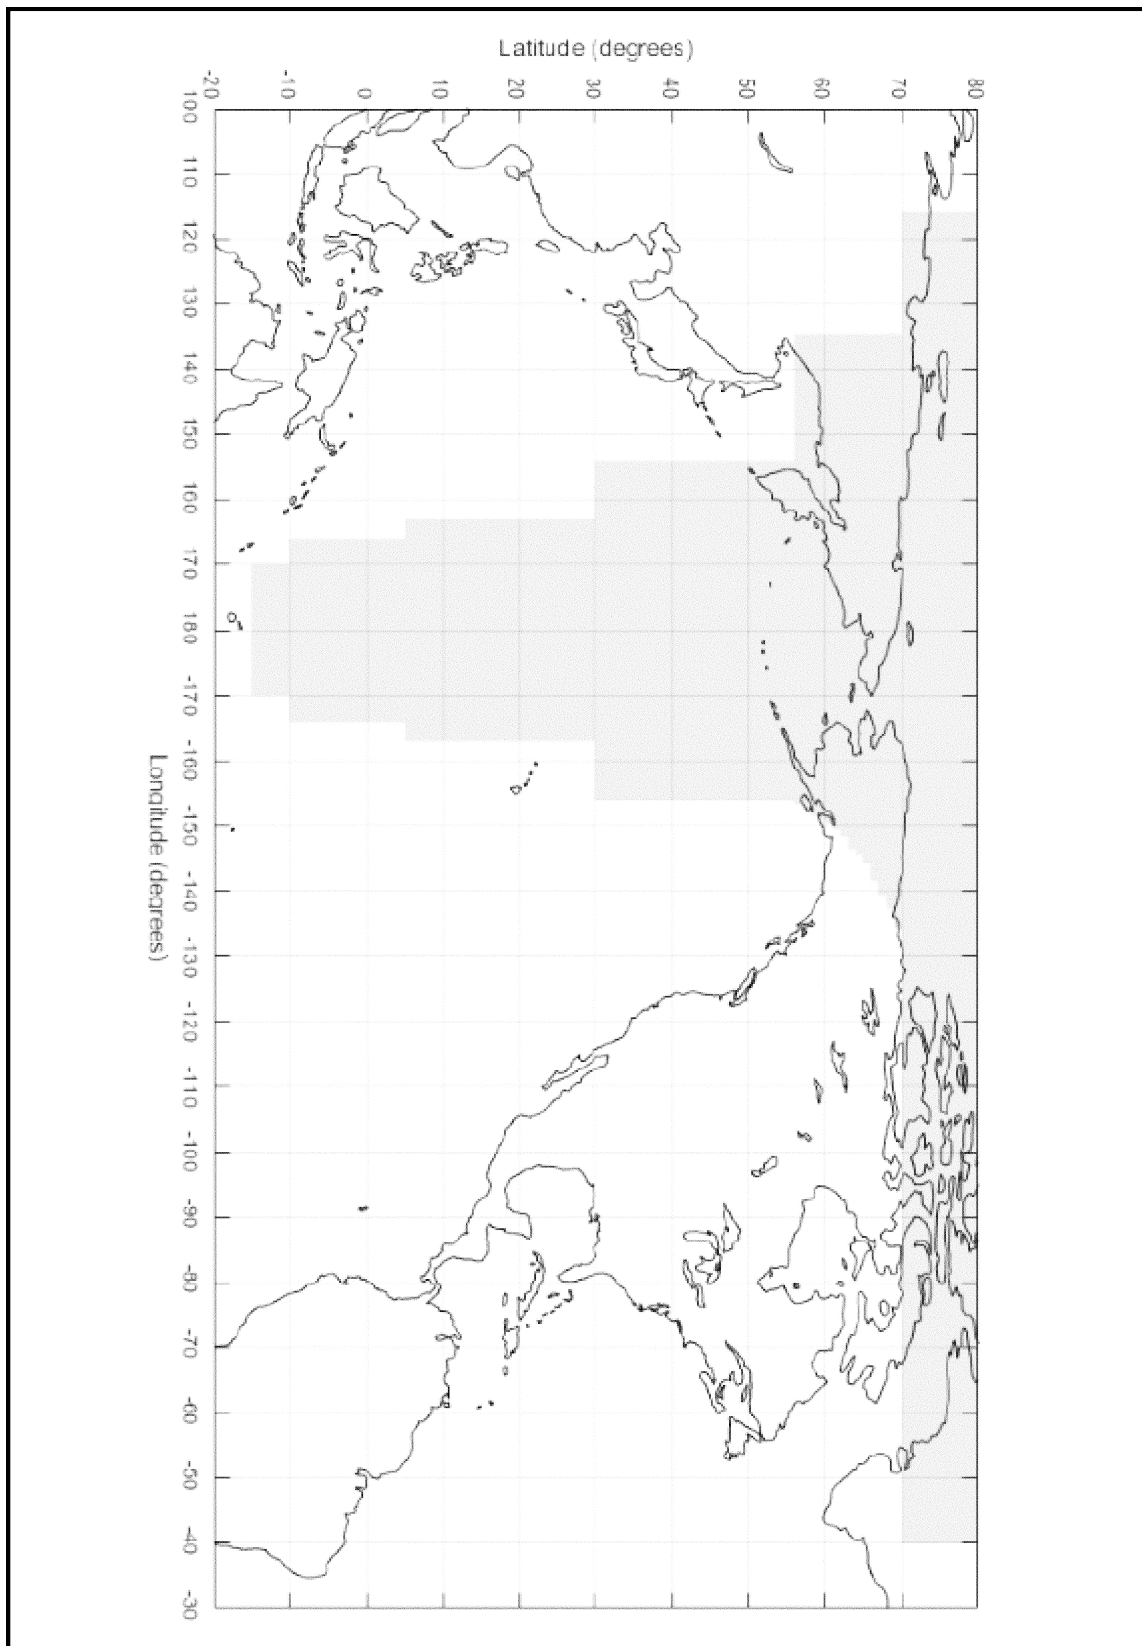
Figure 2 to Paragraph (g)—AFM—Limitations or Certificate Limitations Continued

Operations that require less than 0.3 RNP (For example, 0.1, 0.11, 0.15, etc.) in the region identified below are prohibited with GLU-2100 OPS software number COL4D-0087-0002, COL4E-0087-0001, COL48-0087-0700, or COL49-0087-0701 installed.

Exception: Anchorage (PANC) approach procedures that allow less than RNP 0.3 are authorized provided the instructions outlined in the Electronics – Global Landing Unit Section of Normal Procedures Chapter are followed.

Note: Currently, Fairbanks (PAFA) and Anchorage (PANC) are the only airports in the region with an RNP approach that requires better than 0.3 nmi performance.
