[Docket No. FAA-2025-0618; Project Identifier AD-2024-00637-T; Amendment 39-23280; AD 2026-05-07]

Airworthiness Directives; The Boeing Company Airplanes

Final rule.

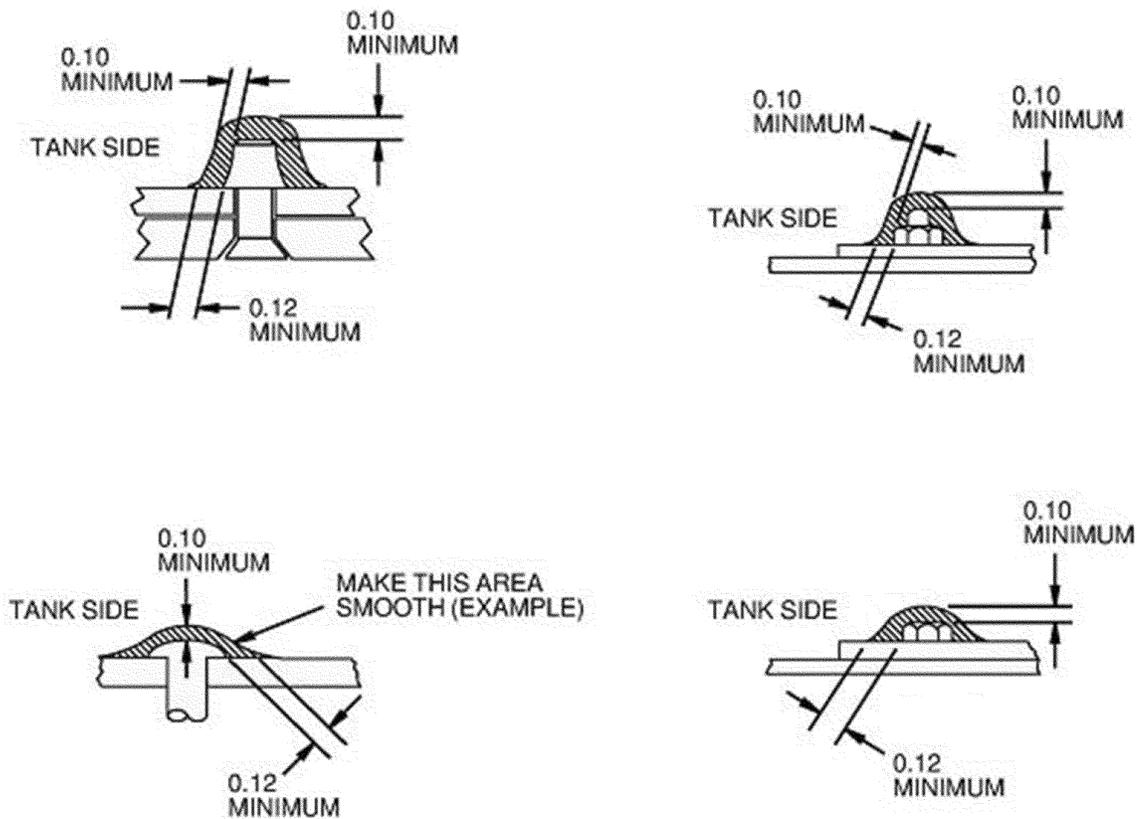
Figure 1 to Paragraph (h)(4)—Cap Seal Minimum Thickness (All Dimensions in Inches)

(4) During application of any cap seal to a fastener, fastener head, and fastener threads and collars inside the tank, as required by this AD, the cap seal must be applied with a thickness equal to or greater than the dimensions specified in figure 1 to paragraph (h)(4) of this AD.
