**[Docket No. FAA-2025-2546; Project Identifier AD-2025-01060-T; Amendment 39-23414; AD 2026-15-02]**

### **Airworthiness Directives; The Boeing Company Airplanes**

Final rule.

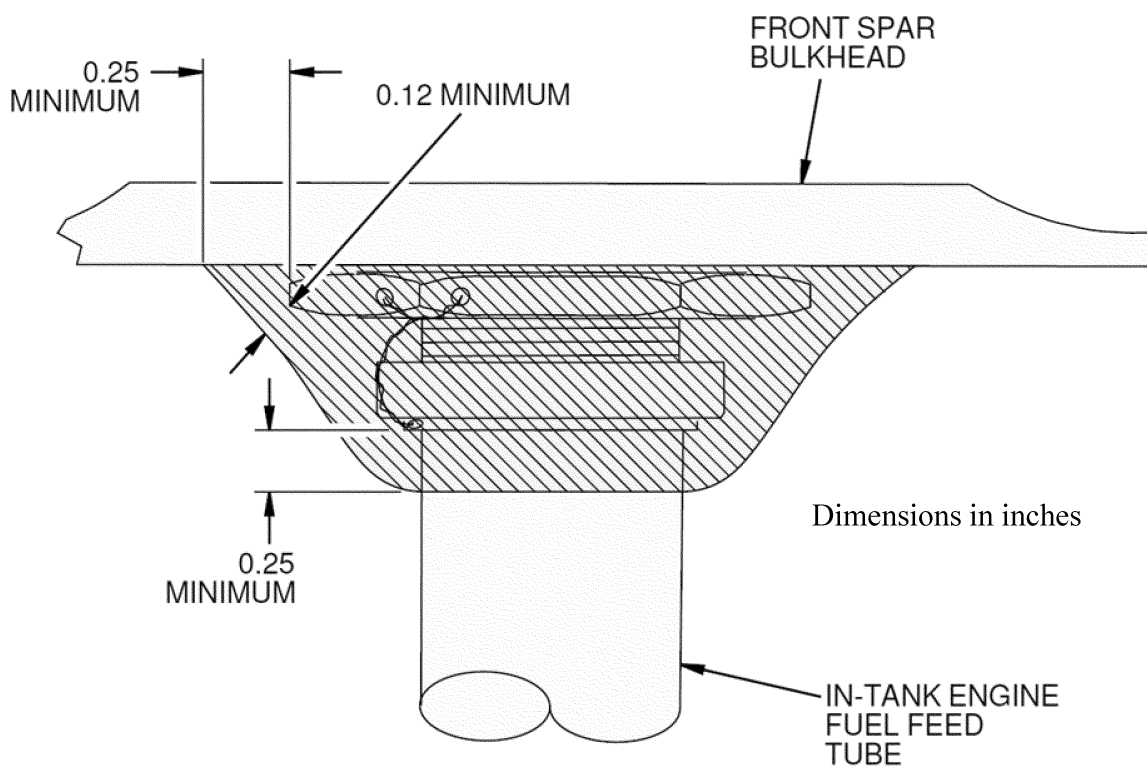
**Figure 2 to paragraph (i) – Fuel Feed Encapsulation**

| AWL NUMBER | TASK | INTERVAL | APPLICABILITY | DESCRIPTION |
|---|---|---|---|---|
| 28-AWL-05 | CDCCCL | N/A | ALL | <p>Lightning Protection – Engine Fuel Feed Line Fuel Tank Penetration Bonding to Spar</p> <p>Concern: Potential for arcing or sparking inside the tank at the interface between the bulkhead fitting and the spar during a lightning strike event.</p> <p>The following design features must be verified (refer to Boeing AMM 28-22-15) if the bulkhead fitting or attached tubing is removed and reinstalled or replaced:</p> <ol style="list-style-type: none"> <li>1. A fay sealed fay surface bond is installed between the bulkhead fitting and the front spar inside the tank.</li> <li>2. The electrical bonding resistance across the fay surface between the bulkhead fitting and the front spar inside the tank is 0.0010 ohm (1.0 milliohm) or less.</li> <li>3. Bonding jumpers are installed as follows. <ol style="list-style-type: none"> <li>a. For airplane line number 1-829: <ol style="list-style-type: none"> <li>i. A bonding jumper is installed between the first fuel tube mating with the bulkhead fitting and structure inside the tank. <ol style="list-style-type: none"> <li>1. If the tube-to-structure bonding jumper was removed and reinstalled or replaced, the electrical bonding resistance between the structure and the first fuel tube mating with the bulkhead fitting inside the tank is 0.0100 ohm (10.0 milliohms) or less.</li> </ol> </li> </ol> </li> <li>b. For airplane line numbers 830 and on: <ol style="list-style-type: none"> <li>i. A bonding jumper is installed between the first fuel tube mating with the bulkhead fitting and the second AFT fuel tube inside the tank. <ol style="list-style-type: none"> <li>1. If the tube-to-tube bonding jumper was removed and reinstalled or replaced, the electrical bonding resistance between the first fuel tube mating with the bulkhead fitting and second AFT fuel tube inside the tank is 0.0100 ohm (10.0 milliohms) or less.</li> </ol> </li> </ol> </li> </ol> </li> </ol> |

| | | <ul style="list-style-type: none"><li>ii. A bonding jumper is installed between the second AFT fuel tube and structure inside the tank.<ul style="list-style-type: none"><li>1. If the tube-to-structure bonding jumper was removed and reinstalled or replaced, the electrical bonding resistance between the structure and the second AFT fuel tube inside the tank is 0.0100 ohm (10.0 milliohms) or less.</li></ul></li><li>4. A full-bodied fillet seal is installed that encapsulates the bulkhead fitting to the front spar and the coupling nut inside the tank. (Refer to Boeing AMM 28-22-15/201 Temporary Revision published between September 16, 2025, and September 17, 2025; Boeing AMM 28-22-15/201 published on or after January 5, 2026.)<ul style="list-style-type: none"><li>a. The sealant is smooth and the sealant meets the required dimensions as specified in the accompanying figure.<ul style="list-style-type: none"><li>i. Sealant is considered sufficiently thick when the outline of the coupling or fitting hardware is not visible under the sealant.</li></ul></li><li>b. Each sealant interface passes an adhesion test using a Frixion eraser.<ul style="list-style-type: none"><li>i. Peeling of the brushcoat is not considered a failure if the peeling stops before the Class B seal.</li></ul></li></ul></li></ul> |
