[Docket No. FAA-2025-3987; Project Identifier AD-2025-00017-R; Amendment 39-23466; AD 2026-19-01]

#### Airworthiness Directives; MD Helicopters, LLC Helicopters

Final rule; correction.

**2026-19-01 MD Helicopters, LLC:** Amendment 39-23466; Docket No. FAA-2025-3987; Project Identifier AD-2025-00017-R.

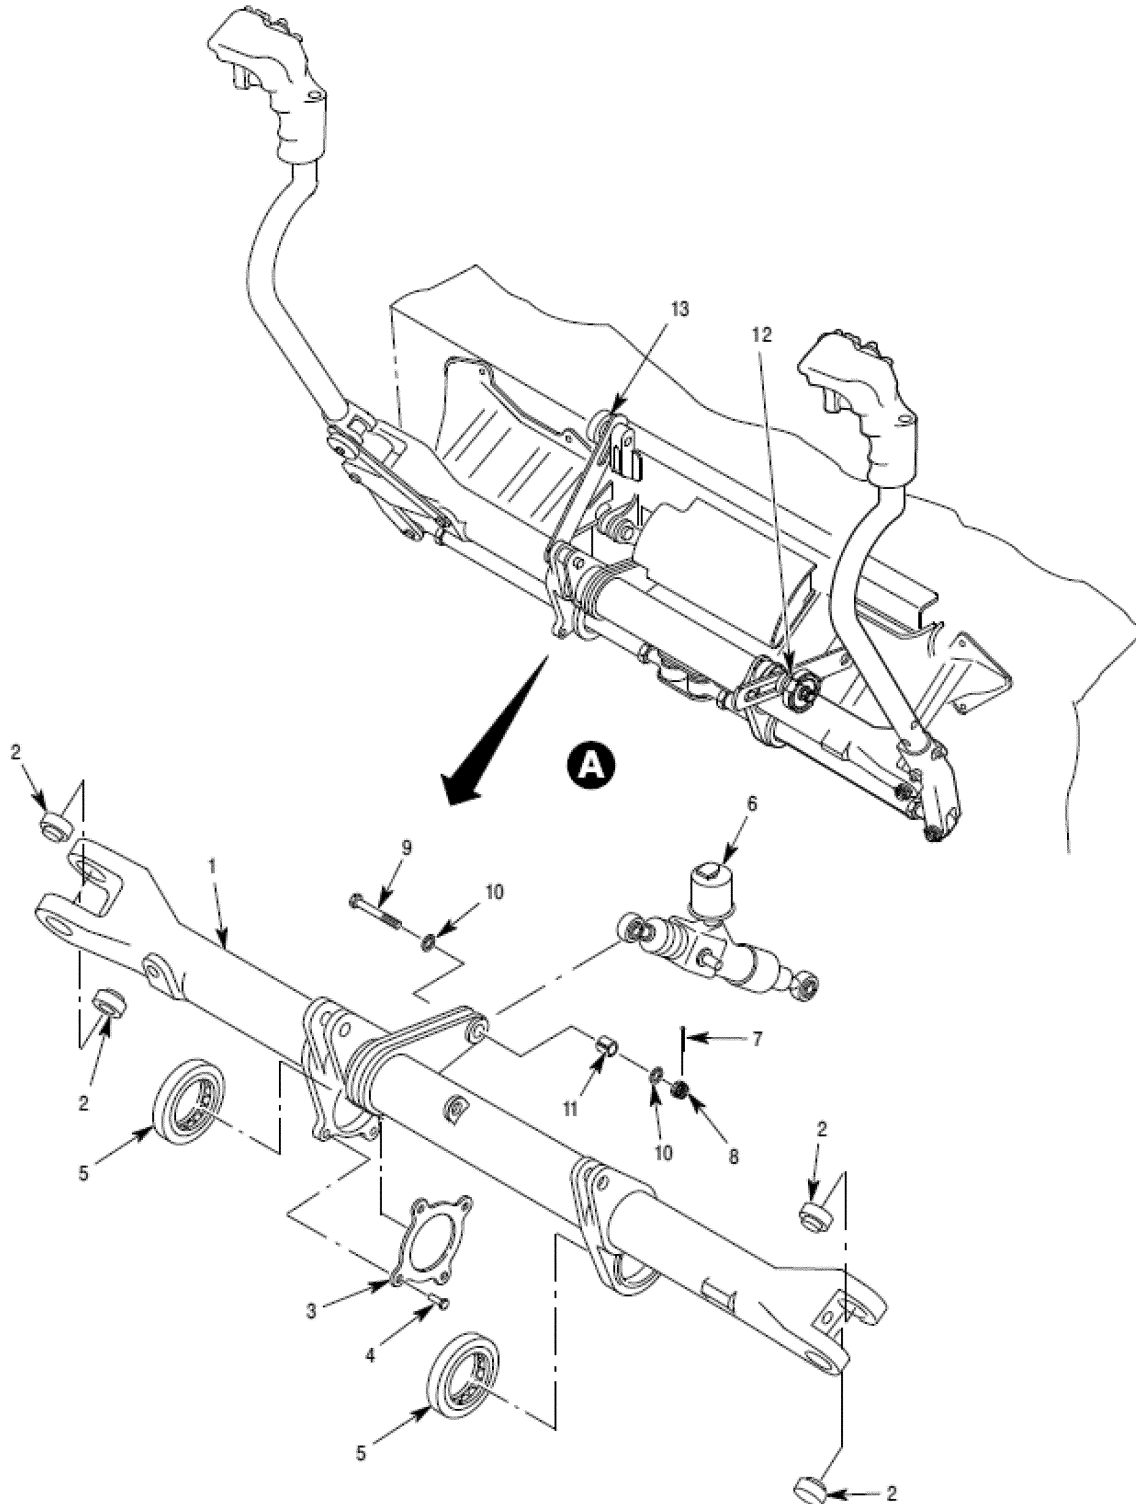
This AD was prompted by a report of a seized and damaged roller bearing assembly in the torque tube assembly. The FAA is issuing this AD to prevent failure of the torque tube assembly. The unsafe condition, if not addressed, could result in reduced controllability and loss of control of the helicopter.

(ii) Visually inspect each roller bearing (number 5) as depicted in Figure 1 to paragraph (g)(1) of this AD for corrosion and degradation. If a roller bearing has any corrosion or degradation, before further flight, remove the roller bearing from service and install an airworthy roller bearing.

(A) If there is any binding or ratcheting as a result of the action required by paragraph (g)(2)(iii) of this AD, before further flight, inspect each roller bearing (number 5) as depicted in Figure 1 to paragraph (g)(1) of this AD for damage. For the purposes of this inspection, damage may be indicated by corrosion, lack of lubrication (dry exterior surface), or material degradation.

(i) Using a flashlight and mirror, visually inspect the torque tube for corrosion and cracks. If there is any corrosion or a crack, before further flight, remove the torque tube from service and install an airworthy torque tube.

(i) Disconnect the one-way lock (number 6) of the torque tube by removing the cotter pin (number 7), nut (number 8), bolt (number 9), washers (number 10), and slotted bushing (number 11) from the torque tube assembly as depicted in Figure 1 to paragraph (g)(1) of this AD.

(ii) Loosen the longitudinal cyclic friction knob (number 12 or 13) of the torque tube assembly as depicted in Figure 1 to paragraph (g)(1) of this AD.

(B) If any roller bearing (number 5) as depicted in Figure 1 to paragraph (g)(1) of this AD has any damage, before further flight, remove the roller bearing from service and install an airworthy roller bearing.

(iv) If there is no binding or ratcheting as a result of the action required by paragraph (g)(2)(iii) of this AD or after accomplishing the action required by paragraph (g)(2)(iii)(B) of this AD, as applicable, tighten the cyclic friction knob (number 12 or 13) as depicted in Figure 1 to paragraph (g)(1) of this AD.

(A) Install the slotted bushing (number 11), washers (number 10), bolt (number 9), nut (number 8), and new (zero total hours TIS) cotter pin (number 7) as depicted in Figure 1 to paragraph (g)(1) of this AD.

(B) Ensure the edge of the slotted bushing (number 11) protrudes 0.010 to 0.080 inch (0.25 to 2.03 millimeters) above the surface of the cyclic torque tube after the nut is tightened.
