**U.S. DEPARTMENT OF TRANSPORTATION
FEDERAL AVIATION ADMINISTRATION**

Airworthiness Directive

61-11-01 BRANTLY: Amdt. 288 Part 507 Federal Register May 23, 1961. Applies to All B-2 Helicopters.

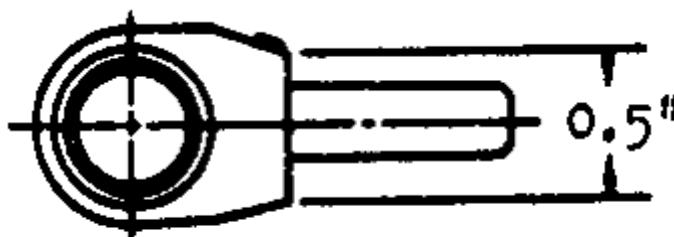
FIGURE 1

A failure in the skid landing gear drag brace rod end bearing (Kahr Bearing Co. P/N HE-3SFN) occurred during ground handling resulting in collapse of the landing gear. This failure occurred through the area of the lubrication fitting.

To preclude the possibility of additional failures, check the shoulder dimension of the two (2) Kahr P/N HE-3SFN rod end bearings at the forward ends of the Brantly P/N B2-259-1 and B2-259-2 landing gear drag struts. If the dimension shown in the sketch is less than 0.5 inch, the part must be replaced before further flight with a new bearing, Brantly P/N B2-259-11, or an FAA approved equivalent.
