Airworthiness Directive

68-04-04 R2 BRANTLY: Amendment 39-557 as amended by Amendment 39-3568 is further amended by Amendment 39-4552. Applies to Model B-2, B-2A, and B-2B helicopters, certificated in all categories.

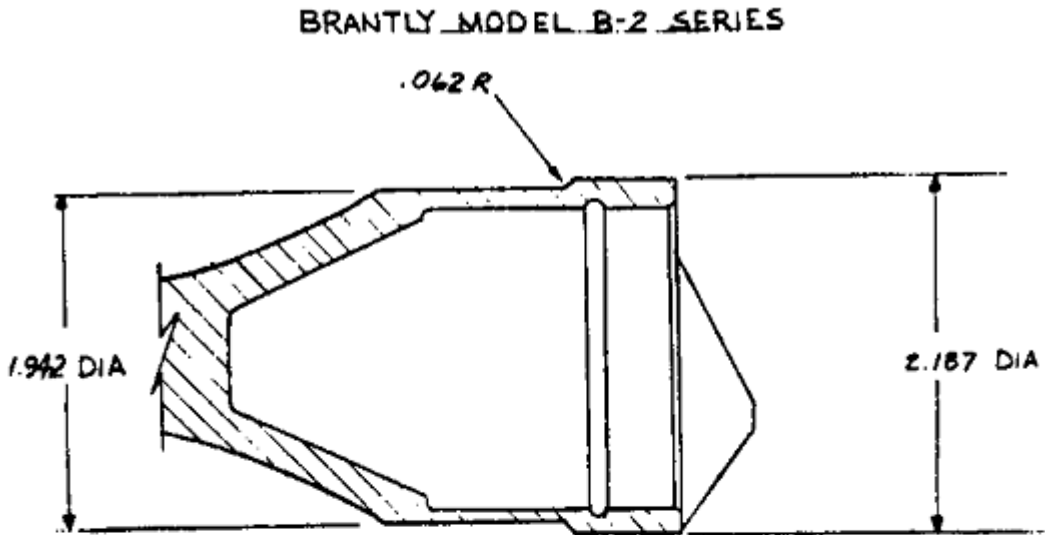
PN III-11

(c) To prevent confusion during subsequent inspections of tail rotor blades due to similarity between tail rotor blade assembly, PN 111-11, and assembly, PN 111-11A, use a permanent marking ink or equivalent acceptable for aluminum aircraft components to mark the tail rotor blade assembly with the proper part number identification (see Fig. 1 for dimensions that determine the part configuration).
