Docket No. 95-CE-28-AD; Amendment 39-9472; AD 95-26-13

Airworthiness Directives; The New Piper Aircraft, Inc. (formerly Piper Aircraft Corporation)
PA28 and PA32 Series Airplanes

95-26-13 THE NEW PIPER AIRCRAFT, INC.: Amendment 39-9472. Docket 95-CE-28-AD.
Supersedes AD 76-25-06, Amendment 39-2788.

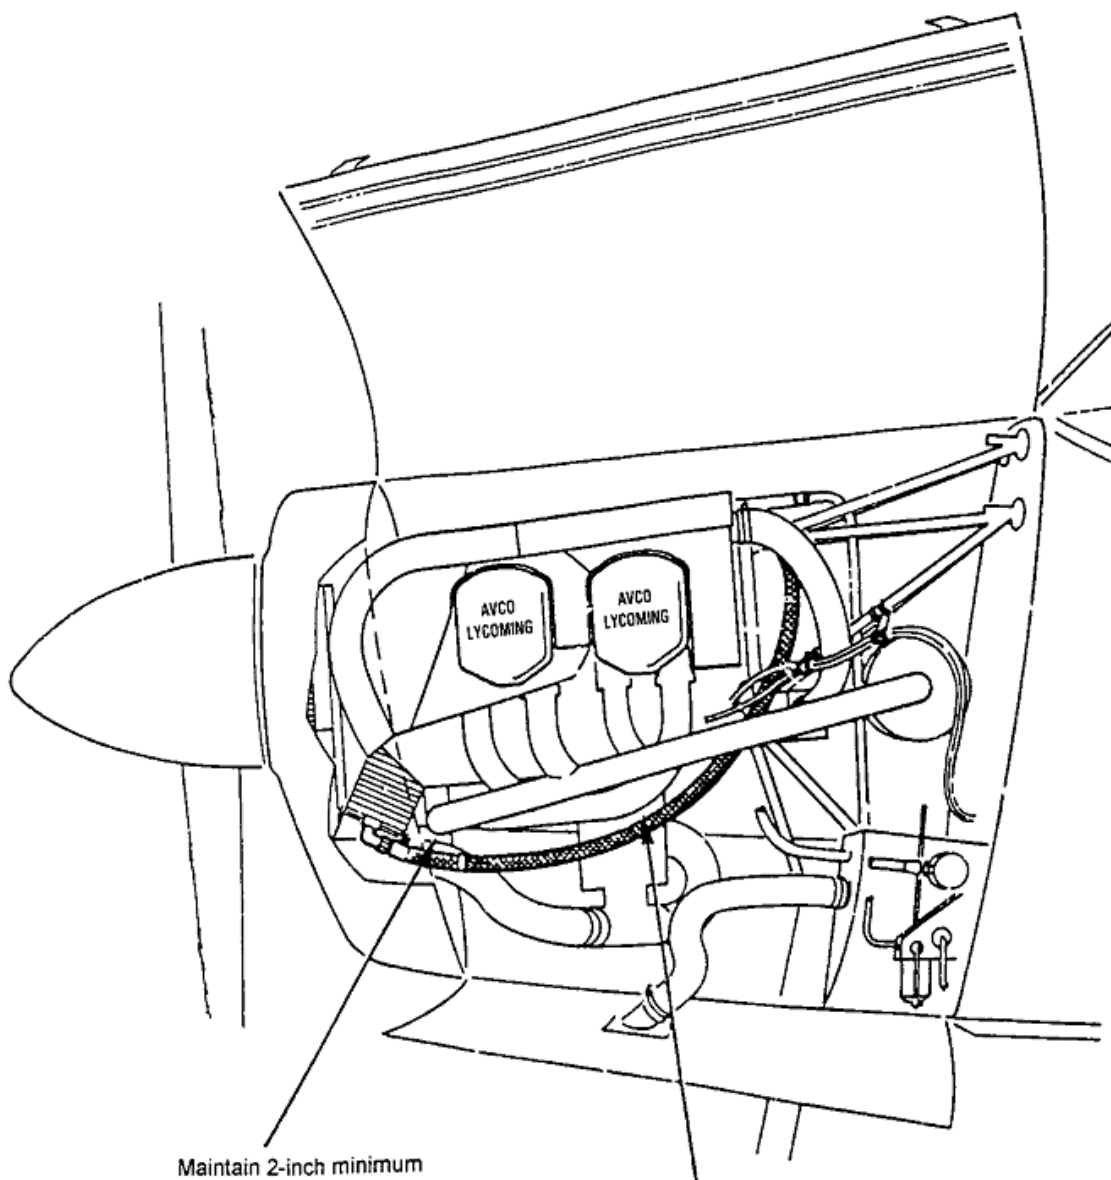
(i) The hose passes underneath and behind the electrical ground cable and in front of the lower of the two engine mount struts when the hose is routed to the rear of the engine; and

(ii) The hose is tied to the engine mount strut and a clearance of at least 2 inches exists between the oil hose and exhaust stack.

NOTE 2: Figure 1 of this AD relates to the conditions specified in paragraphs (a)(2)(i) and (a)(2)(ii) of this AD.

Maintain 2-inch minimum clearance between oil cooler hoses and exhaust stack in this area.

(2) Replace each oil cooler hose assembly with an approved TSO-C53a, Type D, hose assembly ensuring that there is a minimum of 2 inches between the oil cooler hoses and exhaust stacks (as applicable) upon installation. Ensure that there is a minimum bend radius of 6.5 inches on oil cooler assemblies incorporating 0.75-inch outer diameter hoses.

(d) After adjusting or installing oil cooler hoses, prior to further flight, run the engine for 5 minutes to ensure that there are no oil leaks and that the 2-inch clearance is maintained (as applicable) when the engine is warm. Prior to further flight, replace any leaking oil cooler hoses and adjust the clearance accordingly.
