Docket No. 93-CE-54-AD; Amendment 39-9665; AD 96-12-22

Airworthiness Directives; Cessna Aircraft Company Engine Oil Filter Adapter Assemblies Installed on Aircraft

**96-12-22 CESSNA AIRCRAFT COMPANY:** Amendment 39-9665; Docket No. 93-CE-54-AD.

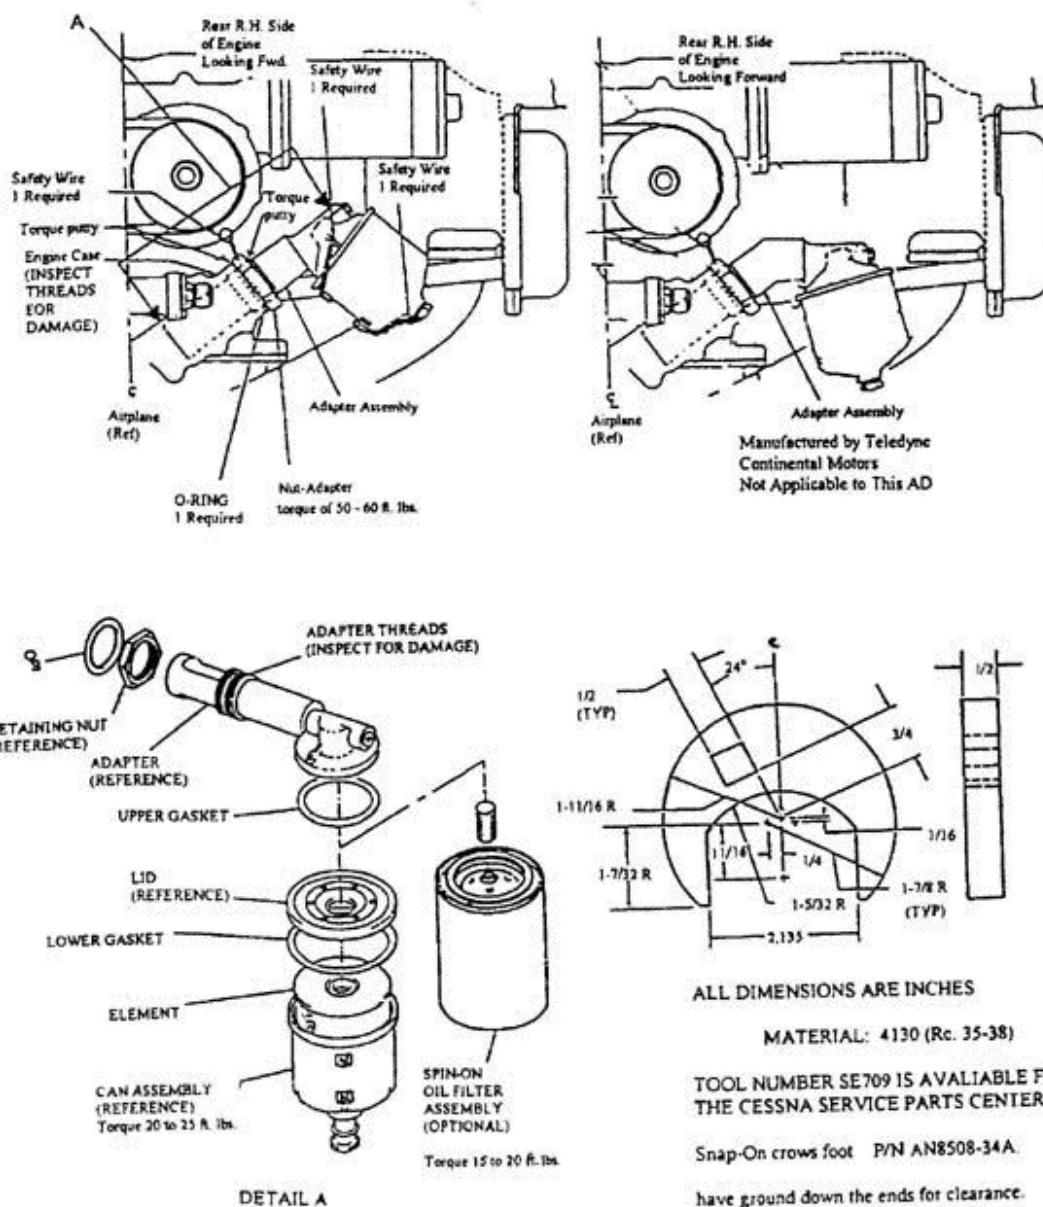
Figure 1. Oil Filter Adapter Installation

NOTE 2: This AD does not apply to engine oil filter adapter assemblies manufactured by Teledyne Continental Motors (See Figure 1 of this AD).

(b) For airplanes with torque putty between the engine filter adapter assembly, nut, and oil pump housing, inspect the torque putty for misalignment, evidence of oil leakage, or cracks.

- (1) Inspect the adapter locking nut installation for evidence of oil leakage.
- (2) Check the torque of the adapter nut installation and ensure that the torque value is within the limits of 50 through 60 foot pounds.
- (3) If evidence of oil leakage is found or the torque is not within the 50 through 60-foot pound limit, prior to further flight, remove the adapter and filter assembly, and:
  - (i) Inspect the threads of the adapter assembly and engine for signs of damaged or cracked threads; and
  - (ii) Replace any adapter assembly and engine oil pump housing (if necessary) that have evidence of thread damage or cracks.
- (4) Apply torque putty between the engine filter adapter assembly, nut, and oil pump housing as specified in Figure 1 of this AD.
- (5) Reassemble the engine oil filter assembly.

(1) If any misalignment, evidence of oil leakage, or torque putty cracks are found, prior to further flight, accomplish the requirements specified in paragraph (a) of this AD, including all subparagraphs.
